Zeitschrift: IABSE reports = Rapports AIPC = IVBH Berichte

Band: 70 (1993)

Bâtiments de protection pour des ruines et monuments Schutzbauten für Ruinen und Monumente

Protection Buildings for Ruins and Monuments

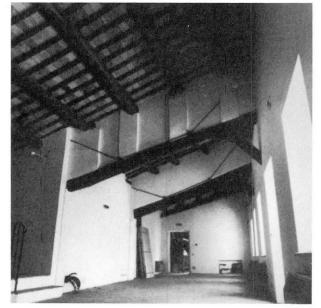
Pic. 6

Pic. 7

A similar intervention was carried out on the principal structure of the upper floor of the hall. This structure is composed of wooden or steel beams. (see pic. 7)

The increase in bearing capacity was obtained by a steel section placed over the principal beam within the height of, and connected to, the secondary structure.

These interventions shown in the photo 6, allow the avoidance of any interference and damage the reinforced structure.
