Zeitschrift: IABSE reports = Rapports AIPC = IVBH Berichte
Band: 73/1/73/2 (1995)

Session A2

Seismic Strengthening of Buildings: Case Studies
Renforcement parasismique des bâtiments: études de cas
Verstärkung bezüglich Erdbeben im Hochbau: Fallstudien

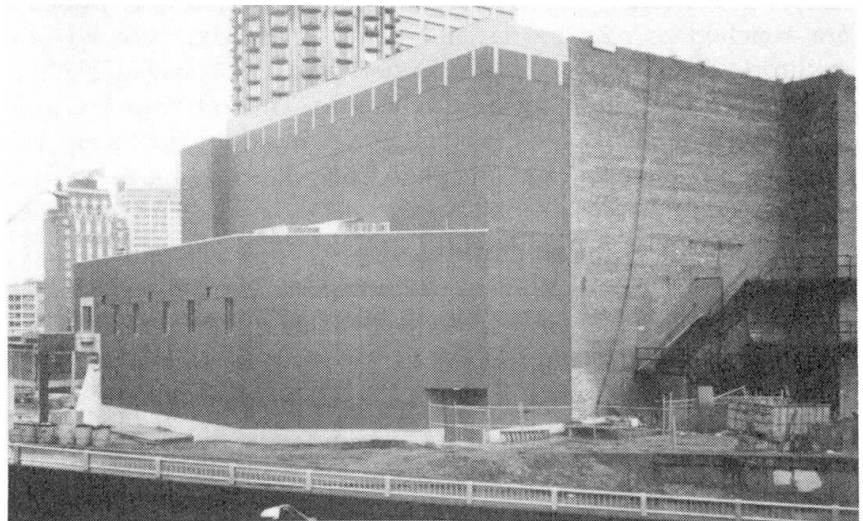
Fig. 4: Backstage Addition

The foundation of the new structure consisted of concrete augercast piles in combination with the steel soldier piles, which were attached to the concrete walls for transfer of permanent gravity loads. The loading dock is a cast-in-place concrete structure designed for highway truck loads. The dressing rooms and roof are conventional steel frame floor systems supported on steel tube columns at the exterior and concrete masonry unit (CMU) walls at the backstage wall. This tall slender 19 cm CMU wall also supports a portion of the expanded stage roof. A photograph of the building showing the backstage addition is given in Figure 4.
