Heated Bridge Deck Construction and Operation in Lincoln, Nebraska

Milo D. CRESS

Bridge Engineer
Federal Highway Administration
Lincoln, NE, USA

The construction and operation of a hydronic bridge/pavement deck heating system are described in this paper. The system is installed in the deck of a 367 m-long by 3.7 m-wide viaduct in Lincoln, Nebraska, USA. The system was monitored and performance evaluated for 12 months following installation.

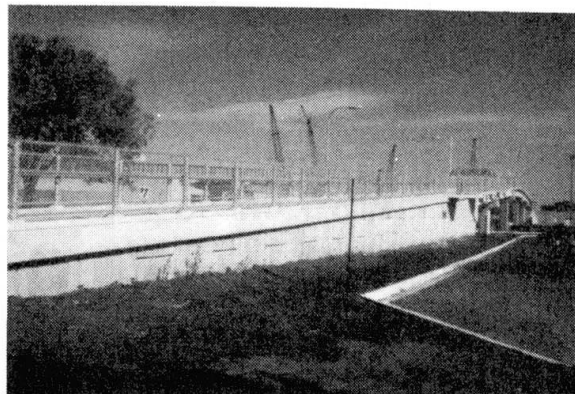
Fig. 1 New 10th Street Pedestrian Viaduct

A new 367-m-long elevated pedestrian viaduct (Fig. 1) was constructed in 1992 over several railroad beds. Special Federal funding was available to install heated decks under an Intermodal Surface Transportation Efficiency Act of 1991 program; this deck was eligible and was a particularly attractive candidate because of its central location, heavy bicycle use, and potential use by the physically impaired.

The structure is a 5-span, 169.8-m-long precast-prestressed-post-tensioned concrete superstructure with an 165-mm-thick by 3.7-m-wide cast-in-place deck. The approaches, supported on mechanically stabilized earth (MSE), are 70.7-m- and 126.5-m-long and have 5 percent grade. The total top surface areas of the south approach, elevated structure, and north approach are 289 m², 696 m², and 614 m², respectively. The highest deck is 8.8 m above the boiler.

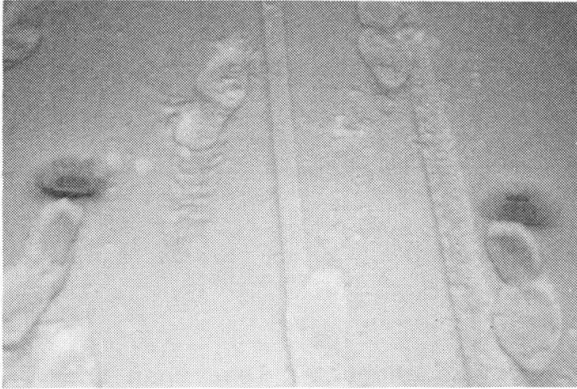
Fig. 9 Moisture Sensors with Snow

Light drizzle with very light snow flakes began early in the morning on December 30, 1994. This continued through most of the day. At 1200 hours the deck was wet, except at the control moisture sensors. Each sensor and about a 50-mm region around each sensor remained dry. Heat from sensors was evaporating moisture. At 1630 hours sensors had some ice accumulation that bridged the sensing elements. At 2330 hours snowfall was very light and about 20 mm of snow had accumulated on the deck. Sensors had no ice and were dry with adjacent snow accumulation (Fig. 9). At 0800 hours on December 31, about 32 mm of snow had accumulated on the deck and sensor location was slightly marked by dark spots on the snow (Fig. 10). Snow accumulation had formed a cap over each sensor and each sensor remained dry. The system did not start automatically because of this "igloo" effect. During investigation of the sensors, snow fell on the sensors, was melted, and the system started at 0955 hours on December 31. Gas and electric meter readings were 8 393 m³ and 2 276 kWh, respectively. At 1840 hours, gas and electric meter readings were 8 996 m³ and 2 320 kWh, respectively. Snow had been melted on about 40 percent of the deck and some spots on the deck were dry. At 1200 hours on January 1, 1995, about 38 mm of snow had accumulated on unheated streets and sidewalks. Gas and electric meter readings were 10 191 m³ and 2 402 kWh, respectively. The deck was about 95 percent cleared with significant dry areas. The boiler was cycling on and off. At 1600 hours the gas and electric meter readings were 10 432 m³ and 2 420 kWh, respectively. The deck was 99 percent clear and the boiler was cycling on and off (Fig. 11). At 1830 hours gas and electric meter readings were 10 516 m³ and 2 421 kWh, respectively. Pump motors were running and the boiler was not operating. The system was manually turned off at 2330 hours and motors stopped. Subsequent

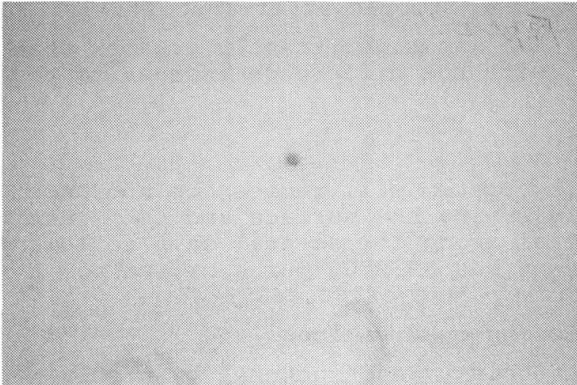
Fig. 10 Moisture Sensor Location as Observed

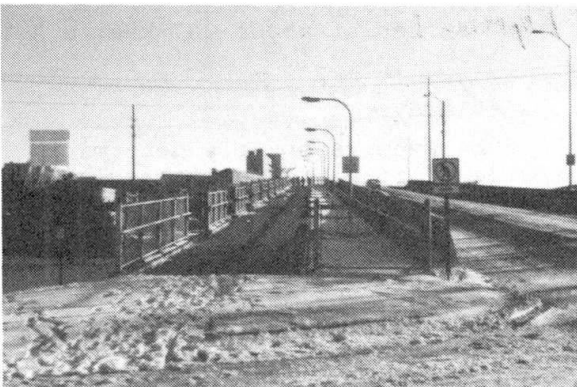
Fig. 11 Advanced Snow Melt
