## Heated Bridge Deck Construction and Operation in Lincoln, Nebraska

**Milo D. CRESS**  
Bridge Engineer  
Federal Highway Administration  
Lincoln, NE, USA

The construction and operation of a hydronic bridge/pavement deck heating system are described in this paper. The system is installed in the deck of a 367 m-long by 3.7 m-wide viaduct in Lincoln, Nebraska, USA. The system was monitored and performance evaluated for 12 months following installation.

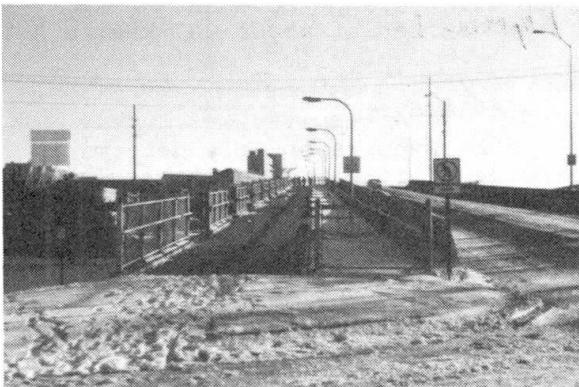
Fig. 11 Advanced Snow Melt
