Zeitschrift: IABSE reports = Rapports AIPC = IVBH Berichte
Band: 73/1/73/2 (1995)

Artikel: Repair and renovation of the Reading Terminal in Philadelphia
Autor: Clark, T. Henry
DOI: <https://doi.org/10.5169/seals-55253>

Repair and Renovation of the Reading Terminal in Philadelphia

T. Henry CLARK
President
Ross Bryan Associates
Nashville, TN, USA

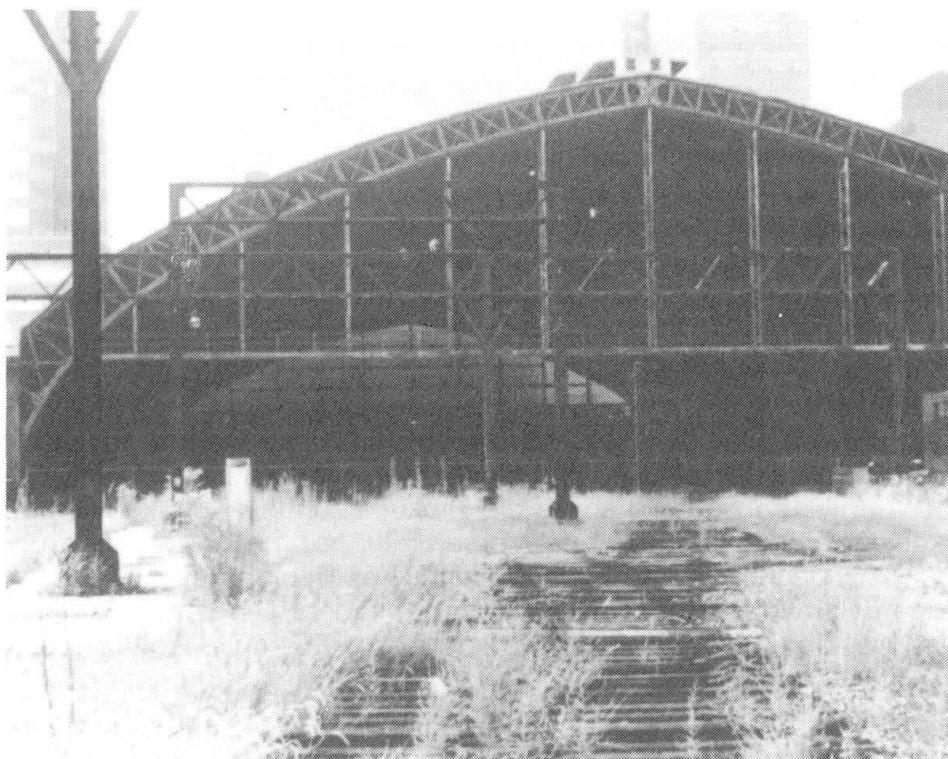
Rail lines in the city were elevated on rubble-filled viaducts with cut stone gravity retaining walls. Arches of steel rail and brick infill crossed streets so that neither rail nor street traffic would impede each other. For that reason, the tracks were required to enter the terminal on the second level which was 7.6 meters above street grade. Placing the tracks this way enabled the first floor to be available for other uses. As it happened, the site contained two important market houses between Filbert and Market streets which were to be demolished and relocated by the terminal construction. The markets were offered space on the first floor. The terminal building was to begin north of the Head House on Market Street. The construction of the Terminal building before the Head House allowed the markets to operate continuously, which set a precedent for the latest renovation when the markets were also kept open.
