Zeitschrift: IABSE reports = Rapports AIPC = IVBH Berichte
Band: 77 (1998)

Rubrik: Session 1: Evaluation of deterioration of buildings

Investigations of Mass Flow in the Existing Building Stock

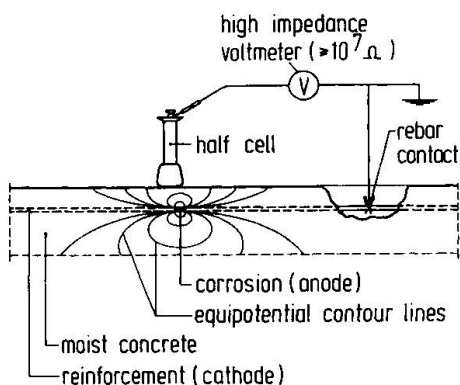
Fig. 1 Scheme for potential measurements with a half cell on the surface of a reinforced concrete member

Coming from one half cell (cp. fig. 1) a more practical measuring equipment was developed: 6 CSE half cells were assembled in a frame, this enabled only one person to handle the equipment (fig. 4).

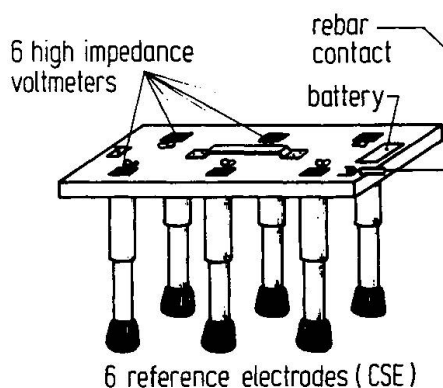
Fig. 4 View of the developed frame with 6 CSE half cells

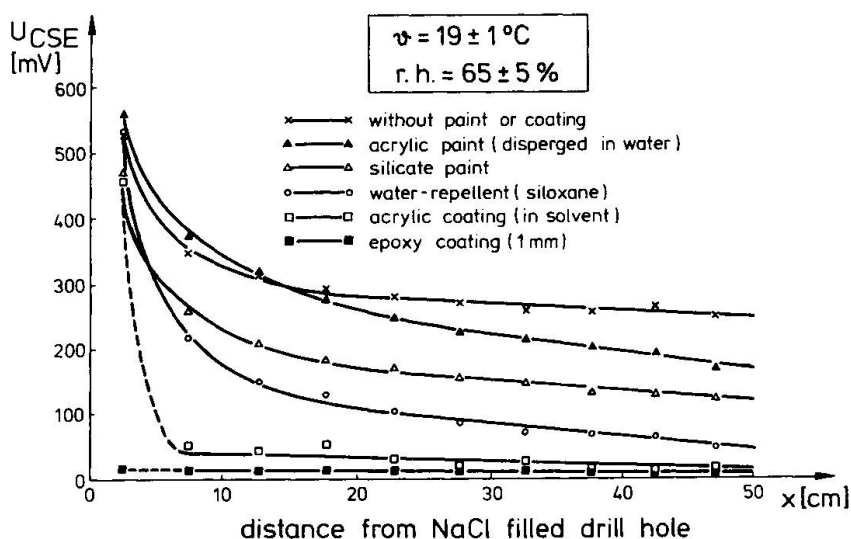
Fig. 2 Dependence of the potential U_{CSE} on the distance x to the NaCl filled drill hole for different paints or coatings on the concrete surface

- temperature and moisture of the concrete,
- thickness of the concrete covering,
- concrete surfaces with or without paints or coatings (fig. 2 and 3),
- components of zinc galvanized steel in concrete.

It could be shown that potential measurements do not depend on the temperature of the concrete but they were only possible between 30 and 90 % relative humidity of the surrounding atmosphere. Thick concrete coverings make it difficult to find small corrosion areas; fair-faced concrete walls coated e.g. with a thin acrylic paint are no problem (fig. 2), but on concrete surfaces with exposed aggregates by washing it is difficult to contact the cement grout (fig. 3). The interpretation of potential measurements in concrete walls with components of zinc galvanized steel is very difficult or impossible.

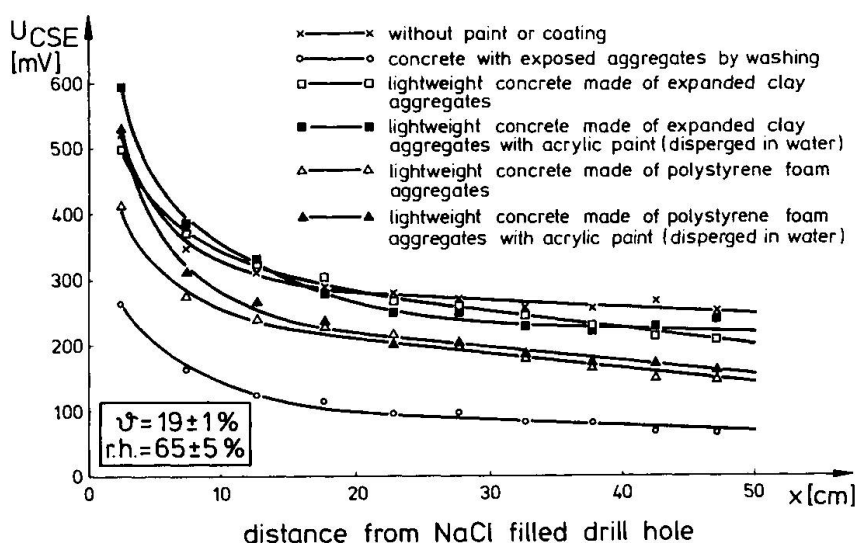
Fig. 3 Dependence of the potential U_{CSE} on the distance x to the NaCl filled drill hole for different lightweight concretes with or without thin acrylic paint

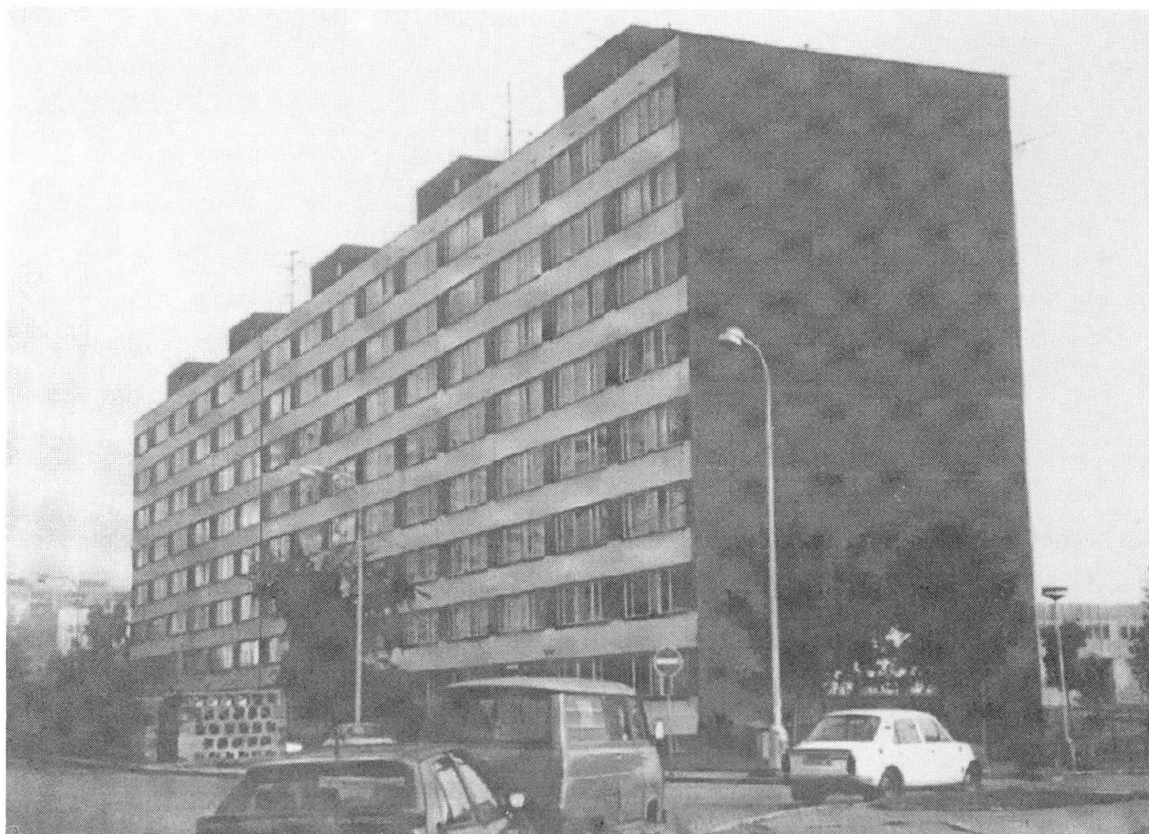
Fig. 1: Photograph of the tested panel building

The panel building that was chosen for the purposes of experimental verification (Resovska street, No. 22, 23, 24) was accomplished in the late seventies in Prague. It is an eight storey building consisting of three equal sections in a row, which are firmly attached to each other (see fig.1). The bearing system is formed by transversal walls 6,0 m apart and one 6m-long longitudinal wall in each section (see fig.2). The joints between the panels (0.19 m thick reinforced concrete slab-elements) consist of concrete and reinforcement. According to the visual survey some of the joints are weakened by hair-thin cracks. The front walls hang on the transversal walls and are not designed for load carrying purposes.

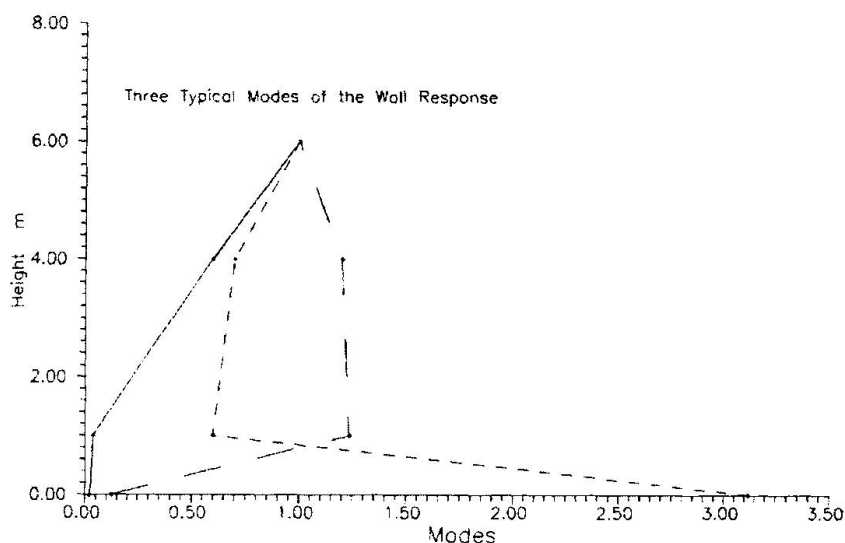
Fig 2. Three typical measured mode forms

Dynamic testing of the wall sections was performed as the only applicable method for evaluation of the structural state. Two methods were applied: (a) impulse tests and (b) transfer function test. As a result of both methods, wall response to dynamic excitation along the height was obtained, and the mode shapes of vibration
