Zeitschrift: IABSE reports = Rapports AIPC = IVBH Berichte
Band: 77 (1998)

Rubrik: Session 1: Evaluation of deterioration of buildings

Investigations of Mass Flow in the Existing Building Stock

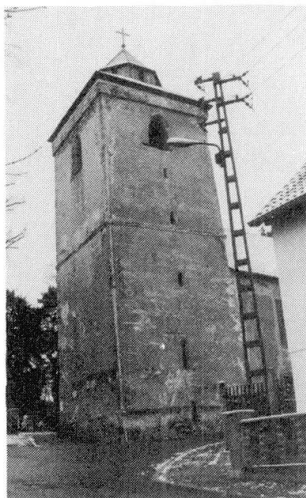
Fig. 1 : The bell tower, view from south-west

The appearance of the medieval Krölpa church tower is significantly characterized by its inclination which was caused by an uneven settlement of the ground. Today the tower is about 2.2 degrees out of the vertical and shows deep vertical cracks in the masonry of its four walls. These damages gave the reason for an investigation of the dynamic structural behaviour of the tower in its current state. It was intended to identify dynamic system properties as well as to model the structure with its specifics numerically.

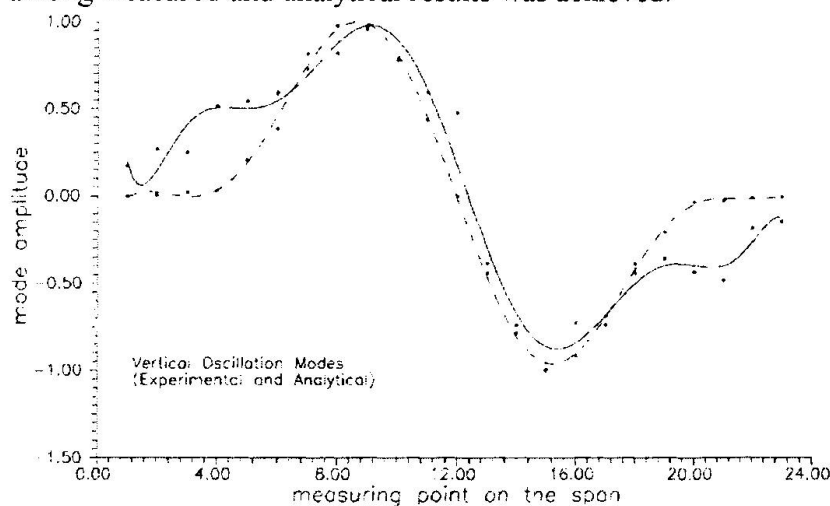
Fig. 3 Vertical mode shapes

The measured mode shapes revealed that for vertical loading bridge behaves as an arch but of a smaller span, while for the perpendicular direction it behaves as a beam with fixed supports. Based on the experimental results, analytical model was modified until a satisfactory correlation among measured and analytical results was achieved.

Good correlation is obvious, and such mathematical model could be used for structural analysis and to check the influence and meaning of the various strengthening methods.
