‘PYLON FOUNDATIONS OF FOUR CABLESTAY BRIDGES THE INDIAN EXPERIENCE’

**TIPPUR NARAYANARAO
SUBBA RAO**
Chairman
Construma Consultancy Pvt.
Ltd.
Bombay
India

The Paper deals with the piers and foundations of four cable stay bridges, each of which are significantly different in concept and execution. Two of the bridges have been executed. One has been executed with the described concept but for a different structural layout and the fourth one is about to be taken up. The kind of problems met with or expected to be met with, are dealt with in some detail. The major project executed, namely the Hooghly River Bridge in Calcutta has been given more attention because of the large span and complexity of the foundations in alluvial soil. The subjects chosen bring out the fact that the foundations for cable stay bridges require indepth attention because of the critical interacting behaviour between the foundation and superstructure system.

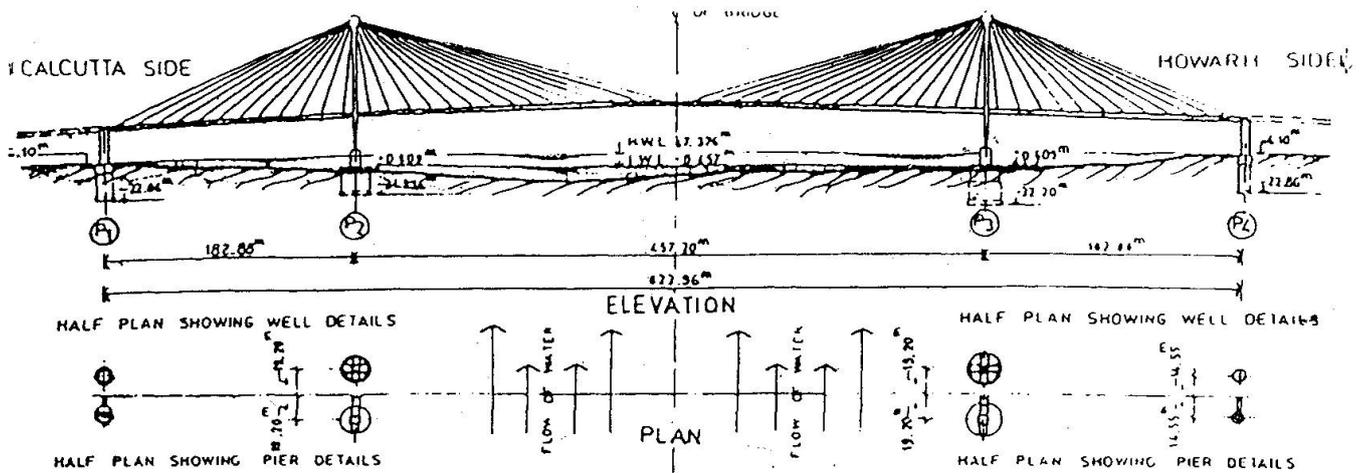
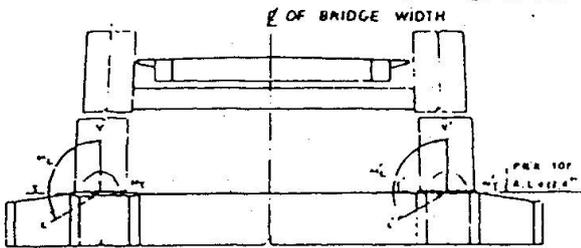
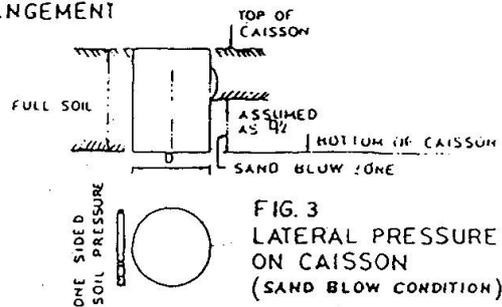
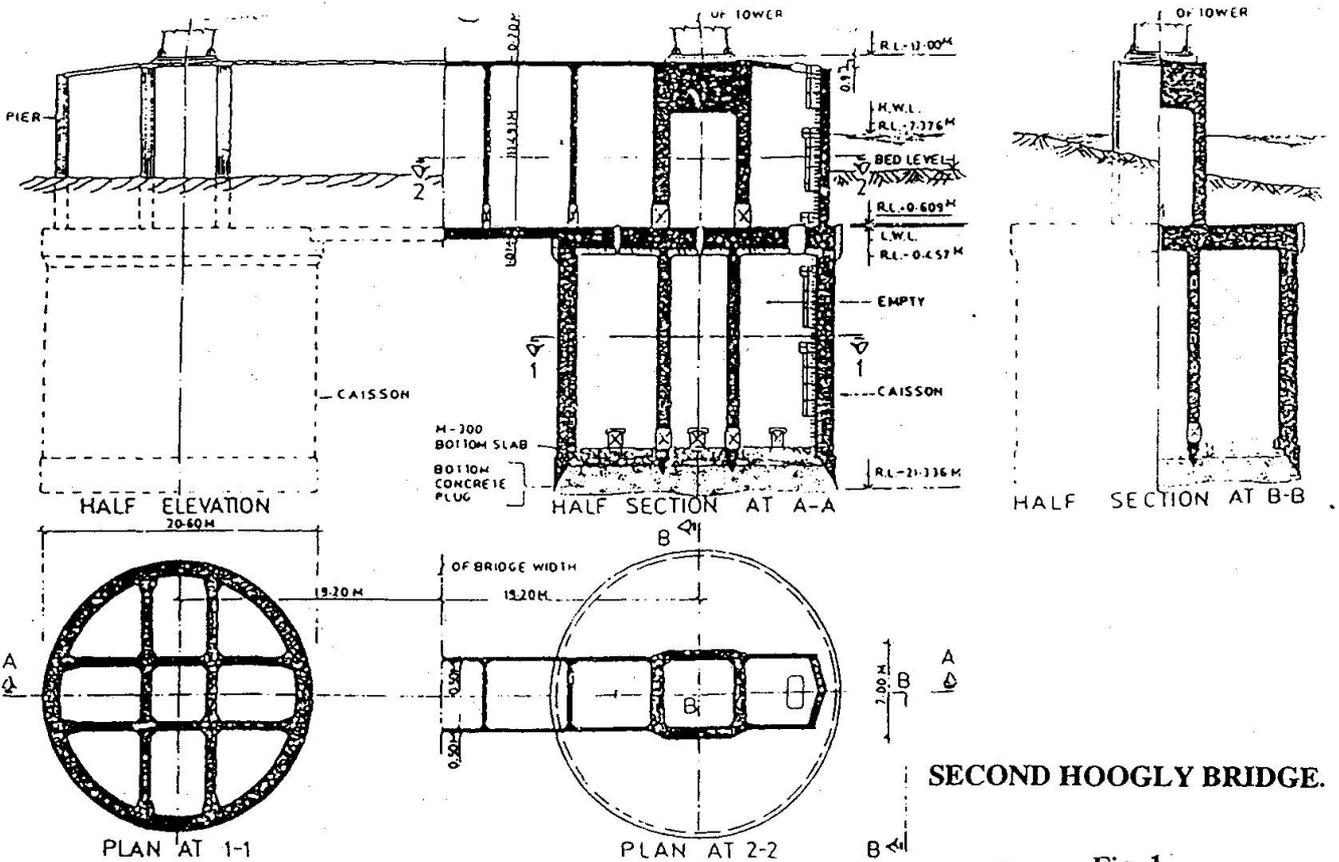
Fig. 1

FIG. 1 GENERAL ARRANGEMENT

FIG. 2 DIRECTION OF LOADS FORCES AND MOMENTS AT THE PYLON BASE

FIG. 3 LATERAL PRESSURE ON CAISSON (SAND BLOW CONDITION)

SECOND HOOGLY BRIDGE.

PIER P 2 & CAISSONS.F-2

The foundations and the piers of the Second Hooghly Bridge in India with a main span of 457 M and side spans of 182 M are most unusual and envelope conceptualisation of several types of complex foundations met with in practice. The (Figs.1&2) illustrate the general layout of the bridge and of the piers and foundations in some detail.

To meet any accidental sand blow conditions during sinking, the caisson was designed for external earth pressure acting on half the diameter on the caisson, with consequent bending effect on the caisson in plan. The vertical steel was also checked for a sudden de-pressurised condition that may develop upto half diameter above the cutting edge of the caisson during the final sinking process. (fig. 1)

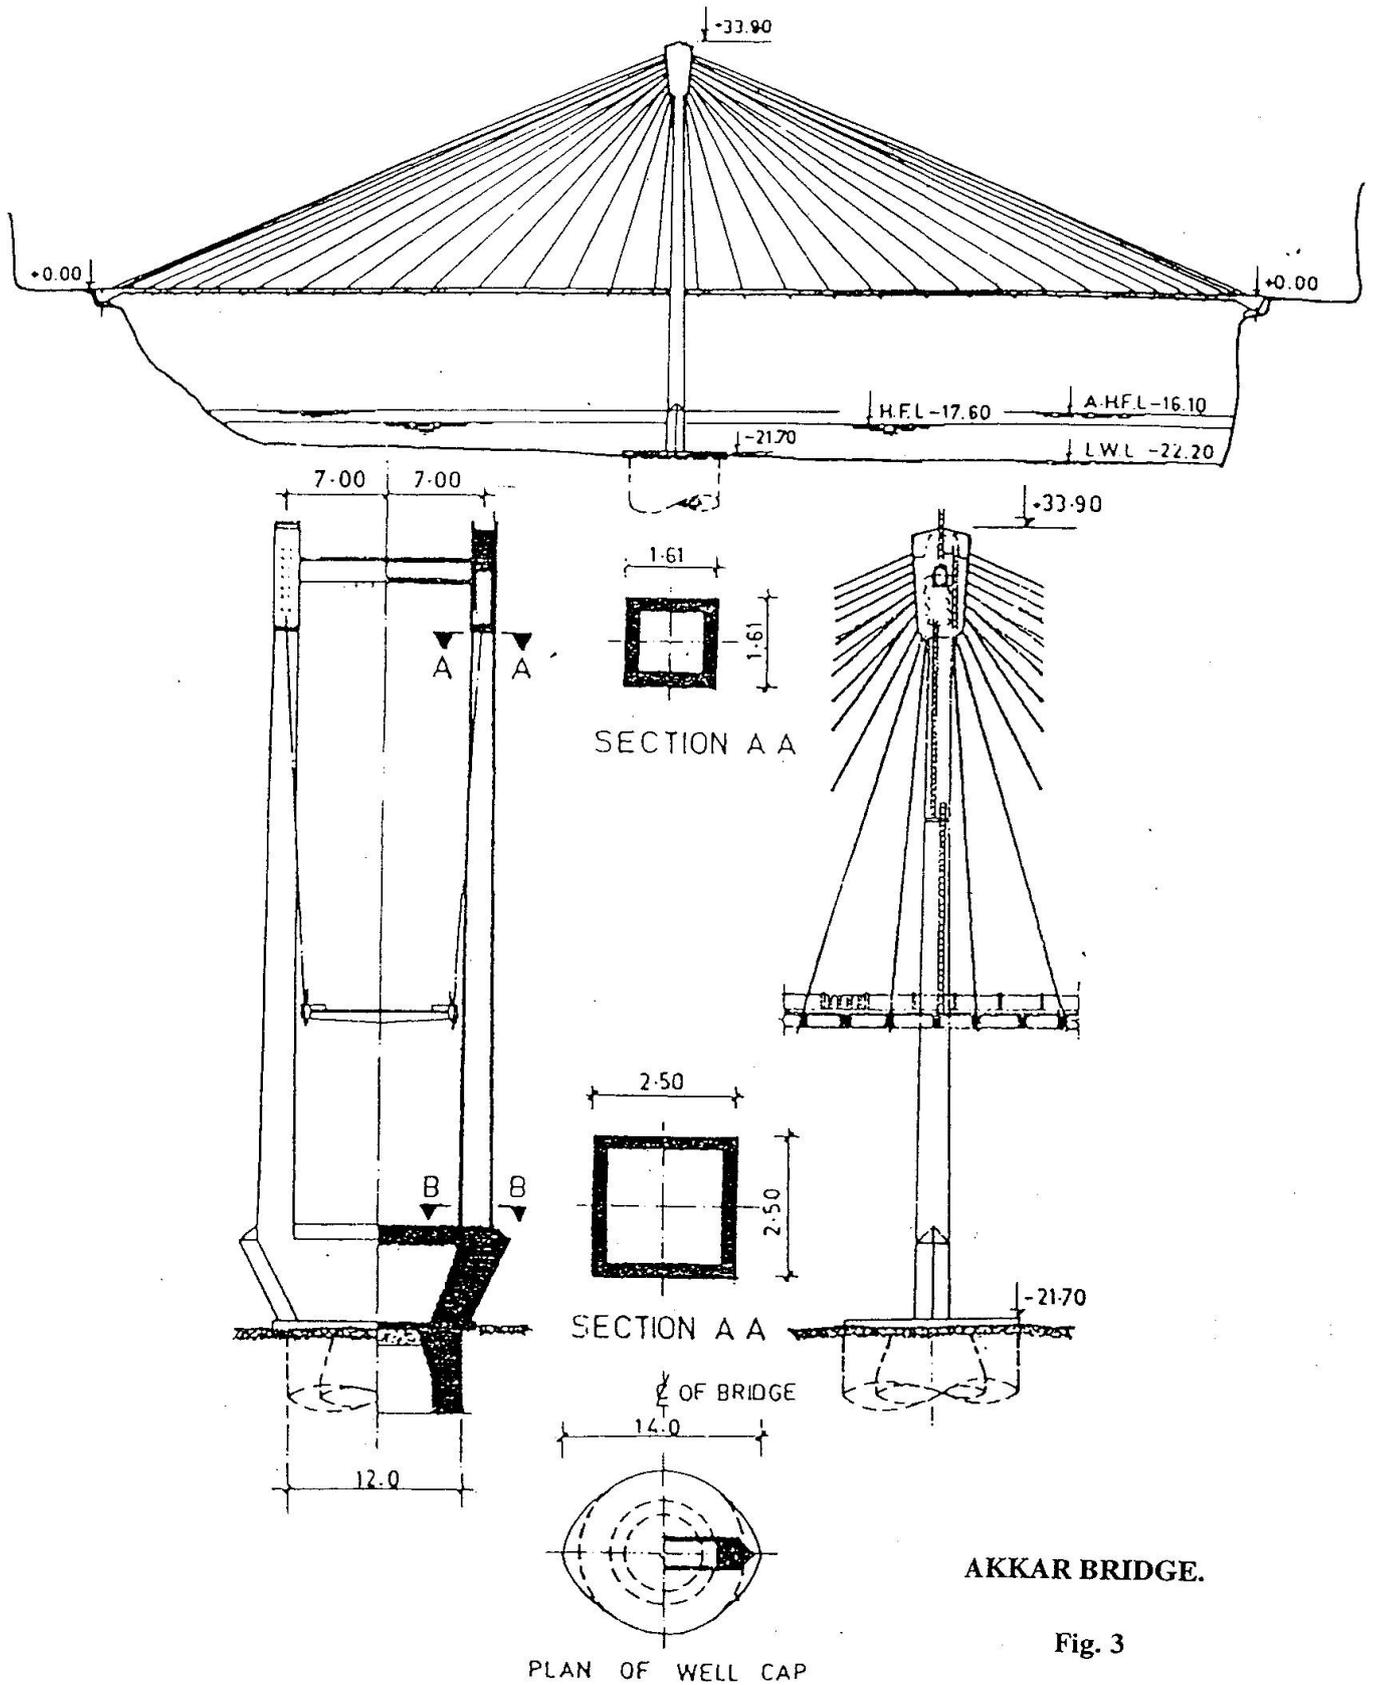
Fig. 3

AKKAR BRIDGE.

The bridge over River Rangeet at Akkar in India has a central pylon with a span of 79 M on either side. The pylon and the deck are all constructed in concrete. (Fig. 3).

The pylon is located on a single circular caisson sunk through rock by using controlled blasting techniques. The caisson is shielded against blasting shocks with steel upto a height of 4.15 M on the outside and 7.70 M inside the dredge hole. The concrete pylon rests on wedge shaped hollow pier just above the high flood level. The nosing of the pier on the upstream side is shielded by armour-plates to protect it from the impact of huge boulders rolling down the fast flowing river during high floods. The pier is founded on a thin slab capping the caisson. (Fig. 3)

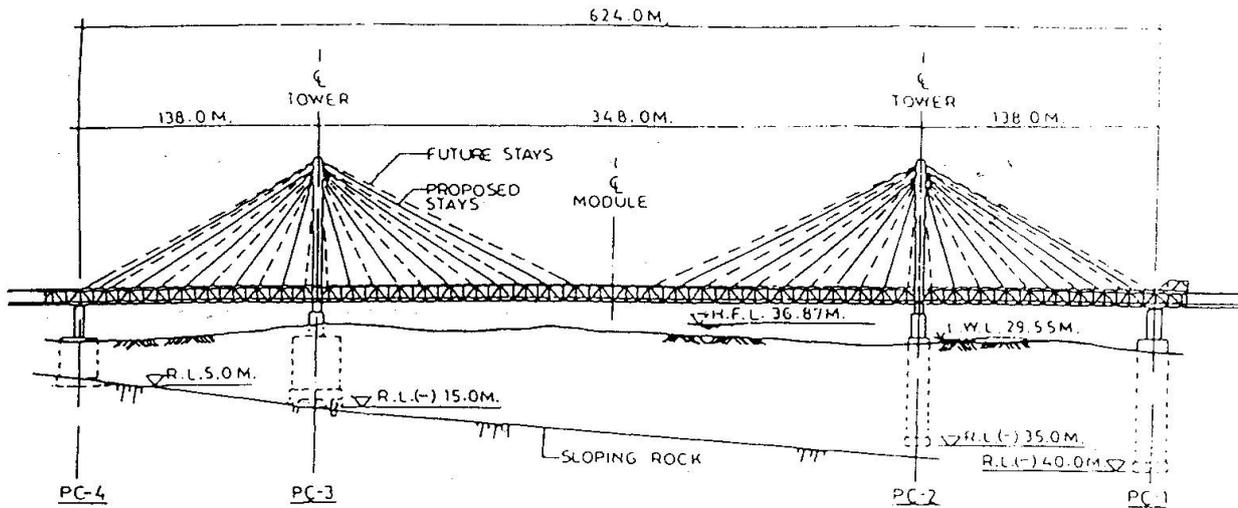
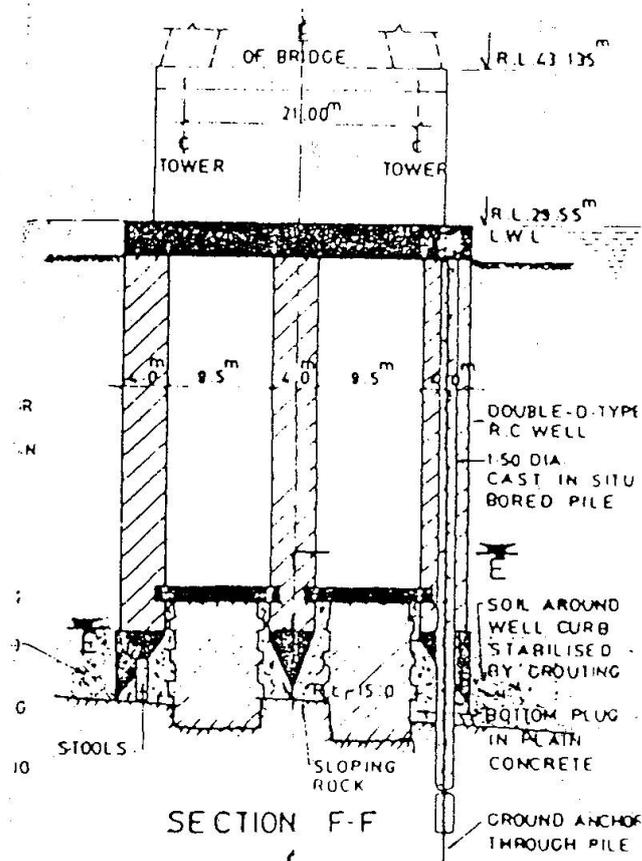
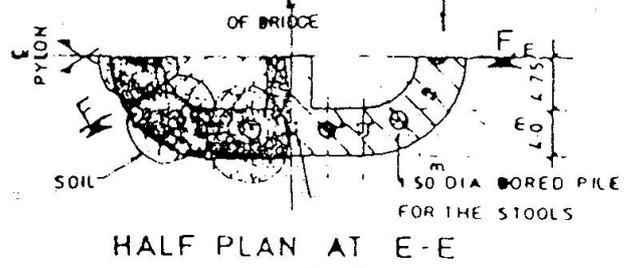
Fig. 4

JOGIGOPA BRIDGE.

length, with spans of 138-348-138 M. The superstructure is designed to be of steel construction. (Fig. 4)

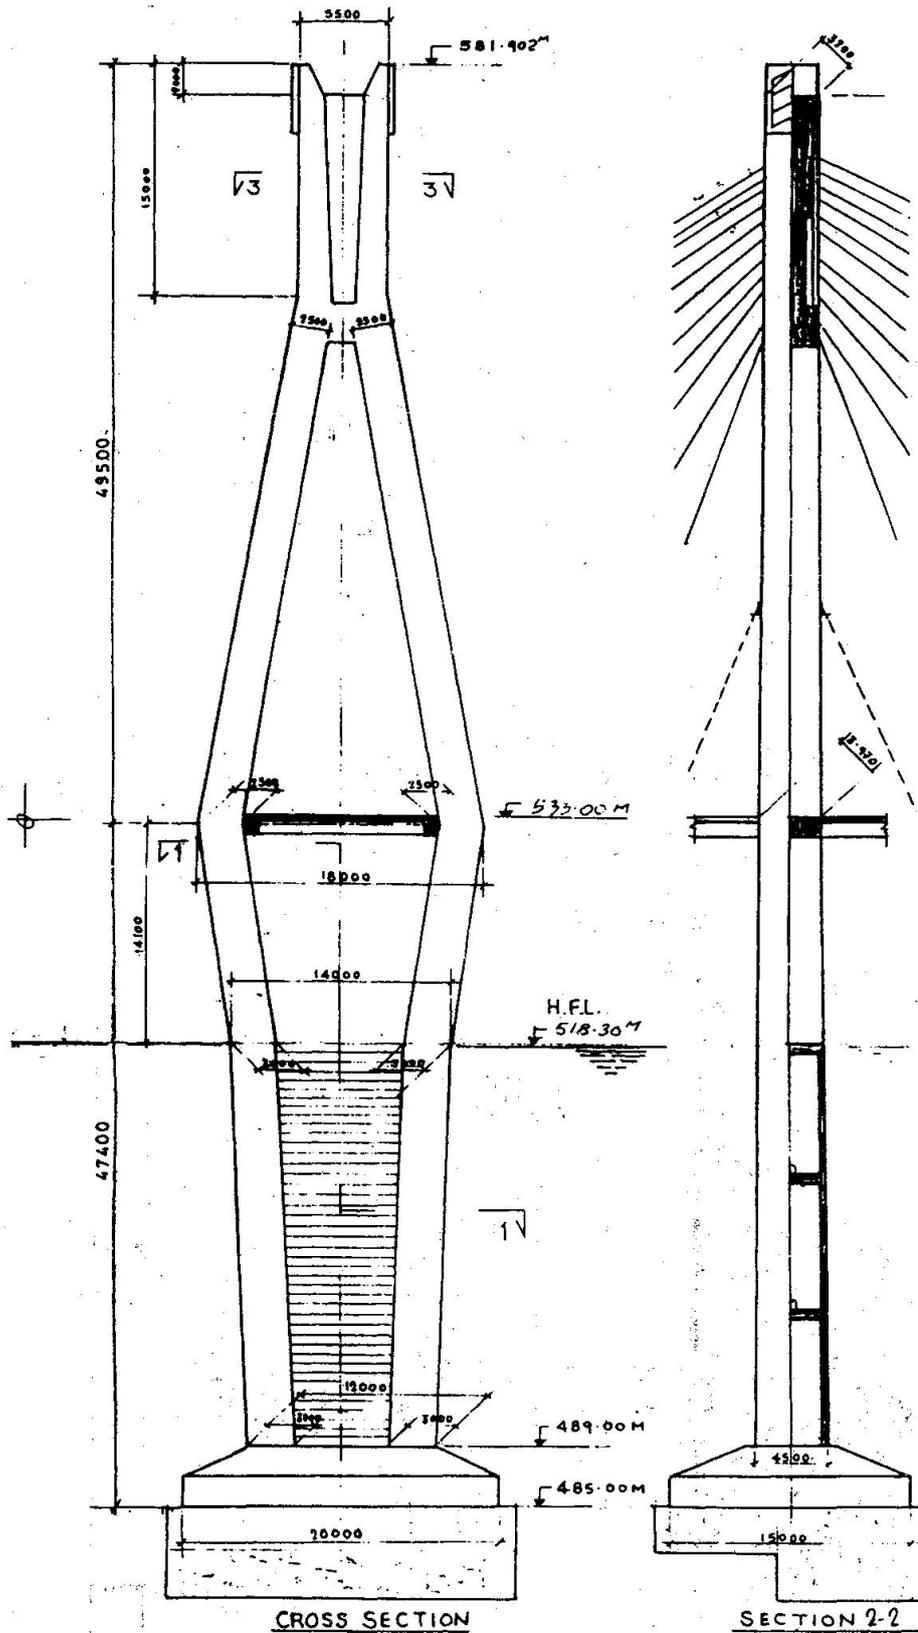
BAGCHHAL BRIDGE Fig. 6

DETAILS OF PYLON

The cablestays supporting the deck are anchored in a pylon head above 32 m ht. along the central axis of the bridge. The A frame and the lower V frame in reverse are anchored to a cellular pier, having openings to allow ingress of water and prevent one sided water pressure. The reason for choosing the cellular pier lies in the fact that the transverse contour of the hill on either approach, has a steep fall and a A frame solution, though simpler, would have necessitated unequal legs of substantial height. The pier is founded on a footing which in turn rests on a 1:3:6 concrete foundation. (Fig. 6)
