# Coal silos in Gillette, WY (USA)

- Autor(en): Illingworth, D.
- Objekttyp: Article

Zeitschrift: IABSE structures = Constructions AIPC = IVBH Bauwerke

## 6. Coal Silos in Gillette, WY (USA)

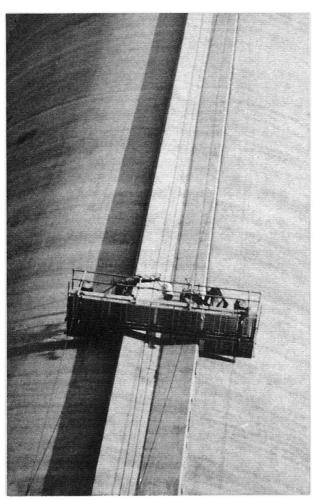
Fig. 5 VSL crew scaffold doing post-tensioning operations

Stressing was done on both buttresses simultaneously although this was not required, but it worked as well as individual stressing. The jack was hung by a separate cables from the roof. The B type anchorage was placed directly against the concrete. The cables were first stressed to 20% and immediately afterwards to 100% of the required force. At this stage the concrete strength had to be at least 24 N/mm<sup>2</sup>. The centre hole of the anchorage was threaded so that a group cup and valve could be screwed in. All grouting was injected through this hole (Fig. 5).
