Health and safety in the Humber bridge construction, 1973-1981

Autor(en): **Sparkes, Michael**

Zeitschrift: **IABSE reports = Rapports AIPC = IVBH Berichte**

THE HUMBER BRIDGE

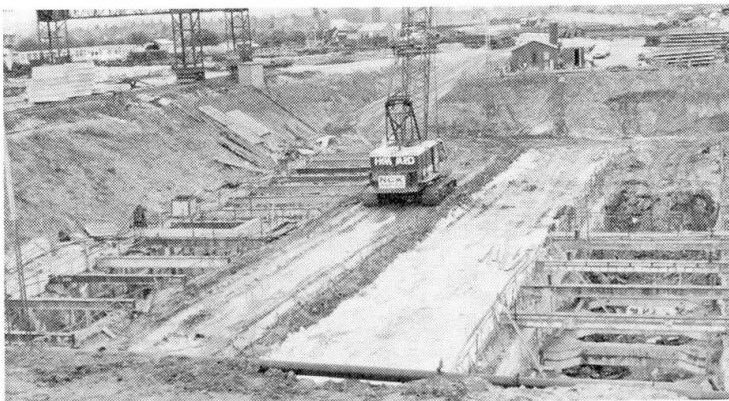
Excavation of the southern anchorage - strutting of longitudinal concrete walls.

Excavation in the chalk for the Northern anchorage was a safe procedure but in the wet clay on the south bank the ground had to be stabilised by sinking reinforced concrete longitudinal walls by Bentonite slurry injection methods to the full depth of 35 metres. Excavation then commenced between the walls which were struttled transversely as the excavation deepened. Both anchorages involved extensive use of scaffolding both below and above ground. Care was taken to ensure that safe access and safe work places were maintained during the use of this scaffolding. Safety committee members were helpful in this respect and reported hazards quickly. Rail mounted Scotch Derricks were used in the excavation process and for raising and lowering materials.

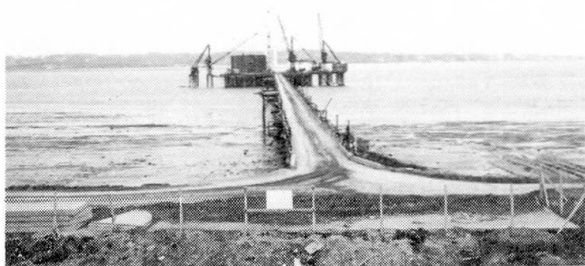
Construction of caissons at the end of the 500 m jetty.

These reinforced concrete structures support the main towers. The Northern piers at high water mark measure 4.4 metres by 16 metres by 11.5 metres high and are founded in chalk 8 metres below ground level. The South piers are located in the river some 500 metres out from the South bank and measure 4.2 metres by 11 metres by 16 metres high, supported on twin hollow caissons about 24 metres in diameter. These caissons were sunk inside steel sheet pile cofferdams by underwater excavation, to a depth of 36 metres below river bed into

hard clay. The construction of the caissons involved building a temporary jetty 500 metres long out into the river, capable of carrying heavy traffic. The caisson work involved the use of divers inside and outside the caissons to inspect progress during the sinking operation. Careful thought had to be given, in addition to the hazards involved in the diving operation, to the conventional problems of safe access and safe place of work. This involved the establishment of rigid rules for working over water where conventional safe working platforms could not be established, such as the provision of safety lines to which harnesses could be attached, the use of life jackets at all working positions where men were liable to fall into the water, and at all times when travelling by water and working from small craft. It also included the provision of adequate illumination for work which was done at night time. The accidents which occurred during this phase included several incidents of men falling into the water, usually when travelling from ship to shore or vice versa. There was one fatal accident during this phase also:- a small work boat fouled the mooring cable of a pontoon and was overturned by the fast current, which swamped the boat. Four of the men on board were saved, but the skipper of the boat was trapped in his cabin and drowned. This accident occurred as darkness approached. Thus rendering unsuccessful the helicopter search for the skipper's body.
