Zeitschrift:	IABSE structures = Constructions AIPC = IVBH Bauwerke	
Band:	12 (1988)	
Heft:	C-44: Structures in Finland	
Artikel:	Lietvesi Bridge, Puumala (Finland)	
Autor:	Hyvönen, J.	
DOI:	https://doi.org/10.5169/seals-20905

## 5. Lietvesi Bridge, Puumala (Finland)

Owner:	Finnish Roads and Waterways Administration (RWA)
Design:	RWA and Insinööritoimisto Pontek Ky
Contractor:	OMP-Yhtymä Oy
Construction Work Duration:	18 months
Completion ·	1986

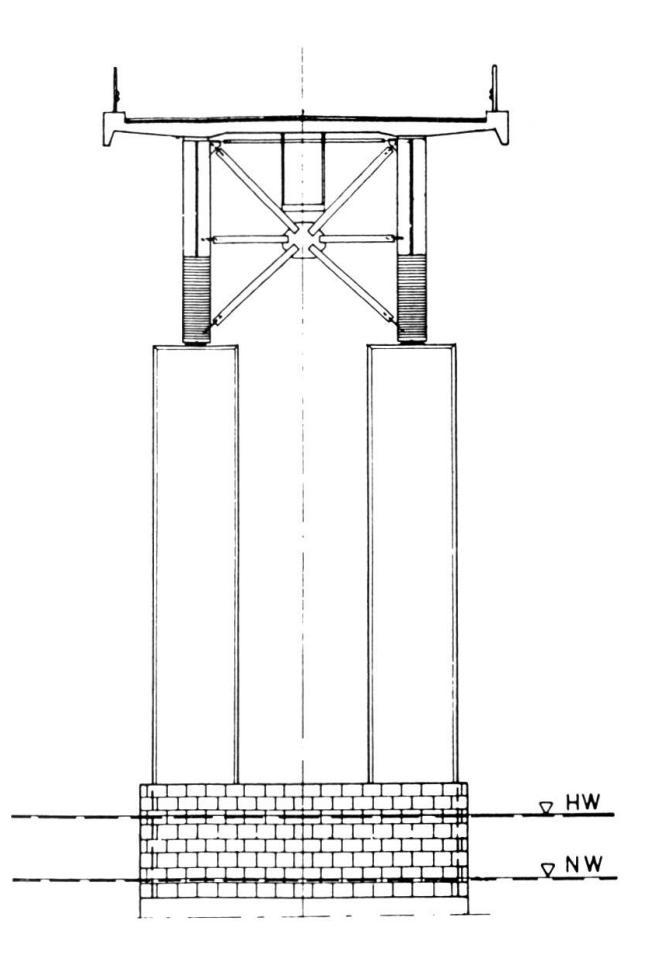
Fig. 1 Bridge cross-section

The bridge is a three-span composite girder bridge spanning 88 + 112 + 88 meters. Its horizontal clearance is 8.5 meters. The main girders are haunched. At midspan the structural depth of the superstructure is 3.32 meters, and the steel girder is 2.85 meters deep. At the intermediate piers the total depths are 5.41 and 4.94 meters respectively. At the bridge location, the required clear headway is 12.5 meters.

The bridge has a composite superstructure. The steel main girders are 5.0 meters apart. They are connected by cross frames at c/c 8.0 meters, by lateral bracing located 2.6 meters below the upper flange of the girder, and by a reinforced non-tensioned concrete deck slab. The superstructure was analysed using an element model. The result of the analysis consisted of the member forces of the cross as well as the lateral frames and of the forces of the main girders.
