Zeitschrift:	IABSE reports = Rapports AIPC = IVBH Berichte
Band:	37 (1982)
Artikel:	Fatigue of HSFG bolted joints: effects of design parameters
Autor:	Cullimore, M.S.G.
DOI:	https://doi.org/10.5169/seals-28974

Fatigue of HSFG Bolted Joints – Effects of Design Parameters

M.S.G. CULLIMORE BSc, PhD University of Bristol Bristol, England

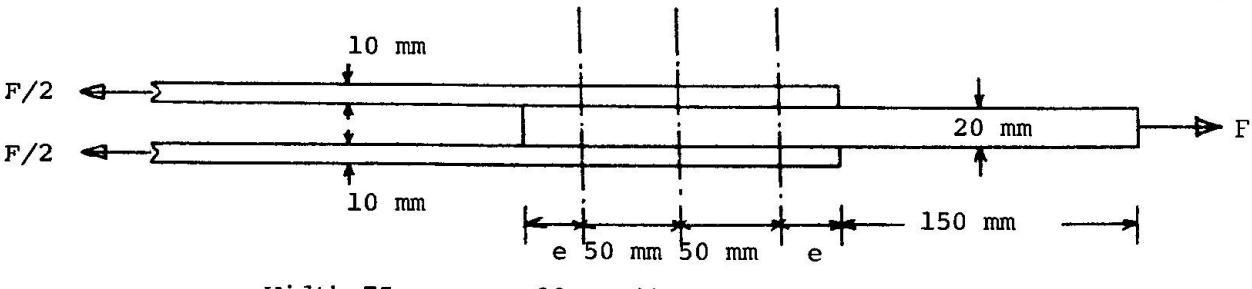
Fig. 1. Standard Fatigue Test Piece

The test piece for the basic test, shown in Fig. 1, was made of BS.4360 Grade 50 steel with three M20 bolts, tightened to 190 kN, the tension specified in BS.4395 Pt. 2. The bolts were a special load indicating type which enabled the bolt tension to be monitored continuously throughout the test. The contact surfaces of the joints were grit-blasted with chilled iron grit G34. $3 \times 20 M$ HSFG Bolts

Width 75 mm, e = 30 or 40 mm

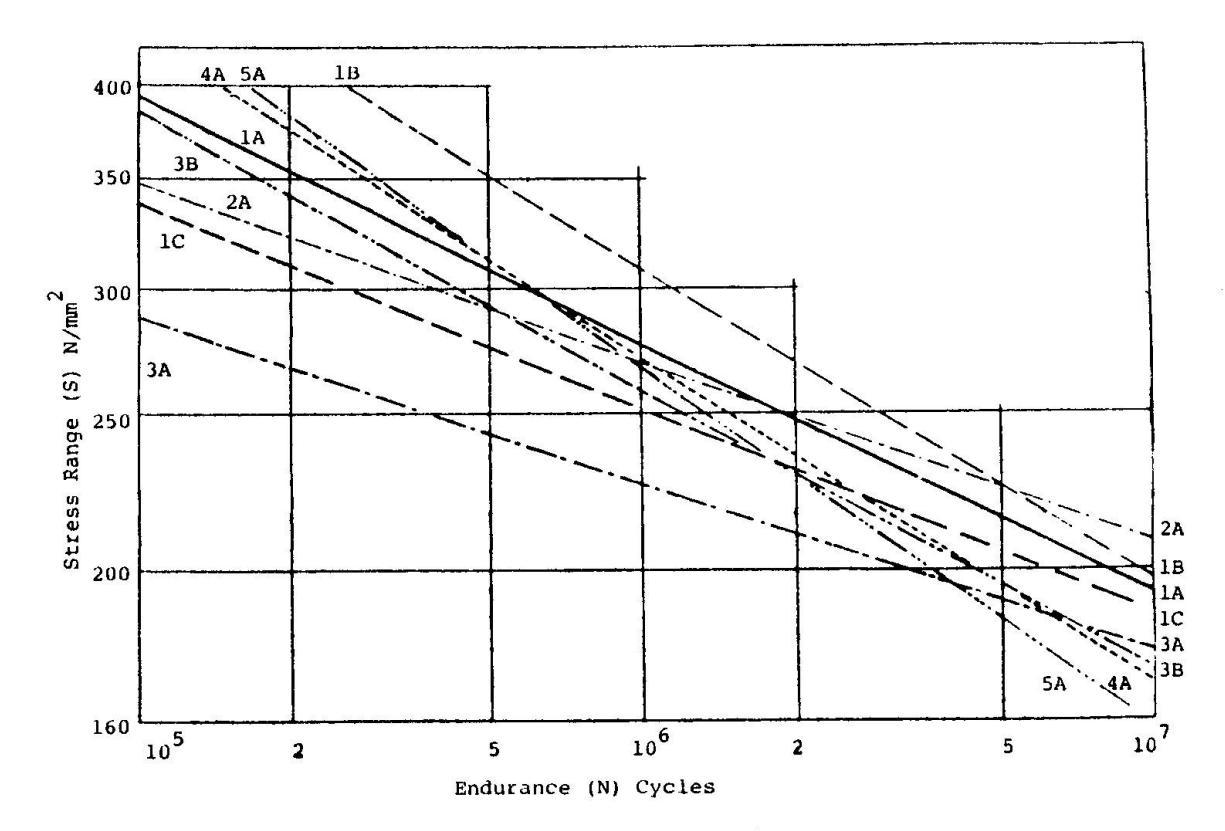
Fig. 2 Fatigue Tests Results S-N Mean Lines

These results are summarised graphically in Fig. 2. The values of the coefficients m and K in the equation :-

2.3.1 Mean stress - A reduction in mean stress gives a marked improvement in the life for a given stress range, especially at the higher stress range.

2.3.2 Surface finish - The mill scale surface joints had a very much lower life at the higher stress ranges than the shot blasted ones. The effect, however, appears to be reversed at stress ranges below about 220 N/mm². The effect of the zinc epoxy primer was to reduce the fatigue life for all the stress ranges used.

2.3.3 Plate strength - The higher strength Grade 55 steel gave a consistently inferior fatigue performance to the Grade 50 steel. The fatigue strength of the lower strength Grade 43 steel joints was poorer than either. In the latter case, the maximum stresses in the area of the first bolt were approaching the yield strength of the material.

2.3.4 Bolt tension - For lives above one million cycles joints with the higher bolt tension had a better fatigue strength than those with the lower tension.

2.3.5 Edge distance - Increasing the edge distance did not produce the expected improvement in performance. The consistency of these results was, however, poorer than for the standard test so that it could be that the increase from 30-40 mm is insufficient to cause a significant change.

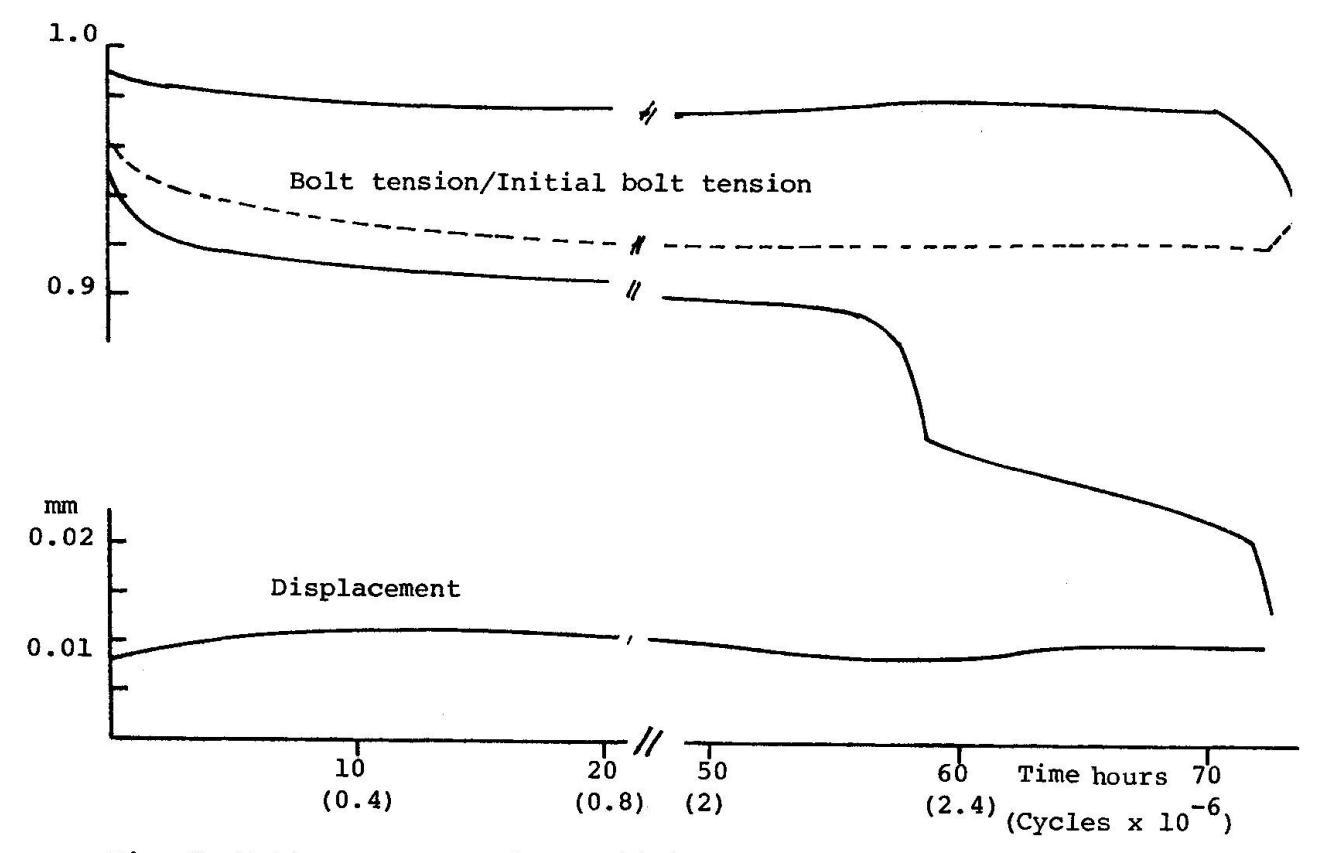
Fig. 3 Fatigue Test - Joint Stability

The results of measurements of bolt tension and displacement monitored continuously throughout a typical test are shown in Fig. 3. The load displacement loop was not closed on the first cycle, giving a small irrecoverable displacement. This got smaller with each succeeding load cycle until complete stabilisation (loops of constant size) was obtained after about 50,000 to 70,000 cycles. The bolt tensions show the expected relaxation with time (51. Failure in this case was by cracking of the cover plate and washer, which probably accounts for the loss of bolt tension in the bolt there (lower of three curves) after about 58 hours. After the initial increase, the displacements show very little change.

4.1 No evidence of fatigue failure having been accompanied by slipping was noted, except in the case of the highest loads used in the Grade 43 steel tests (and in the 1-bolt tests), where the upper load was a high proportion of the slip load and the stresses at the first bolt were approaching yield.
