A 12 Year Case Study of a Reinforced Concrete Building

Leslie PARROTT Research Engineer British Cement Assoc. Slough, UK

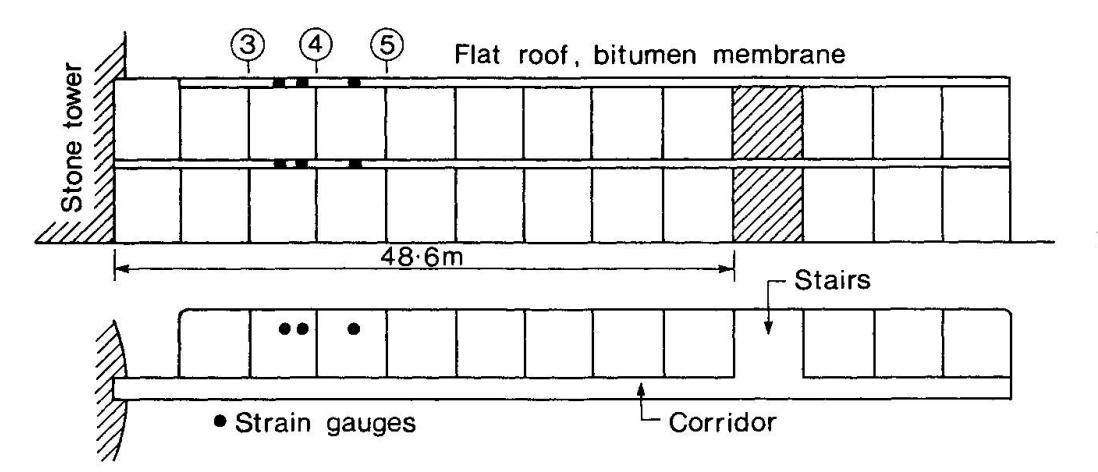
A diagram of the two-storey office building is shown in Figure 1. There are twelve bays each 5.4m long with a stairway at the ninth bay providing some longitudinal restraint. The 4.4m wide offices are accessed by 1.3m wide corridors on the ground and first floors. The longer portion of the building between the stairway and an old stone tower can move longitudinally by virtue of a movement joint at the interface of the tower and office corridors. At this interface and for one bay the width of the structure is reduced to that of the corridor and the walls are fully glazed. The continuous floor and roof slabs were cast in-situ on precast concrete cross beams that were supported by a frame of precast columns and longitudinal beams.

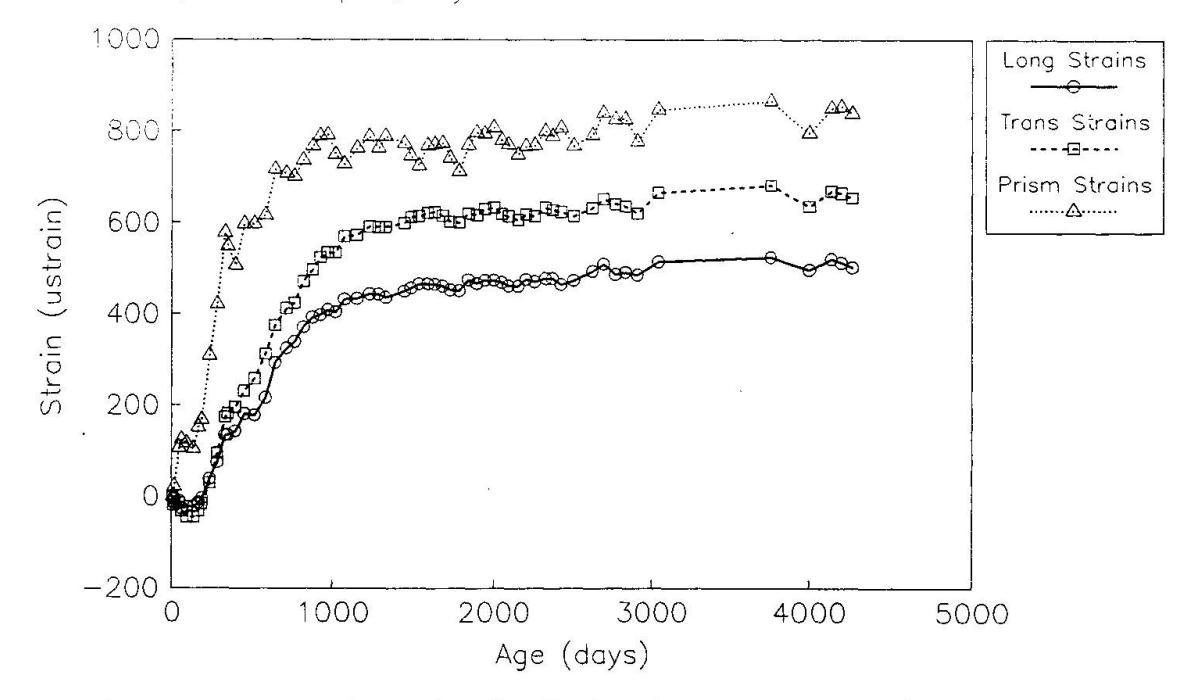
<u>Fig. 2</u> Strains in prisms; longitudinal and transverse strains at quarter span, bay 3-4 in floor.

Six prisms were stored beneath the roof for long-term measurements of shrinkage and weight loss. The shrinkage results in Figure 2 suggest that approximate moisture equilibrium was reached after about 3 years and this was consistent with the weight loss measurements: thereafter the small increase in shrinkage was accompanied by a slight gain of weight that was indicative of carbonation [2].

First floor, Quarter span, bay 3-4

Figure 2 shows that initially longitudinal strains are slightly larger than transverse strains at quarter-span in the floor. This is consistent with the expected, small flexural stresses. After about 250 days the transverse strains exceed the longitudinal strains and this indicates that axial tensile stresses develop at later ages. Similar patterns of transverse and longitudinal strain were observed at mid-span in bays 3-4 and 4-5 of the floor.

The calculated strains for bay 4-5 of the floor slab are shown in Figure 3. There were only small differences in shrinkage between the three instrumented sections. The shrinkage of the floor slab developed more slowly than the prism shrinkage (Fig 2) and appears to be stabilizing at a smaller, final strain. These effects are attributable to differences in drying path length [3]. The stress-induced strains exhibit the expected pattern for flexural loading but they are superposed by the development of tensile strains.

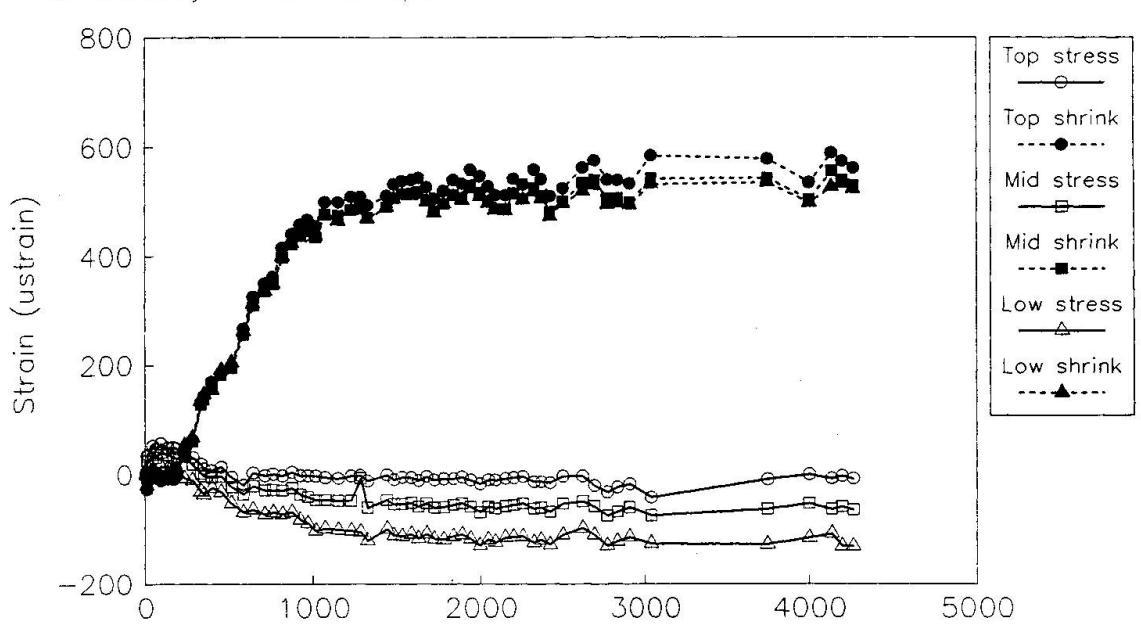
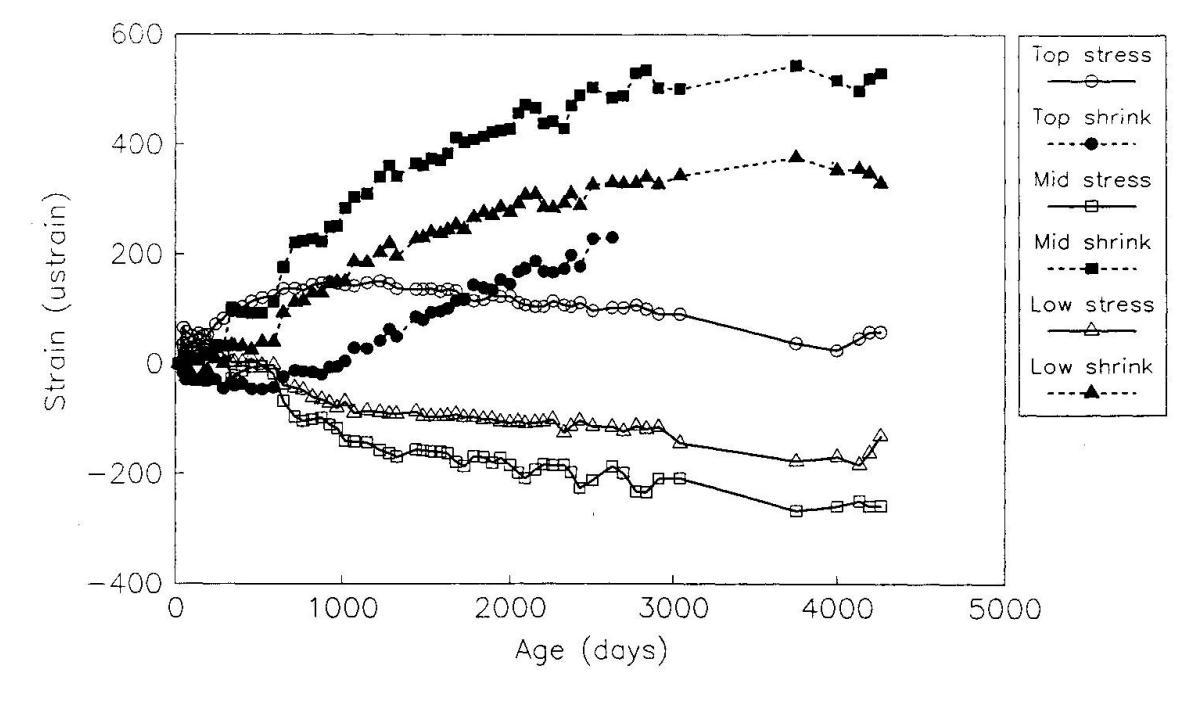
First floor,bay 4-5, mid-span

The calculated strains for the roof slab in Figure 3 show that shrinkage developed more slowly than that in the floor. Although the roof slab was similar in thickness to the floor slab drying was retarded by the waterproof layer on its upper surface. The stress-induced strains exhibit the expected pattern for flexural loading but they are superposed by the slow development of small tensile strains. The tensile strains in the roof develop more slowly than those in the floor.

The strain patterns in Figure 3 suggest that longitudinal drying shrinkages of the floor and, to a lesser extent, the roof are restrained and thus cause the development of longitudinal tensile stresses. This is consistent with the similarity in shape and period of occurrence of the shrinkage versus age and stress-induced strain versus age curves. Restraint may have derived from the columns, longitudinal beams, internal block walls and the foundation.
