Measurement of Service Stress and Fatigue Life Evaluation of Bridges

Kentaro YAMADA Professor Nagoya University Nagoya, Japan

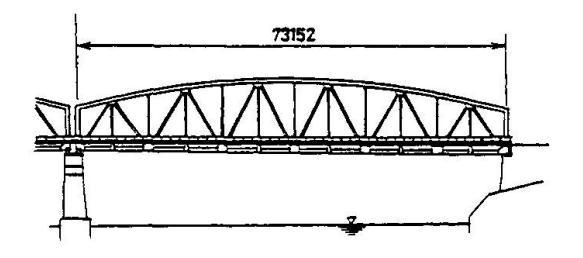
Fig.1 Bridge A: Riveted truss bridge

1) Bridge A: It is a 60-year old riveted Warren truss bridge, as shown in Fig. 1, with a span of 73 m and a 16 m wide roadway. The bridge is daily subjected to about 250 trains at a speed of about 10 km/h and about 10,000 vehicles, in which 11 percent are trucks. The traffic is considered rather light in Japan.

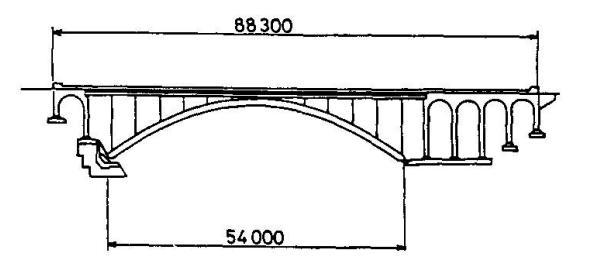
Fig.5 Bridge E: Deck type arch bridge

5) Bridge E: It is a two-hinge deck type arch bridge built in 1964. The arch has 54 m span and the width of roadway is 9.9 m, as shown in Fig.5. The bridge is subjected to about 80,000 vehicles every day, and 26 percent of them are trucks. The bridge is also subjected to severe traffic condition. Fatigue cracks were found in stringers of floor system and vertical members of arch. The cracks of the stringers were repaired and the cracked parts were stiffened. Further repair and strengthening of the arch and replacement of concrete slab into orthotropic steel deck are underway.

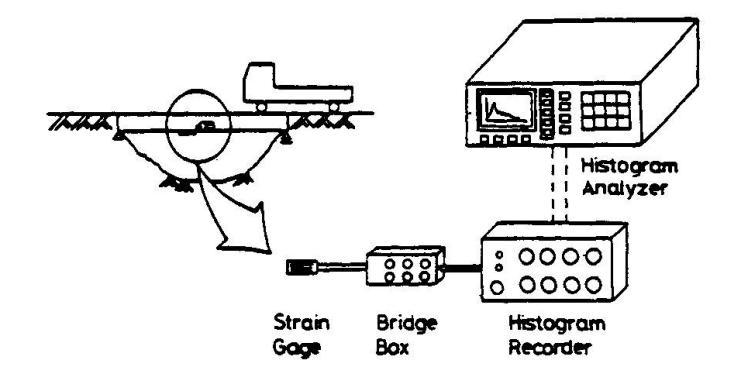
Fig.6 Measurement of stress histogram

Stresses under service condition are important to evaluate the durability of structures. Service stresses can be measured by using a Histogram Recorder, as

shown in Fig.6 [9]. It analyzes the strain waves in real time and records the stress ranges and the number of their occurrence. The analysis may be based on rainflow counting method, peak counting method, level crossing counting method, and so on. The rainflow counting method was used in this study to obtain stress range histogram. The Histogram Recorder has some advantages as that it requires no traffic control, and the disadvantage is that it distinguishes neither the type of trucks nor their axle weight. Therefore, stresses under model vehicle with controlled weight are often measured and used as reference values.

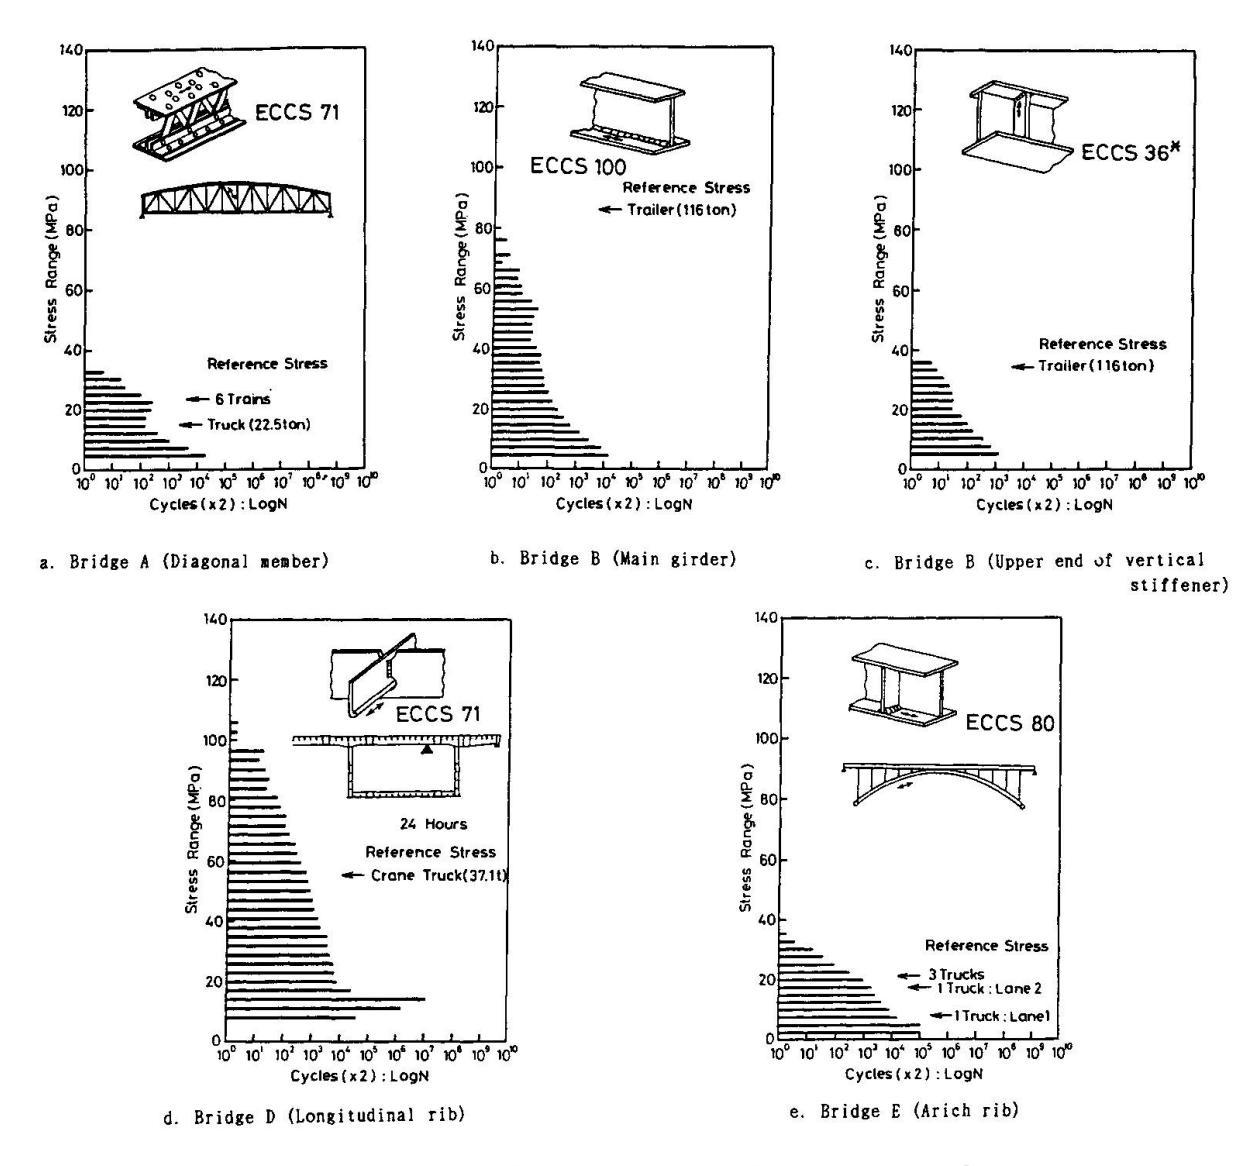
Fig.7 Example of stress range histogram records

Examples of the stress range histogram measured for 24 hours are shown in Fig. 7, where the ordinate indicates stress range and the abscissa shows the number of half stress cycles in logarithmic scale. The stress ranges corresponding to the model vehicles are also shown as reference values.

The stress histogram of a diagonal member of the Bridge A is shown in Fig.7a. The model vehicles are a 22.5-ton dump truck with 3 axles and a train with 6 cars. It seems that the upper peak of stress cycles is caused by the trains. The stress cycles below the reference value by the model truck may be caused by lighter trucks and the other vehicles and that above the reference value by the train is considered to be caused when the trucks and the train passed on the bridge simultaneously.

Figs.7b and 7c show stress range histograms measured at a lower flange and the upper end of a vertical stiffener of Bridge B, respectively. The measured maximum stress range in the lower flange is close to reference stress range by the 1140 kN (116 tons) trailer truck. And that in the lower flange of Bridge B is about 80 MPa, about twice of that in the diagonal members of Bridge A.

Fig.7d shows stress range histogram measured at bottom of longitudinal rib in the orthotropic steel deck of Bridge D. The model vehicle was a crane truck of 364 kN (37.1 tons). The maximum stress range was about 105 MPa, about twice of stresses due to the model vehicle. It is either because the trucks weigh more than the model vehicle, or because heavy trucks crossed the bridge simultaneously. There was extremely large number of low stress ranges. This may be explained by the frequent passage of small trucks or vibration in the orthotropic steel deck due to the passing traffics.

Fig.7e shows stress range histogram measured at the arch rib of passing lane side of Bridge E. The reference stress ranges due to a truck of 206 kN (21 tons) passing on the slow lane or on the passing lane, or three same trucks are also shown in the figure. The measured stress range were larger than the stresses by the three trucks. It implies that vehicles weighed more than the model trucks frequently passed on the bridge.

The stress range histograms of Bridges D and E were different from that of Bridges A and B. This is because the volume of traffics is much greater in Bridges D and E than in Bridges A and B. For example, about 250 trains and 10,000 vehicles passed on Bridge A, while over 100,000 vehicles passed on Bridge D and about 80,000 vehicles passed on Bridge E for 24 hours.

In this study the design S-N diagrams specified in the ECCS Recommendation for the Fatigue Design of Steel Structures [8] were used to evaluate the fatigue strength of weld details. Since the design S-N diagrams correspond to the mean-2xs (s:standard deviation) S-N diagrams, the computed fatigue life is the lower bound fatigue life. The design S-N diagrams are given for classified structural detail. The detail categories evaluated for fatigue life in this study are also shown in Fig.7.

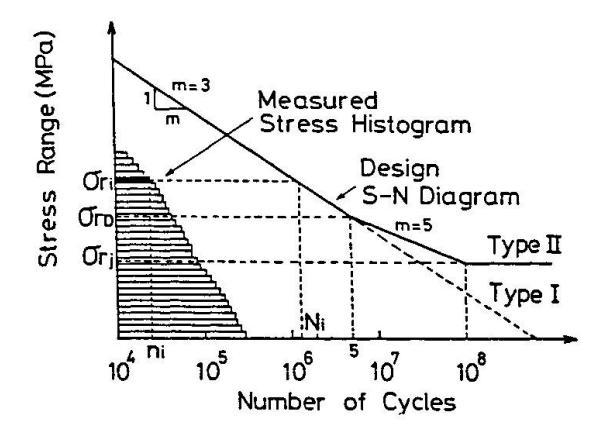
Fig.8 ECCS design S-N diagram

Two types of design S-N diagrams specified in the ECCS Recommendation are used to evaluate the fatigue damage based on the stress range histogram, as shown in Fig.8.

1) Type I (Modified miner's rule): The S-N diagram of slope of m=3 is extended linearly.

2) Type II (Three line method): The slope of the S-N diagram m is equal to 3 for N less than 5 million cycles, and 5 for N between 5 million and 100 million cycles. Stress ranges below the cut-off limit are neglected.

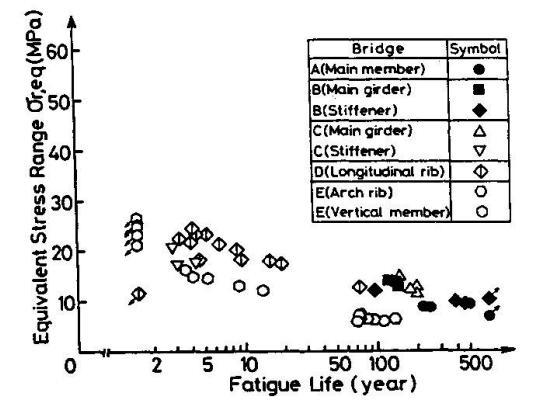
Fig.9 Equivalent stress range and fatigue life for Bridges A and B

Fatigue lives of the above-mentioned structural details in the Bridges A and B computed from the measured stress histograms are plotted in Fig.9. The two bridges were subjected to relatively light traffics, and their fatigue life are shown by the solid symbols in Fig.9. The fatigue life of the main members of Bridge A yields to more than 220 years, and that of the tension flanges of Bridge B are between 120 and 140 years. Even the upper end of vertical stiffeners of Bridge B showed the life longer than 90 years. Considering that the evaluated fatigue life is the lower bound because of the use of the lower bound S-N diagrams, it may be safe to concluded that fatigue cracks would hardly occur in these details, provided that traffic condition will remain unchanged and structural deterioration such as corrosion will not take place.

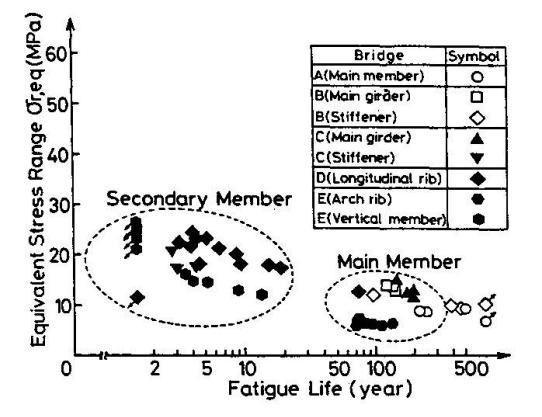
<u>Fig.10</u> Equivalent stress range and fatigue life for Bridges C, D and E

Bridges C, D and E were subjected to severe traffic condition, and their fatigue lives are plotted by the solid symbols in Fig.10. If the structural details are grouped into main members and secondary members, the computed fatigue lives can be also grouped accordingly. For example, the fatigue lives of the tension flange of Bridge C are more than 100 years, and that of the arch ribs of Bridge E is between 70 and 130 years. On the contrary, the fatigue lives of the vertical members of the arch are less than 4 years, that of the longitudinal ribs in Bridge D are less than 20 years, and that of the upper and lower ends of the vertical members of Bridge E are below 15 years. Actually, the welded details in these secondary members were found susceptible to fatigue cracking previously [2,3,4]. Therefore, the fatigue lives obtained from the measured stress range histogram are a good indicator of the severeness of structural detail against fatigue, even though the fatigue lives computed here are still inaccurate due to many uncertainties involved in the analysis.

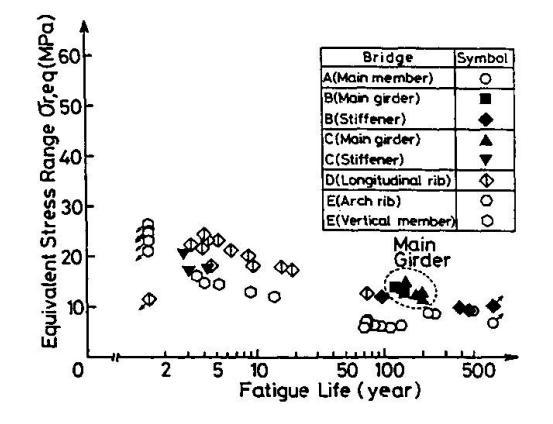
Fig.11 Equivalent stress range and fatigue life for Bridges B and C

Bridges B and C are both plate girder bridges with similar structural details, and their fatigue lives are plotted by the solid symbols in Fig. 11. It is noted that the main girder of Bridge B showed shorter fatigue life than Bridge C, although Bridge C are subjected to about 100,000 vehicles daily. This may be because Bridge B carries special vehicles of of over 785 kN (80 tons). However, the upper ends of the vertical stiffeners in Bridge B showed long fatigue lives. This may be due to the 35 cm thick concrete slab and the 2.0 m girder spacing in Bridge B. They reduced the stresses and hence increased the fatigue life. On the contrary the Bridge C has a 19 cm thick concrete slab and 3.2 m girder spacings.

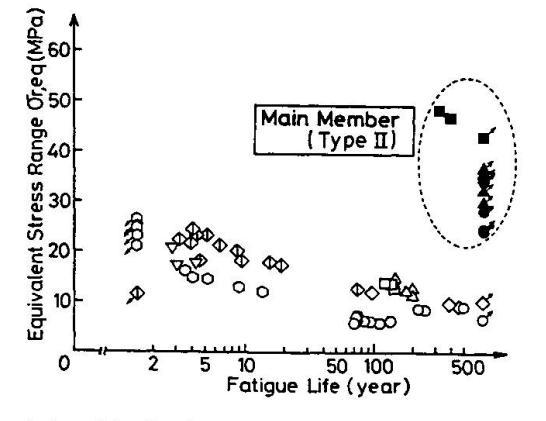
<u>Fig.12</u> Equivalent stress range and fatigue damage for main members

The type II S-N diagram (Three line method) was also used to evaluate the fatigue life of each detail, and the results are plotted in Figs. 12 and 13. In Fig. 12, computed fatigue life of the main members (the tension flanges and the arch ribs) using the type II S-N diagram are shown by the solid symbols. They are over 300 years, longer than that evaluated by using the type I S-N diagram. This is because most of the stress ranges in the histograms are below the cut-off limit and they are neglected in the type II S-N diagram. In the case of the arch ribs of the

bridge E, the fatigue life becomes infinite because all stress ranges are below the cut-off limit.

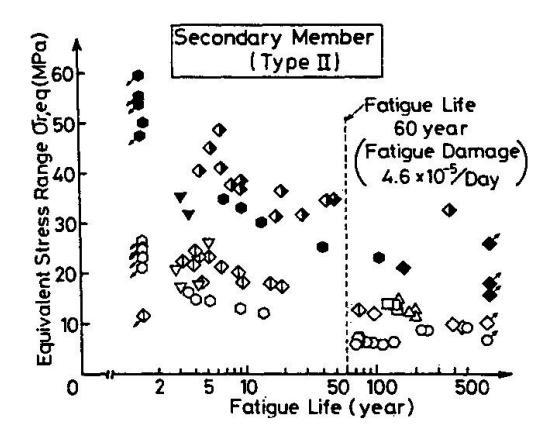
Fig.13 Equivalent stress range and fatigue damage for secondary members

The fatigue lives of the secondary members are shown by the solid symbols in Fig.13. Although the equivalent stress ranges increase, the computed fatigue lives are similar to the lives computed based on the type I S-N diagram. A good part of the stress ranges in the histogram were above cut-off limit and contributed to the fatigue damages of the secondary members. Some secondary members actually experienced fatigue crackings, and therefore this trend can also be used to evaluate the severeness of stresses against fatigue.
