Maintenance of the Structures of the Existing Severn Crossing

K. SRISKANDAN Consultant Mott MacDonald Ltd Croydon, UK

In 1992, the operation and maintenance of the structures comprising the existing Severn Crossing passed from UK Department of Transport to a private company, who had won the franchise to also design, finance, build and operate a second Severn Crossing. Both crossings would revert to the Government at the end of the concession period. This paper describes the findings of a handover inspection, the requirements for routine inspection and maintenance, and for other repairs, and also the arrangements for managing all this work.

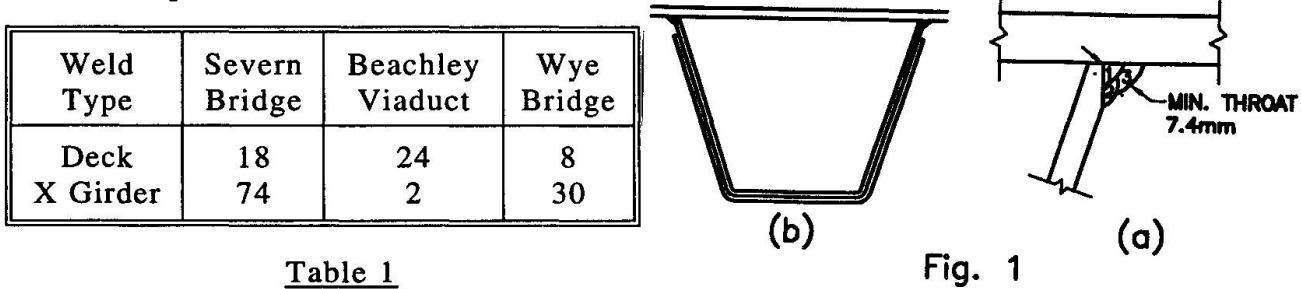
5.1.1 Most of the work has been in reinstating/repairing fillet welds in the orthotropic deck, joining trough stiffeners to deck or to the diaphragms. Standard repair methods have been devised. For the first, Fig 1(a), the existing 6mm weld is cut out over a certain length and replaced by a larger fillet weld which includes some preparation of the stiffener web. In the Second, Fig1(b), a shaped strap is fillet welded to the trough and also the diaphragm. Table 1 gives the numbers of these repairs on each structure from concession date to the present time.
