Inspection of Bridges with Orthotropic Steel Decks with Particular Attention to Fatigue

Structures of orthotropic steel decks, where the deck plate with open or closed stiffeners is supported by and establishes an integrated structure with the deck and crossbeams, show to be susceptible to traffic induced fatigue. This paper shows the behaviour of the stiffener to crossbeam connections in various structures in the Netherlands. The behaviour is related to the essential locations for inspection and several examples of damage in real bridges.

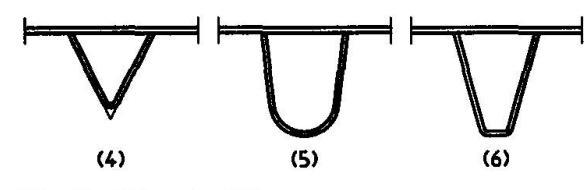
Fig. 2 Closed stiffeners

The introduction of the closed V-shaped, Ushaped and trapezoidal stiffeners as shown in Fig. 2, was a large improvement, which alloyed spans of approximately 4.0m. The secondary crossbeams and main girders were no longer needed. The amount of work involved reduced as well as the costs.

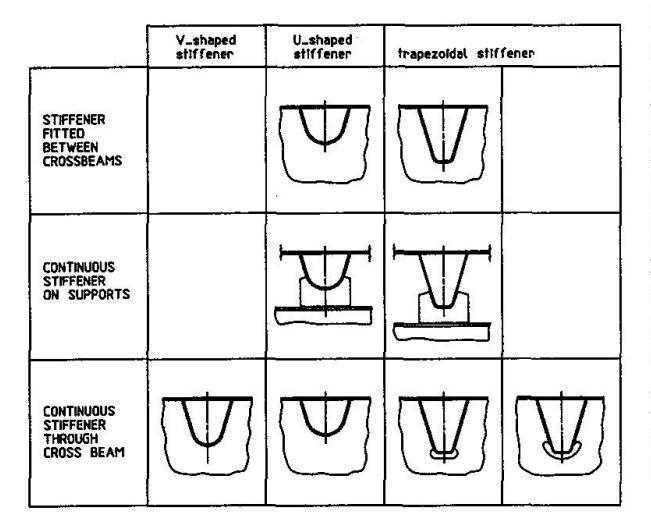
Fig. 3 Types of trough to crossbeam connection

Fig. 3 shows a complete overview of all types of closed stiffeners and stiffener to crossbeam connections used in the Netherlands.

Like the open stiffeners the closed stiffeners could be fitted between or as continuous elements passing through the crossbeams. In this case the cut-out can be of close fit or being featured with an additional oval shaped cope hole or other like the "Haibach" cut out. All details showed to be susceptible to fatigue induced cracks, which resulted in world wide research to the fatigue strength of the details in order to develop data that can be used for the design of new bridges and the repair of existing structures.

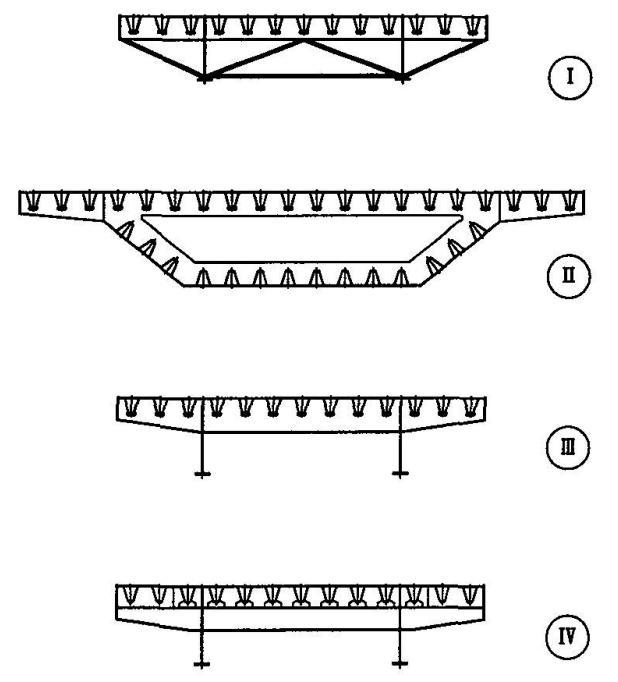
Fig. 4 Structural types of bridges

Fig.4 shows four load carrying systems. For simplicity only systems with continuous closed stiffeners are shown. Type I is a plate girder bridge with crossbeams that consists of a truss and a top cord acting as a continuous beam with short spans. The continuous beam transfers the loads by bending and shear to the truss nodes. The truss is supported by the main girders. Type II is a box girder bridge. The diaphragm of the box acts as a deep crossbeam that transfers the loads to the inclined and vertical webs of the box girder. Type III is a conventional crossbeam with cantilevers that are supported by the main girders. Type IV is an I-shaped crossbeam that receives the loads from the supports of the closed stiffeners. The shear connections in the cantilever sections cause a rotational spring using the axial stiffnesses of the deck plate and the I-beam and a lever arm. This is called the "Floating Deck Structure" and is used in a few bridges in the Netherlands [1]. It has been developed for its easy of assembly.

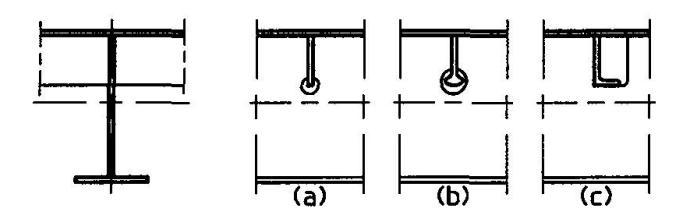
Fig. 5 Crossbeam connections with continuous open stiffeners

Because the influence lines show short distances between the zero-crossings a rather unfavourable connection is submitted to many cycles caused by the wheel loads. Fig.5 shows the connections of continuous open stiffeners to the crossbeams. In the connections shown, cope holes have been used for fitting purposes. The cope hole causes a discontinuity in the crossbeam. In Fig.5

type (a) and (b) it causes a local stress concentration, but in Fig.5 type (c) a "Vierendeel" effect with additional bending is to be expected. This effect will be explained later in conjunction with the closed stiffener connections.

In two plate girder bridges with open stiffeners and truss diaphragms cracks have been found in the stiffener to crossbeam connections [11]. Here the bulb stiffeners pass through circular cut outs as shown in Fig.5(b).

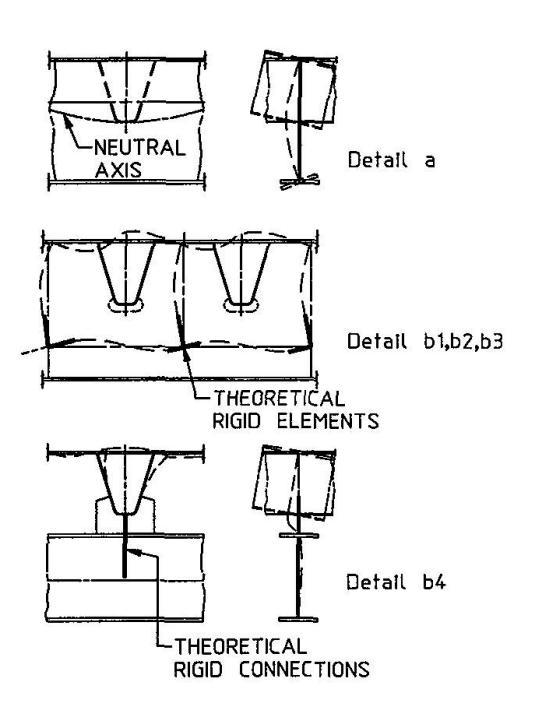
Fig. 6 Closed stiffener connections and structural behaviour

Fig.6 shows both the connections and their structural behaviour. Two groups are distinguished:

a. Troughs fitted between the crossbeams

b. Continuous troughs passing through cut outs with cope holes

Usually Group "a" connections are applied in structures with shallow crossbeams, where cut outs cause a too low shear capacity of the crossbeam. In the past, the detail with fillet welds showed many fatigue cracks. The details with full penetration welds show a much better fatigue performance.

The Group "b" connections are applied in structures with deeper crossbeams, diaphragms of Box Girder Bridges, "Floating Deck" structures. The following subdivision can be made:

"b1": Continuous troughs passing through a cut out with close fit and welded around with fillet welds; "b2": Continuous trough passing through a cut out with an oval shape or similar;

"b3": Continuous trough passing through a cut out with additional cope holes with varying radius, the so-called "Haibach cut out" [4] or a similar shape; "b4": Continuous trough supported by a counterfitted support plate, welded around the bottom of the trough. Further the support is welded to an I-beam.

In plane, the cut out causes a "Vierendeel Effect" if the depth of the cut out is substantially, compared to the depth of the crossbeam or diaphragm [5,6,7]. This is likely to occur if the detail is applied in Crossbeams Type I and III bridge structures (see Fig.6). Further all details are subjected to locally applied forces and a contraction effect of the bottom of the stiffener caused by bending moments at the stiffener supports [8].

Passing vehicles generate bending and shear in the stiffeners, which deflect subsequently and makes the supports of the stiffeners rotate (see Fig.6). The rotation of this connection causes an out of plane movement of the crossbeam web. This phenomenon takes place in all types of stiffeners. The connection "b2" has been investigated in ECSC research Phase 3 and 4. In [2,3] the fatigue behaviour has been reported for various types of stiffeners and cut outs. The fatigue strength of details "b2" has been investigated under simultaneous vertical forces with out of plane bending in the web plate. Fig.12 shows for three test specimens the stress results of FE analyses under equal vertical load and out of plane rotation.

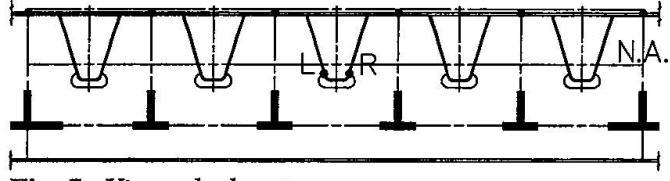
Fig. 7 Vierendeel system

In crossbeams with connections "b2" a significant part of the web has been removed. Consequently an "in plane" Vierendeel behaviour is generated (see Fig.7). The part between the troughs, often called the "tooth" acts as a post clamped in a continuous T-beam upside down. Below the cut outs the T-beam remains as the bottom cord. Between the cut outs the web is fully intact. Features like the presence or absence of different shaped cope holes do not change the behaviour significantly [7].

Due to crossbeam bending the locations "L" and "R" translate in horizontal direction. Depending on the neutral axis of the system an elongation or compression of the distance between them, is generated. Shear forces cause relative vertical displacements and rotations in the locations "L" and "R". In [4] these phenomena have been reported for detail "b2". Further, nominal stresses for a set of beams have been calculated. These results have been combined for the locations in the beam where the interaction between shear and bending effects reaches a maximum. For easy comparison the external load introduction is ignored in these results.

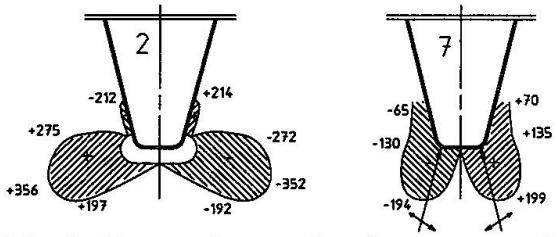
Fig. 8 Principal stress distributions around cut out and continuous weld (N/mm²)

Fig.8 shows the results of FE-analyses with for a test specimen [3,7,9] the principal stresses around the cut out for crossbeam to trough nr. 2 (detail "b2") connection and a fully welded around crossbeam to trough nr. 7 (detail "b1") connection under the same but symmetrical bending and shear loads. The model consists of shell elements, which ignores the effect of the plate and weld dimensions in the neighbourhood of the welds. The arrows show the direction of the principal stresses at a specific location. Near to the welds the stress levels reach approximately the same level, but the direction with respect to the weld is completely different. Fatigue tests on a true scale specimen [3] showed a better performance for the connection of trough nr.7.

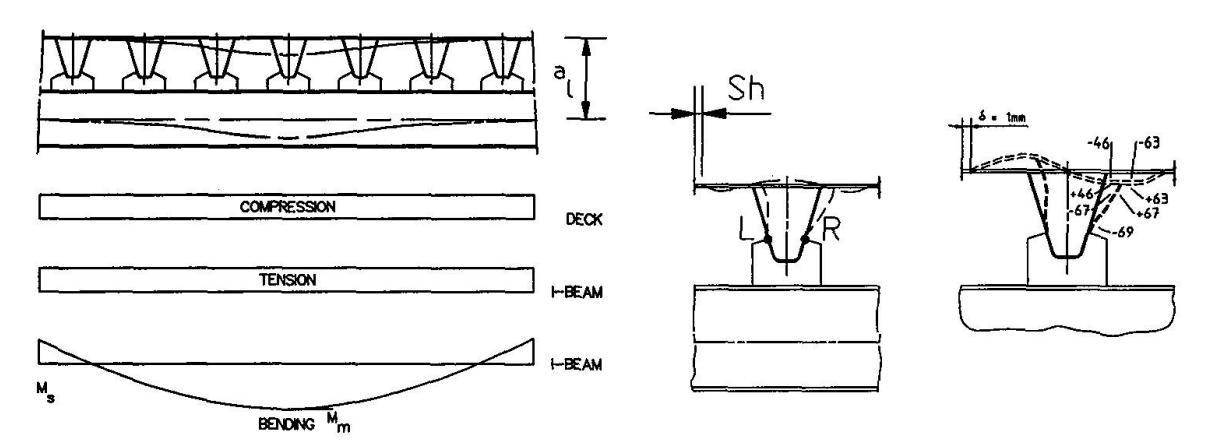
Fig. 9 Model of floating deck crossbeam

In the "Floating Deck" structure as shown in Fig.9 [1,10], the end of the I-beam is restrained by the lever system, which generates a compression in the deck and a tension in the I-beam. The horizontal compression and tension forces at a distance a_l are balancing the bending moment M_S at the support. The normal forces in the deck and the I-beam, the rotations in the I-beam and the shear deformation in the I-beam cause the deck shifting over a distance S_h with respect to the I-beam as shown in Fig.10. Asymmetrical loads cause in some locations larger shifts S_h [10].

The shift S_h generates normal forces and bending moments in the trough web. Fig.11 shows the nominal stresses in the trough web and the deckplate caused by the shift S_h of 1mm. The shifts S_h for a set of beams of with depths are shown in [10]. Realistic values of S_h under maximum crossbeam loading vary from 0.1 - 3.3 mm. In real structures these stresses must be multiplied with a stress concentration factor in order to find the Hot Spot Stresses which are relevant for fatigue.

It is obvious that these stresses which mainly are governed by bending effects in the deck plate and trough web, can not be neglected. The stress concentration factors related to the bottom connection are assumed to be higher than the stress concentration factors related to the trough to deck connection. If however the stresses due to the wheel loading on the deck are added, high stress amplitudes may occur due to the combination of both effects.

In two bridges with the "Floating Deck" structure [1,9] some cracks were found in the longitudinal trough to deck weld (location 3) in the crossbeam neighbourhood of the crossbeam during a resurfacing operation [11]. Fig. 18 shows the relevant locations for fatigue which relate to the stresses in Fig 11. In the inspected bridges the deck plate had a thickness of 10 mm. No other cracks were found. The lack of time and the obtained insight in the mechanism led to the decision that the crack and the original weld were ground and replaced by a weld of 80% penetration, which had to be made in an overhead position. During repair the bridge was closed for all traffic.

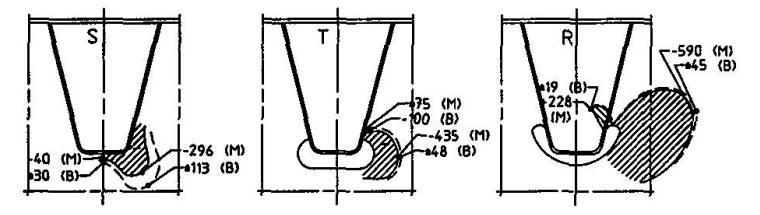
Fig. 12 Stress distributions under vertical load in combination with out of plane bending (N/mm^2)

The stresses shown are the membrane stresses (M) and the out of plane bending stresses (B) for test specimens at the Stevin Laboratory (NL) as reported in [2]. The models consisted of shell elements, which means that the stresses in the neighbourhood of the trough to crossbeam connection do not include the weld and plate dimension effects [9]. Nevertheless it is obvious that in this case, the rigid support not far below the trough to crossbeam web connection causes in the detail "b1" (S) much higher bending stresses than in the details "b2" (T) and "b3" (R). The types "b1";"b2" and "b3" refer to the detail categories of Section 4.2. The tests in the Stevin laboratory showed a better fatigue strength for the type "S", if compared to the types "T" and "R". The V-shaped stiffener connection tested at TRL (UK) however showed a lower fatigue strength. The results have been reported in [2].

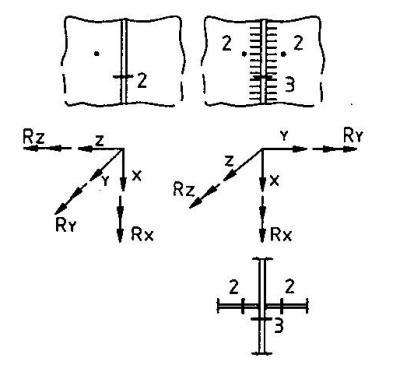
Fig. 13 Fatigue locations and degrees of freedom detail "a"

As a simplification, most of the details used in real structures can be reduced to 2 types of welded details, those with and without cope holes, see Groups "a" and "b" in Section 4.2. The combination of relevant degrees of freedom and the critical locations can be derived from the mechanical behaviour. Fig.13 and Fig.14 show the relevant degrees of freedom and critical fatigue locations for details without and with cope holes, Groups "a" and "b", respectively. Particular attention must be paid to the relevant influence lines and the stress concentration factors related to a degree of freedom and stresses in a specific location.

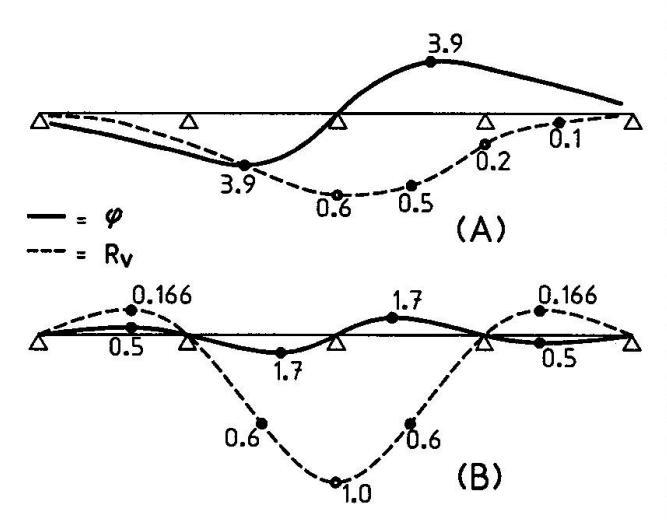
Fig. 15 Influence lines for stiffener support rotations (f) and reactions (R_v)

Fig.15 shows the influence lines for rotations (ϕ) and crossbeam loading (R_v) of the middle trough stiffener support due to wheel loads. Lines (A) show the results for more flexible crossbeams and a (B) for more rigid crossbeams. Rigid crossbeams show higher loading than flexible crossbeams, but the amount of cycles under unit loads is higher. This effect applies as well for vehicle loads.

Flexible crossbeams show larger rotations, but a smaller amount of cycles than rigid crossbeams. It may be expected that in many cases open stiffeners will tend to have an influence line of type (B) which applies for closed stiffeners in box girder bridges too.

Closed stiffeners near crossbeam mid-span in plate girder bridges will act according a line between (A) and (B), depending on the vertical stiffness of the crossbeam. Near the supports they will tend to behave like (B).
