## Fatigue Life of Railway Bridge Welded Joints

**Bernard WICHTOWSKI** Civil Engineer, PhD Technical University of Szczecin Szczecin, Poland **Tomasz CZAJKOWSKI** Civil Engineer, PhD Technical University of Szczecin Szczecin, Poland

# ABSTRACT

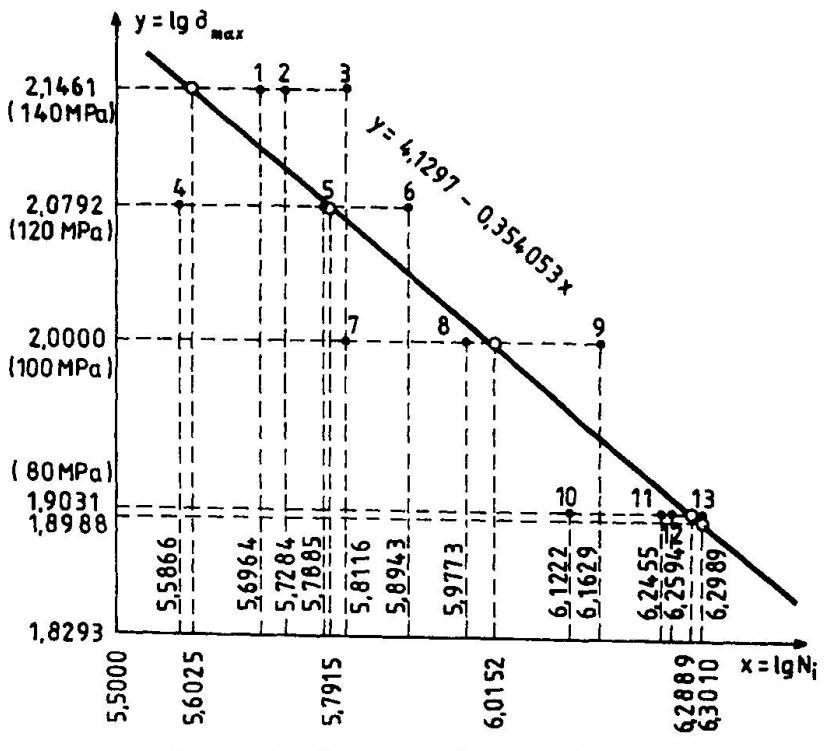
The tests were carried out under pulsating tension at 4 levels of the nominal stress: 140, 120, 100 and 80 MPa, by means of a pulsator at frequency of 500 cycles per minute. The cycle stress ratio  $(R = \sigma_{nin} / \sigma_{max})$  was equal to R = 0,1. On the basis of the test results, by means of the least square method, the following regression line equation was formulated:

### y = 4,1297 - 0,354053 x

where:  $x = lg N_i$ ,  $y = lg \sigma_{max}$ ,  $N_i$  - number of cycles to the specimen failure,  $\sigma_{max}$  - maximum value of stress, in MPa.

The value of mean safe fatigue strength derived from the regression line equation for  $N_i = 2 \cdot 10^6$  cycles was  $Z_{rj} = 79,2$  MPa, and for  $N_i = 10^5$  cycles was  $Z_{rj} = 228,8$  MPa.

Regression line derived from fatigue tests
