# Cable Supported Bridge under Movement of Foundation due to Earthquake

Summary

The experience of the Akashi Kaikyo Bridge hit by the earthquake indicates that a suspension bridge is such bridge as not seriously effected by movement of foundation as compared with a cable stayed bridge. If the bridge was cable stayed bridge, much more damages would be observed. This paper describes the magnitude of stress of suspension bridge and cable stayed bridge having the same span length caused by movement of foundation due to earthquake.

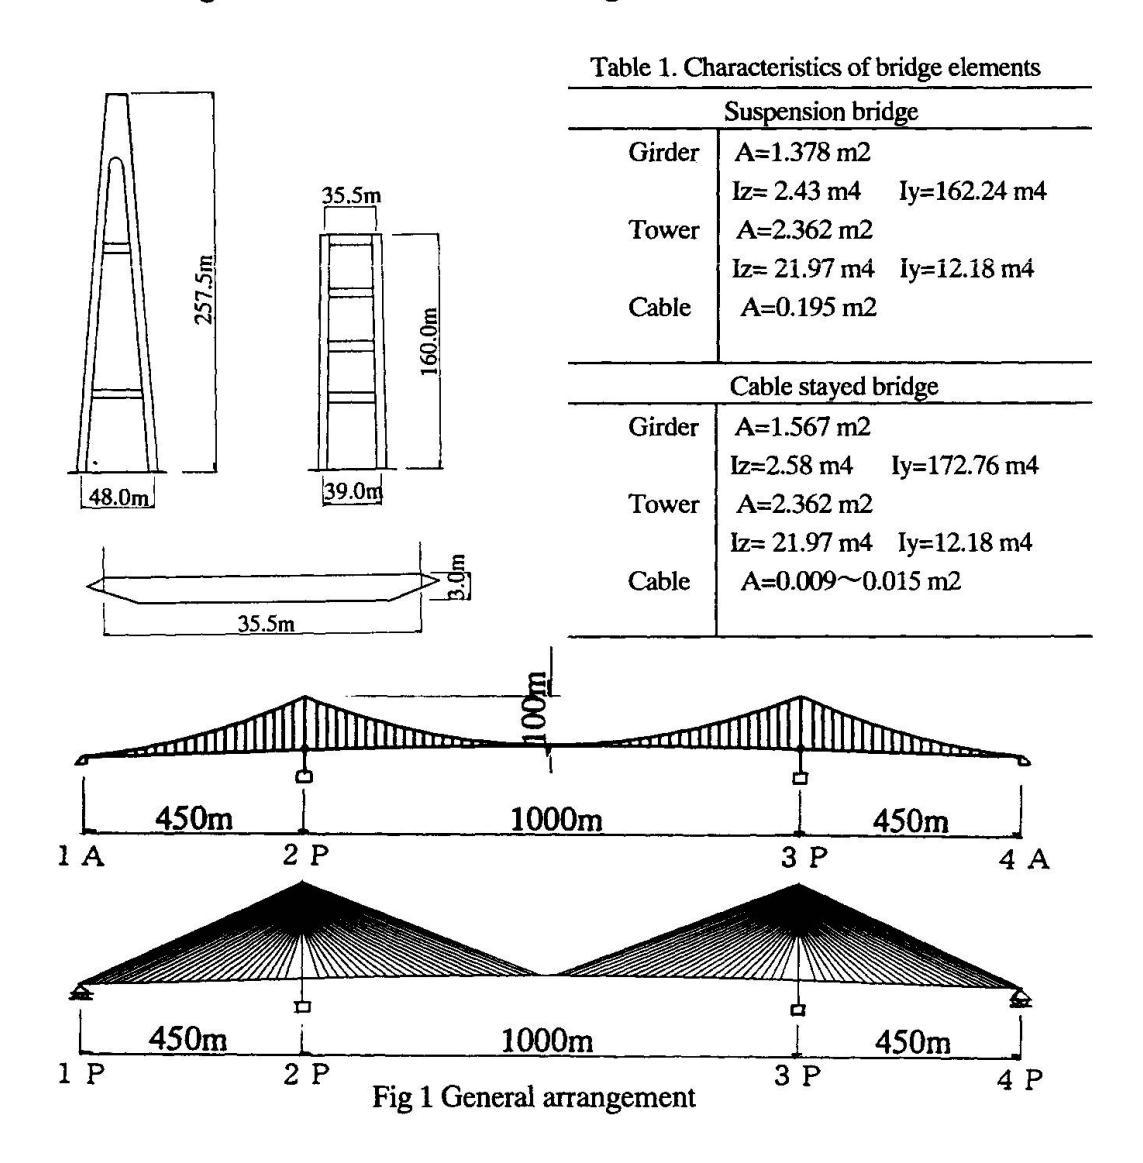
In this circumference, we have computed the behavior of suspension bridge and cable stayed bridge after the completion under the similar scale of movements of the foundations. The bridges for computation are suspension bridge with a main span of 1,000m having un-continuous suspended girder vertically supported by links and transversely supported by wind shoes at the towers and the anchorages, and cable stayed bridge with a main span of 1,000m having continuous suspended girder vertically supported by bearings and links, transversely supported by wind shoes at the towers and the anchorages, and longitudinally supported by spring from the towers. The general arrangements of the bridges are shown in Fig 1. and the characteristics of bridge elements are shown in Table 1.

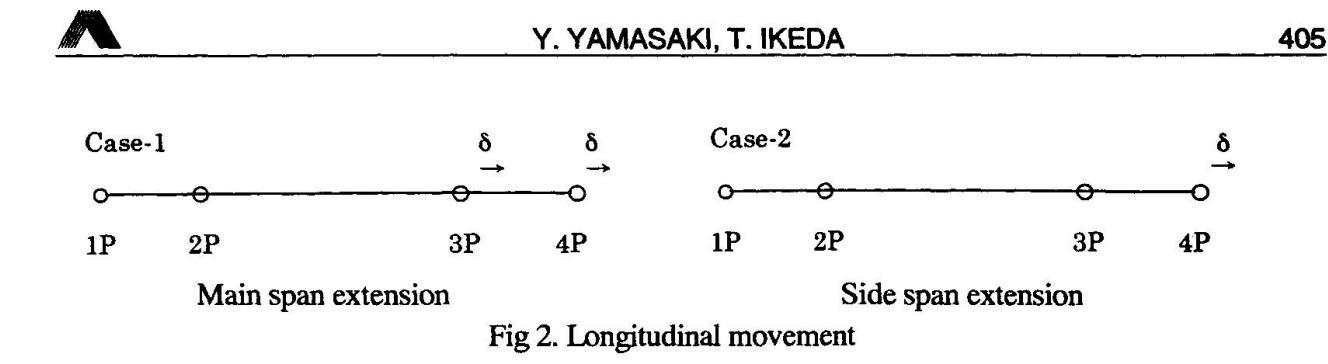
We assumed two cases. One is a tower foundation and an anchorage (or a pier) in the same side move longitudinally outward by the same distance (main span extension), which simulates that fault located in the main span slides, and the other is only an anchorage (or a pier) moves longitudinally outward (side span extension), which simulates that fault located in the side span slides, as shown in Fig 2.

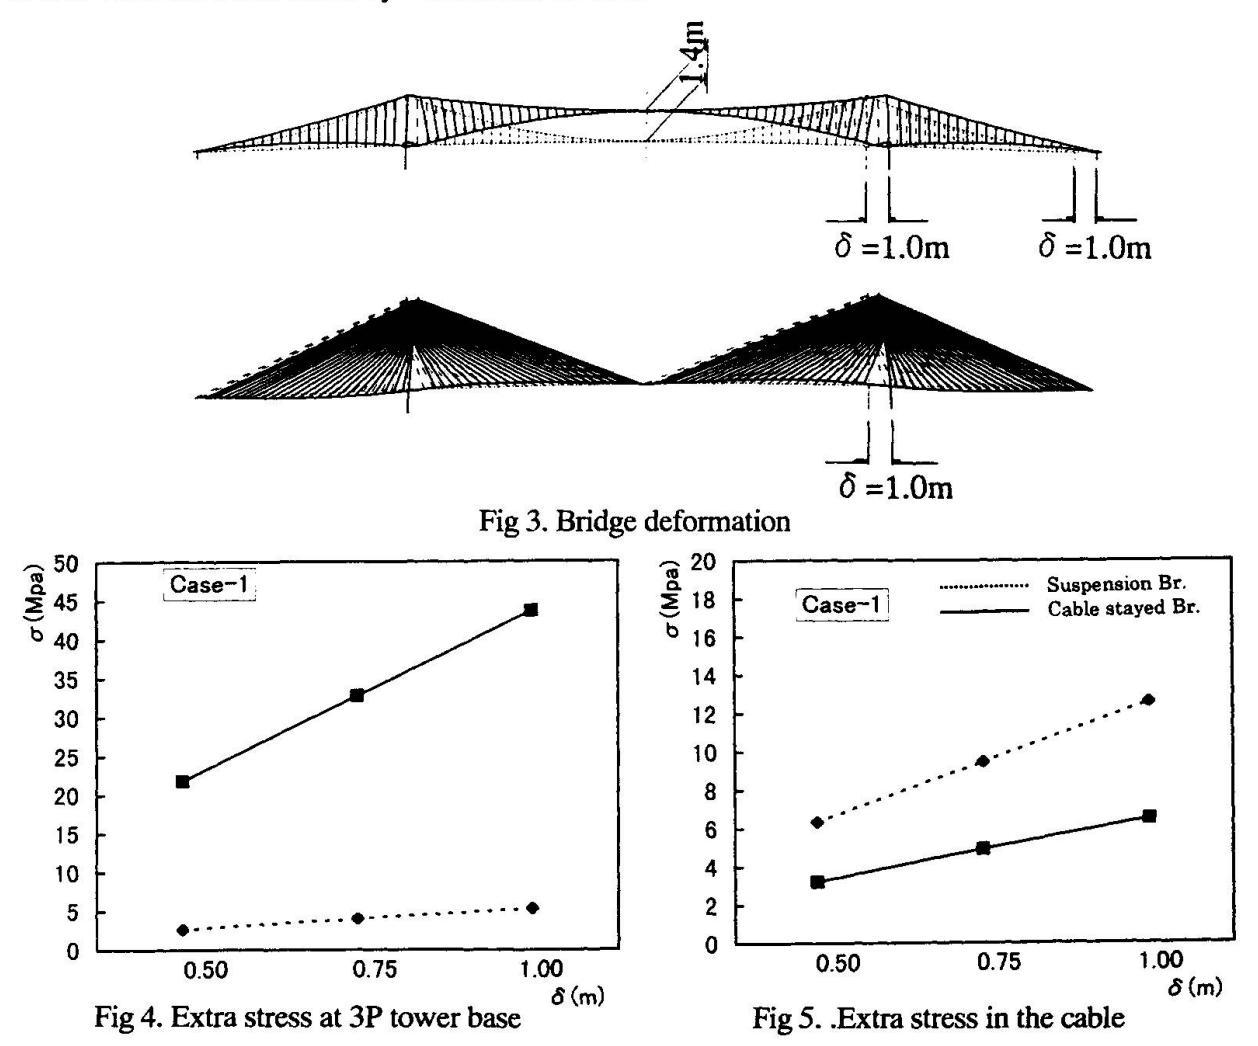
Fig 3. shows the deformation of two bridges for the main span extension of 1.0m, and Fig 4. & 5 show the extra stresses occur in the tower and in the cable of the two bridges by the main span extension ranging from 0.5m to 1.0m. Suspension bridge is able to absorb a extension of main span easily by a change of cable sag (1.4m for extension of 1.0m), which doesn't make tower top displacement much (0.09m each) to balance cable forces of main span and side span at tower top and increase a stress of main cable (13Mpa). By this behavior, suspension bridge is not much overstressed by main span extension. While, cable stayed bridge absorbs a extension of main span by displacement of tower tops (0.52m each for extension 1.0m) inward pulled straight by stay cables. By this behavior, cable stayed bridge is much stressed by main span extension, and the extra stress occurs at the tower base comes up to 17% of its allowable stress by a extension of 1.0m.

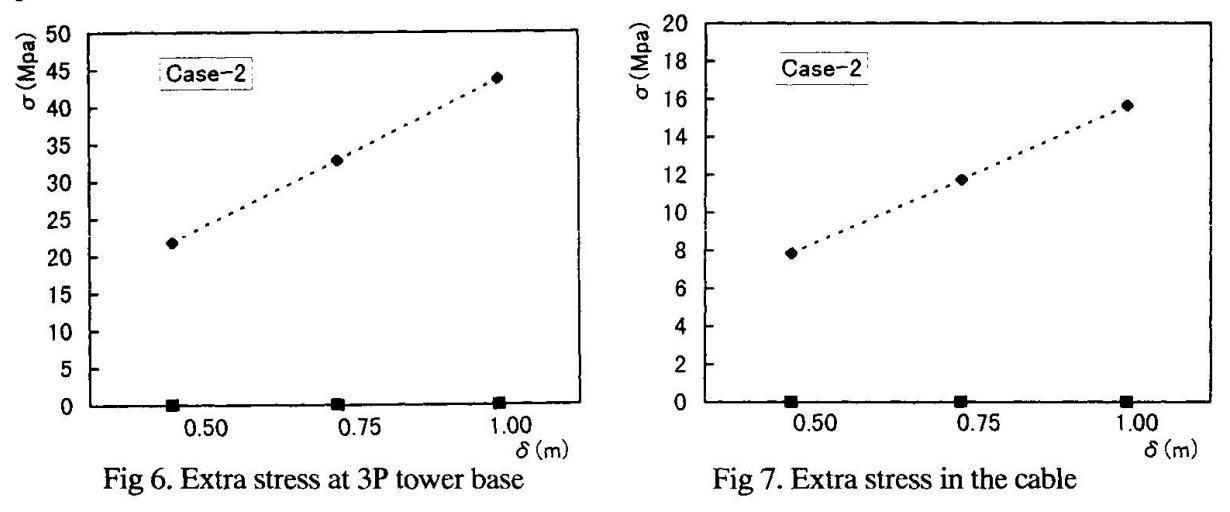
Fig 6. and 7. show the extra stresses occur in the tower and in the cable of the suspension bridge by the side span extension ranging from 0.5m to 1.0m. Suspension bridge is much effected by a extension of side span. The tower top moves by nearly the same scale as that of the movement of anchorage (0.86m for extension of 1.0m), which doesn't produce much extra stress in main cable (16Mpa), but produces, depend on the stiffness of tower, some stress at the tower base. Cable stayed bridge is not effected by a extension of side span, because a damage of bearing at the end pier absorbs most of such extension.

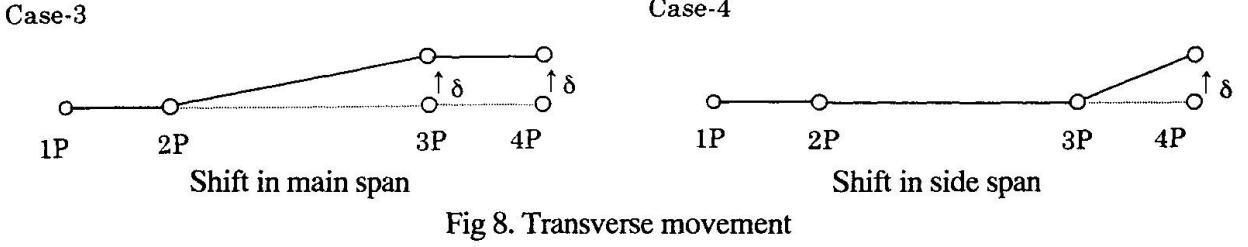
We assumed two cases. One is a tower foundation and an anchorage (or a pier) in the same side move transversely by the same distance (transverse shift in main span), which simulates that fault located in the main span slides, and the other is only an anchorage (or a pier) moves transversely (transverse shift in side span), which simulates that fault located in the side span slides, as shown in Fig 8.

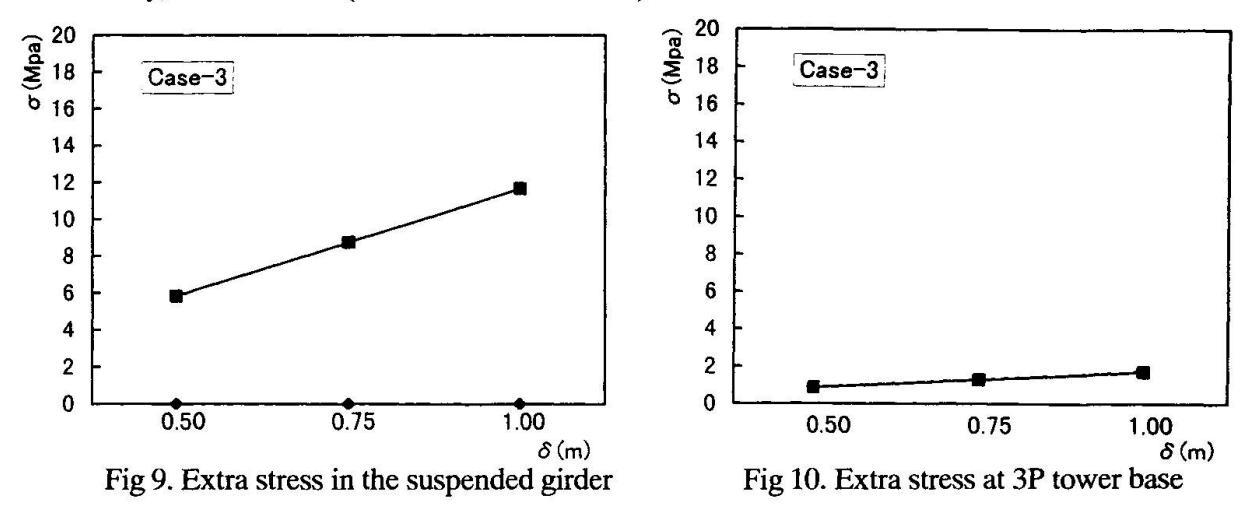
Fig 9. and 10. show the extra stresses occur in the suspended girder and in the tower of the two bridges for the transverse shift in main span ranging from 0.5m to 1.0m. The governing factor to produce the extra stresses in the suspended girder is a continuity of the suspended girder. Suspension bridge with un-continuous girder, which is normally applied to Japanese suspension bridges, is not effected by transverse movement of foundation. The tower tops of suspension bridge move

transversely much (0.39m each for shift of 1.0m) because a big force is applied at the tower top by the main cable. While, cable stayed bridge, for which continuous girder is necessarily applied, is much effected by transverse movement of foundation, and the extra stress occurs in the suspended girder at the tower comes up to 6% of its allowable stress. The tower tops of cable stayed bridge moves transversely, but not much (0.27m for shift of 1.0m).

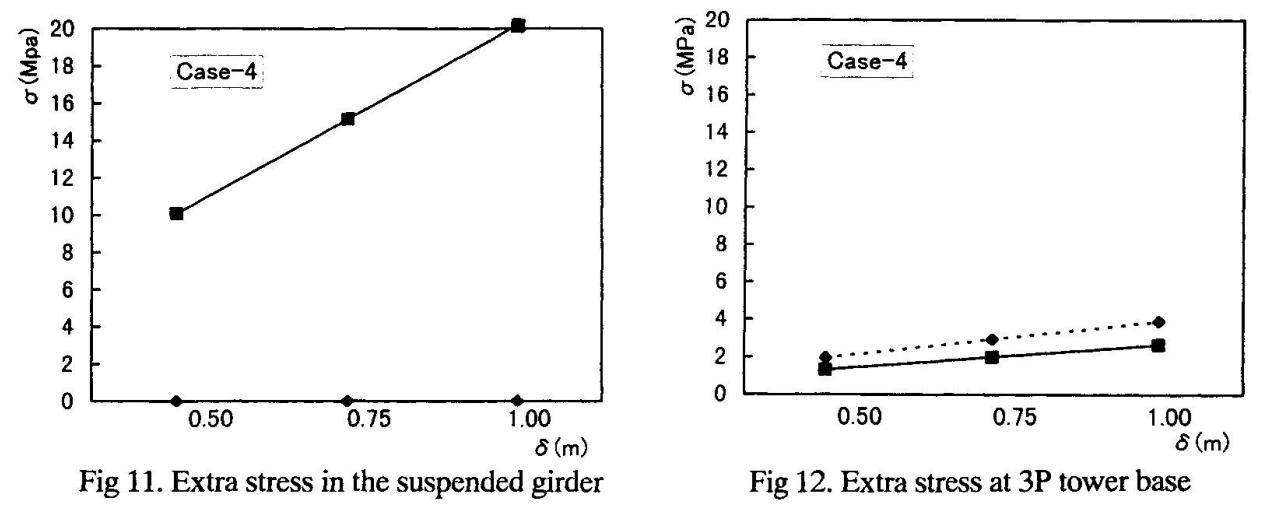
Fig 11 and 12. show the extra stresses occur in the suspended girder and in the tower of the two bridges for the transverse shift in side span ranging from 0.5m to 1.0m. Cable stayed bridge is much more stressed by the transverse shift in side span than by the transverse shift in main span. The extra stress occurs in the suspended girder at the tower is 10% of its allowable stress. The top of 3P tower moves transversely by 0.54m, but doesn't produce much extra stresses at the tower base because A-shape tower change the in-plane bending moment due to the tower top displacement to the axial forces in the tower section. Suspension bridge with un-continuous girder is not effected by transverse movement of foundation.
