CASE STUDIES AND LESSONS LEARNED FROM RECENT SCOUR-RELATED BRIDGE FAILURES IN THE UNITED STATES

Peter F. LAGASSE Senior Vice President Ayres Associates, Inc. Fort Collins, CO USA

SUMMARY

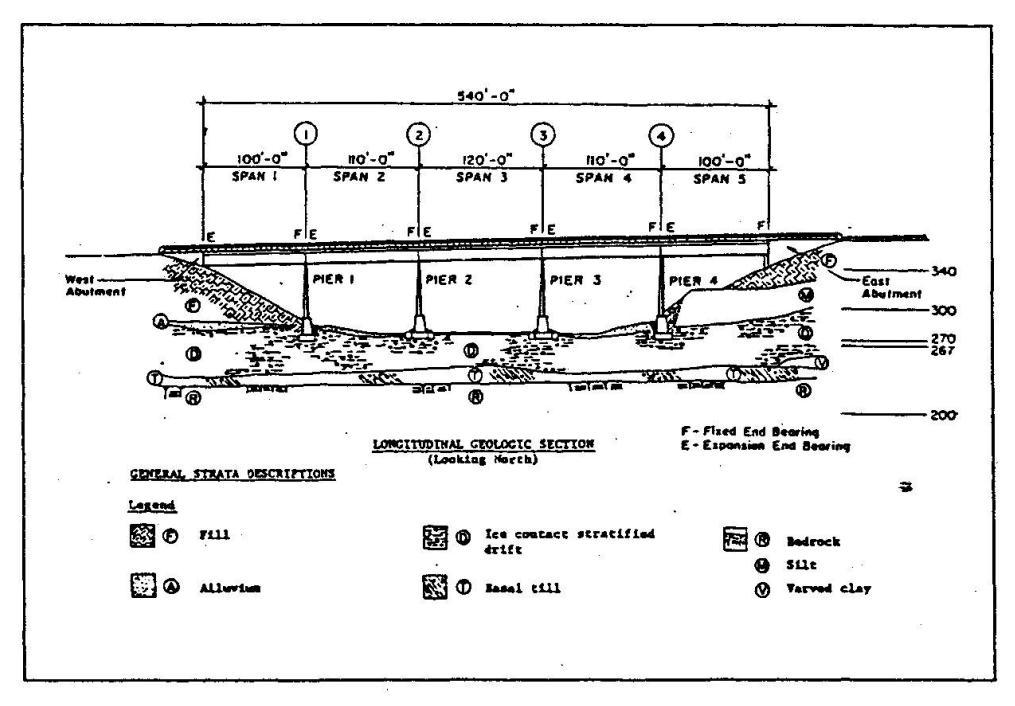
Figure 1. South elevation of Schoharie Creek bridge showing key structural features and schematic geological section.

The substructure consisted of four piers and two abutments. Each pier was a rigid frame (columns and tie beam) supported on a lightly reinforced concrete plinth (pedestal) and spread footing bearing on glacial till just below the streambed. The abutments were founded on piles driven through the embankment fill into the underlying glacial till. The

piers were founded on spread footings 1.5 m deep by 5.5 m wide by 25 m long with no piles. The bridge designers assumed that the glacial till substrate was "nonerodible."

After an extensive investigation and detailed analyses, which included hydraulic computer and physical modeling [1], the U.S. National Transportation Safety Board (NTSB) [2] determined that the probable cause of the collapse of the Schoharie Creek bridge was the failure of the Thruway Authority to maintain adequate riprap around the bridge piers, which led to severe erosion (scour) in the soil beneath the spread footings. It was concluded that the 1987 flood alone probably did not cause failure of the Thruway bridge. Rather, the cumulative effect of local scour around pier 3, particularly in the last 10 years, was the most significant hydraulic factor contributing to the failure.

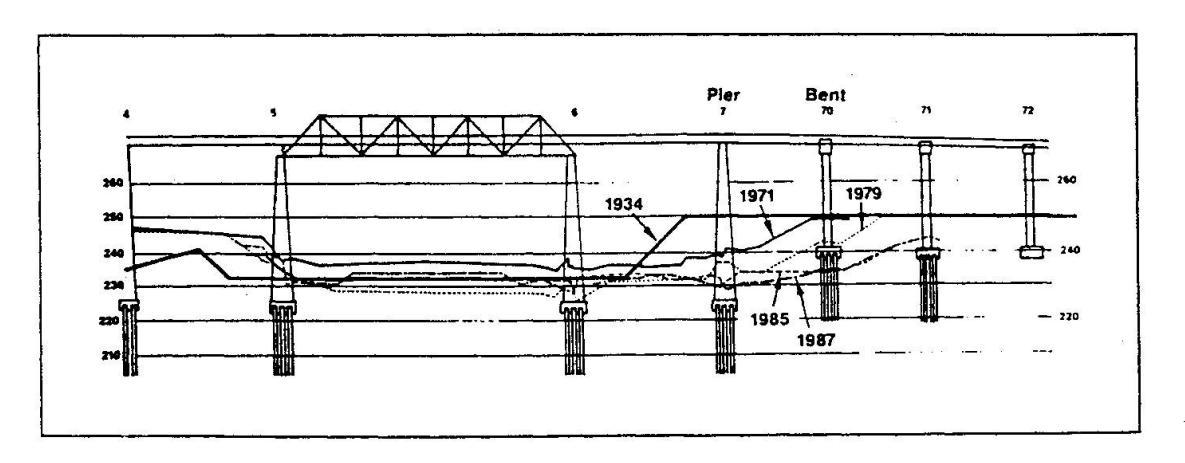
The bridge substructure consisted of main channel piers and floodplain bents supported on piles about 6.1 m long (Figure 2). There was about a 4-meter difference in elevation between the pile cap for the main channel piers and the pile cap of the shallower floodplain bents. A post-failure investigation revealed the following rates of channel migration into the north bank of the river at the bridge: 1931 to 1975 - 0.24 m/yr; 1975 to 1989 - 1.37 m/yr; and 1981 to 1989 - 0.58 m/yr [4].

The NTSB determined that the probable cause of the collapse of the northbound U.S. Route 51 bridge spans was the northward migration of the main river channel, which the Tennessee Department of Transportation failed to evaluate and correct. As with the Schoharie Creek failure, the lack of structural redundancy in the design of the bridge spans contributed to the severity of the accident [4].
