# CONSTRUCTION OF ANCHORED CAISSONS FOR A MOTORWAY VIADUCT

Nader HALIMEH Viaduct Engineer Dár Al Handasah Consultants Adana, Turkey

#### SUMMARY

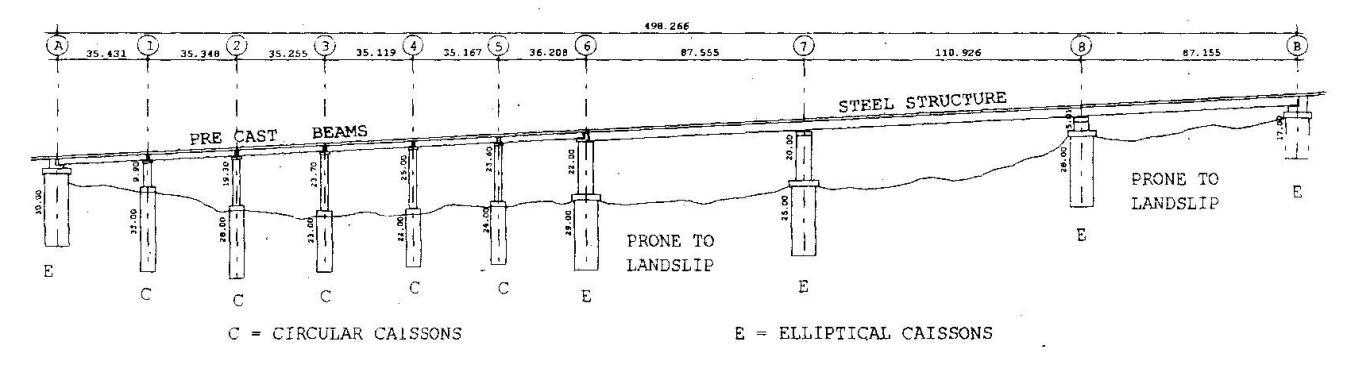
Figure 1: Longitudinal section of Viaduct V5.

Viaduct V5 is 500 m long, comprising nine spans, with a maximum span of 110 m in each carriageway, see Figure 1 below. The entire design and concept is governed by geological factors, as described below, which necessitated the use of caisson structures to form the deep foundations for all piers and abutments. Part of the viaduct super-structure is constructed of pre-cast beams, the remainder of structural steel box girders; accordingly, two different types of pier columns and foundations were required. Two types of caissons were designed, one circular, 6 m in diameter, and the other elliptical, 12 m by 8.5 m; the elliptical shape was chosen to reduce the obstructing effect that might occur in the event of a landslide. The caisson depth varies between 10 m and 31 m.

In general, tie-back walls are constructed in soft ground such as clay, sand, gravel and shales. The caissons for the piers adjacent to Abutment A of Viaduct No. 5 were six metre diameter circular caissons, as shown in Figure 1. When the Contractor came to create Abutment A itself, for each carriageway it have been logical to have two similar caissons, but he elected instead to have one larger 12 x 8.5m elliptical caisson with anchor-supported walls because the excavation of the smaller circular caissons at the adjacent piers had proved to be slow. Hanna points out that for any specific problem, and the above is a good example, a large number of possible solutions is often available, and selection is usually controlled by factors other than technical.

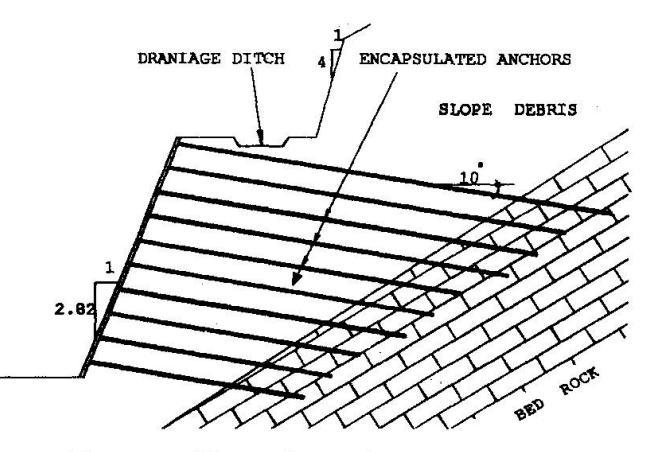
Figure 2: Slope formation.

Preparatory excavations were made in the slope debris in order to obtain a level working platform for construction of the caisson proper. These excavations were carried down step by step, each step being supported by shotcrete reinforced with wire mesh and retained by encapsulated (passive) anchors comprising 26.5 mm diameter bars of

835/1030 U.T.S. steel inserted into a 130 mm diameter hole. The anchors were embedded three metres into the bed rock, as shown in Figure 2. Two inclinometers were installed to monitor any movement during excavation.

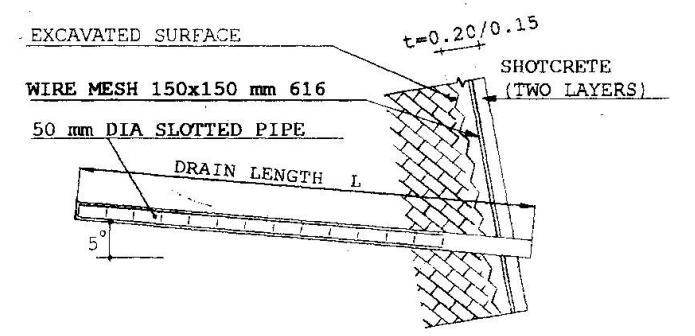
Figure 4: Drainage behind shotcrete lining.

Excavation was carried out, using a hydraulic excavator, the use of explosives was rejected both from fear of precipitating further landslips, and to prevent loosening of anchors already installed for previous stages. The ground was removed down to the level of the next support stage; wire mesh was applied to the exposed ground that formed the wall of the excavation, and then shotcrete was applied as shown in Figure 3 on the next page. In the circular caissons, shotcrete 150 mm thick was sprayed onto the exposed ground, increased to 200 mm thick when more than 10 m below the top of the caisson. In the elliptical caissons, in addition to 200mm of shotcrete, a reinforced concrete ring beam was cast at the bottom of each excavation stage, through which pre-stressed cable anchors (active) were installed as described in Paragraph 3.3 below. These beams and anchors were only required through the slope debris; in rock, ring beams were formed in shotcrete. Drainage pipes , as shown in Figure 4, were installed through the shotcrete of alternate vertical panels, of each caisson, to prevent accumulation of ground water pressure behind the shotcrete.

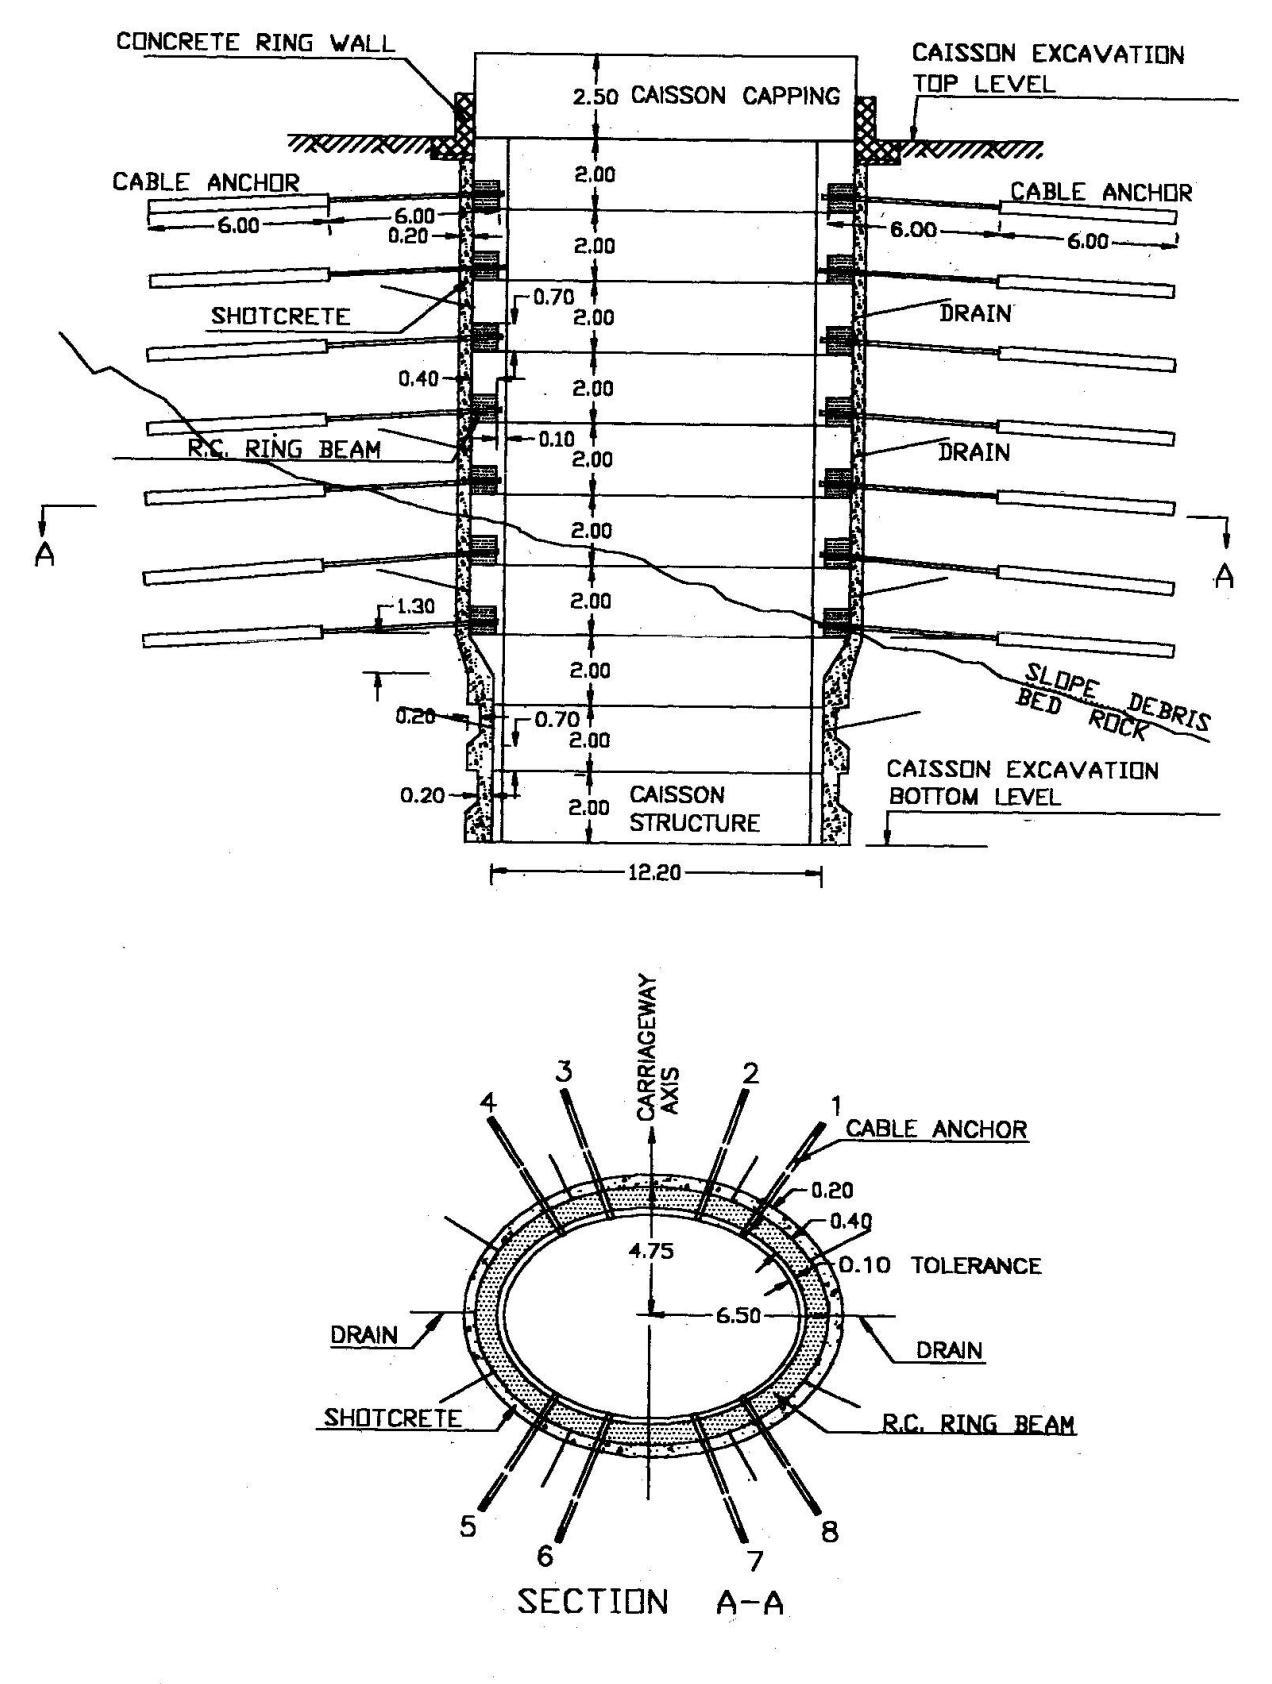
Fig. 3. Plan and section of an elliptical caisson showing excavation stages and the peripheral supporting system.

Eight cable anchors were used at each stage of excavation of the elliptical caissons, as shown in Figure 3, each anchor had two strands 15.24 mm in diameter as shown in Figure 5. The drilling of

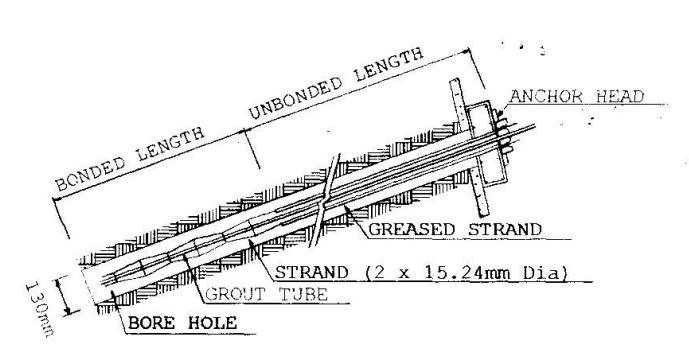
Figure 5: Pre-stressed cable anchor details.

the 130 mm diameter holes was performed by a SoilMech SM 305 drilling rig, lowered down to the current floor of the excavation. The cable anchors were assembled on site, and inserted into the holes, after which grout was pumped in to form an anchorage, from a grouting plant located on the surface nearby. After the ring beam had gained sufficient strength, the anchors were stressed. The imposed stressing force was 150 kN for the top row, and 250 kN for the remainder; however, for some anchors at the second level this could not be achieved, even after the bond length was increased from six to ten metres, probably due to excessive ground water. This was overcome by accepting 150 kN for these anchors as well, and post-grouting them. One anchor at each level was tested in accordance with the relevant AASHTO specification.
