Zeitschrift:	IABSE reports = Rapports AIPC = IVBH Berichte
Band:	80 (1999)

Rubrik: Session 7: Case studies

Session - 7 Case Studies

Design of Foundations for the Storebælt East Bridge

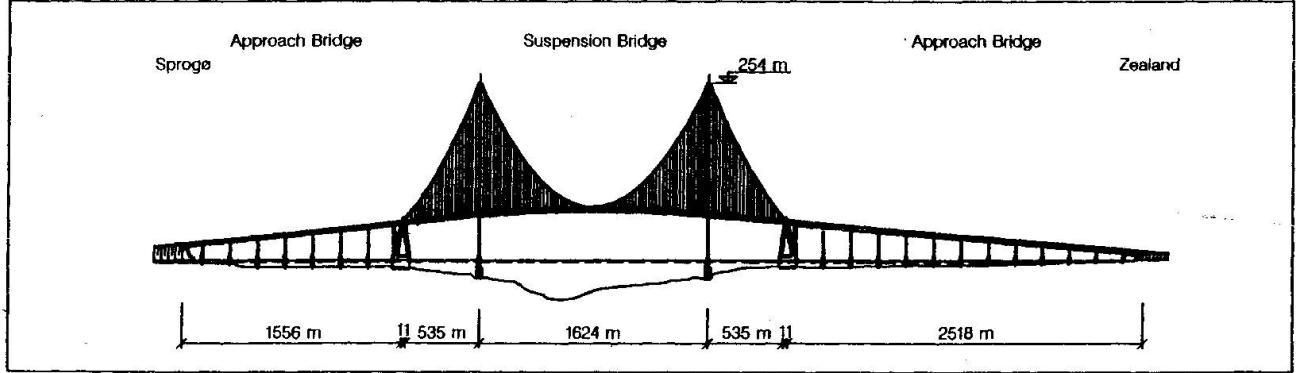
The Storebælt East Bridge comprises a major suspension bridge with a free span of 1624 m, the second longest in the world, and approach bridges with spans of 193 m. The total length of the bridge is 6790 m and the navigational clearance in the main span is 65 m, see Fig. 1.

Fig. 1: Longitudinal section of the Storebælt East Bridge (exaggerated vertical scale)

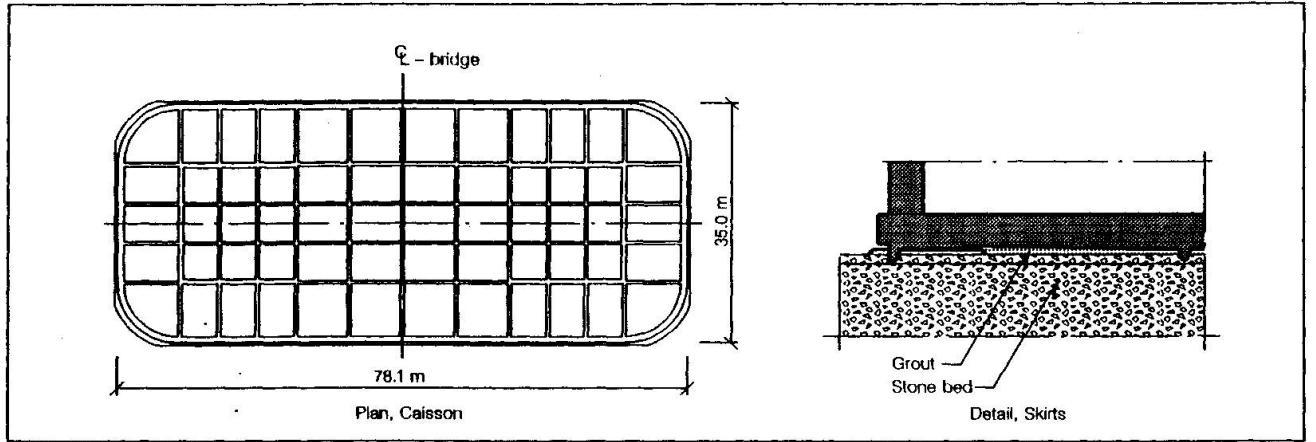
The foundation caissons, each covering an area of 2,770 m², are 78 m long and 35 m wide, see Fig. 2. However, the corners and the edges are rounded in order to reduce the water blocking effect and to limit damage to possible colliding ships by avoiding sharp corners and edges. They are divided into 60 cells by internal walls and are 20 m high, including a 3 m thick plinth cast in situ on top of the cellular caissons within a temporary steel cofferdam. This was required because the top of the caisson is kept 3.5 m below water level in order to avoid the undesirable visual effect of the slender pylon legs and the voluminous caisson standing one on top of the other.

The bottom slab of the caissons has a variable thickness between 0.95 m and 1.1 m, creating a roof-shaped underside to the slab. Around the periphery of the slab and below some of the internal walls 0.5 m deep skirts are provided, designed to penetrate about 0.3 m into the uncompacted screeded top layer of the stone beds, see Figure 2. The voids thus formed between the roof-shaped underside of the slab and the stone bed were subsequently filled with sand/cement grout through pre-installed pipes, the skirts serving to confine the grout. For each of the caissons the quantity of grout was some 725 m³, placed in about 40 hours

Fig. 2: Plan and Detail of Foundation Caisson

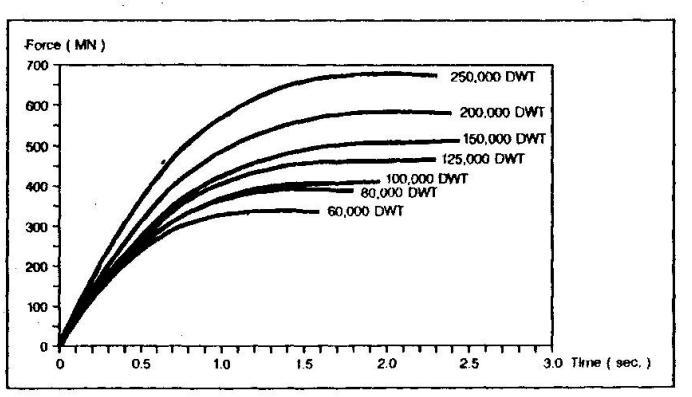
The load-time curve for the impact against the non-moving pier was established based on theoretical considerations of the energy dissipated by adding up the contributions during plastic deformation of all basic structural elements of the ships hull. The procedure developed for bow crushing analysis is based on an upper-bound plasticity theory which can also handle rigid body motions of crushed and non-crushed parts of the structure. Validation of the numerically predicted crushing loads has been done by comparison with experimental crushing results of small scale bow models.

Fig. 3: Idealised load-time curves for ship impacts

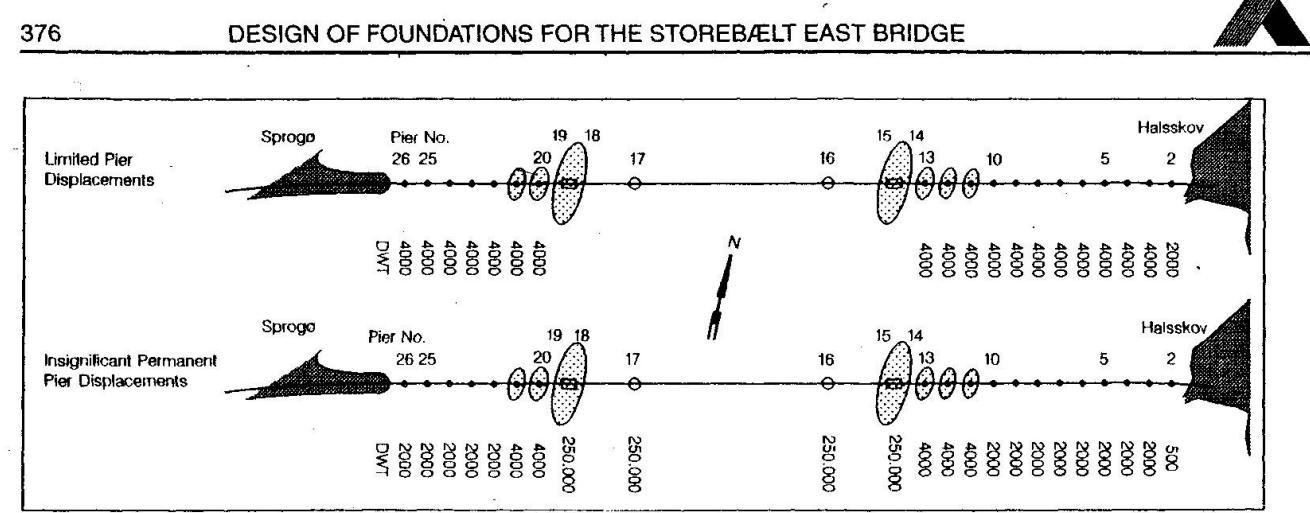
Based on the collision risk model the design basis for the ship impact loads was established, see Fig. 5.

Fig. 5: Design vessels (in DWT) for Head on Bow Collisions with Approach Bridge Piers

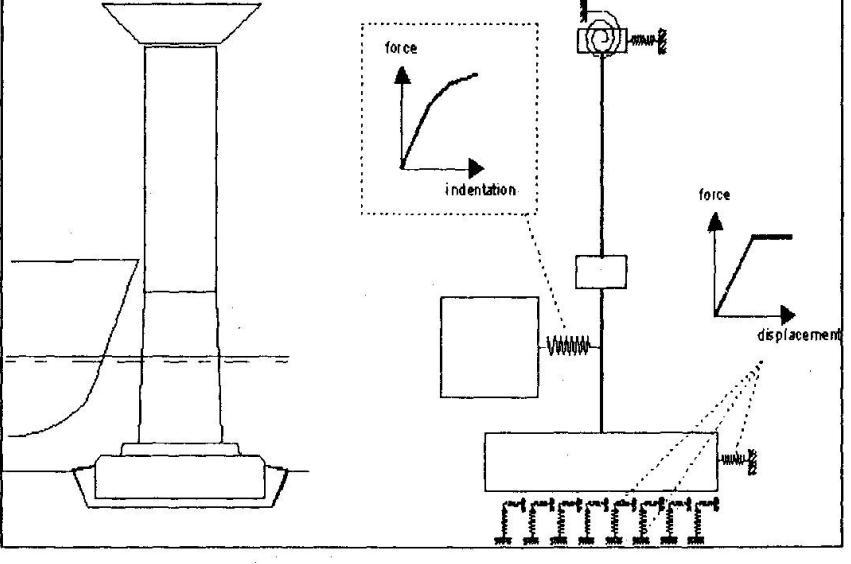
A simplified but still advanced computer model was developed for the ship impact analyses, see Fig. 6. The model comprises: a non-linear elasto-plastic model of the soil-structure interaction, a stiff foundation caisson, elastic beam elements for the pier shaft and a concentrated mass and spring at the pier top representing the bridge girder. To verify the simplified model, independent 2D finite element analyses were carried out using two different programs ABAQUS and FENRIS. In addition the effects of eccentric impacts were studied by 3D models with a more refined

Fig. 6: Idealised model

The comparison of results from the simplified model and the finite element analyses showed a good agreement with differences in ultimate bearing capacity being some 10% only. However, the finite element models give a better description of the behaviour of the soil especially when failure is dominated by overturning and twisting moments. For further information, see Feld and Gravgaard, [4].

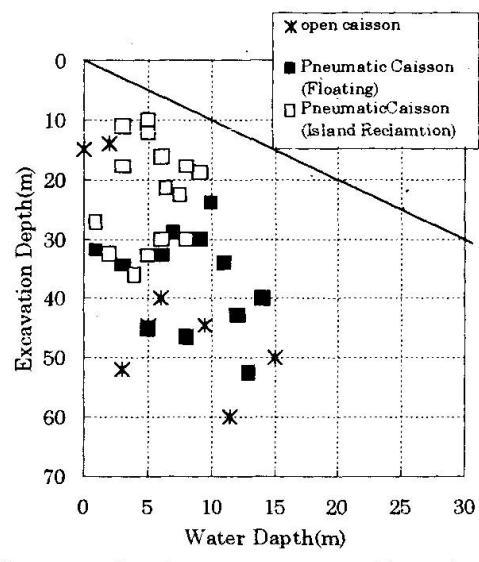
Fig. 1 shows that many of those caisson foundations, which support long span bridges, have been constructed at locations with very deep water. The reason of this situation is that they are appropriate for deep foundations thanks to the benefits cited above and the large bearing capacity of a caisson foundation.

Figure.1 Underwater caisson Foundation Executions in Japan

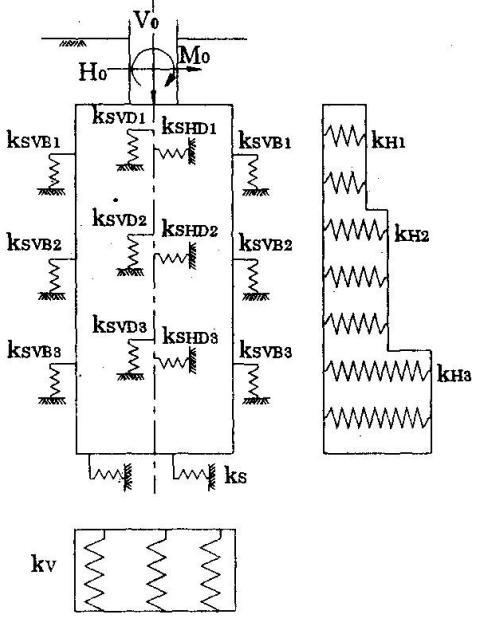
Figure. 2 Ground Resistance

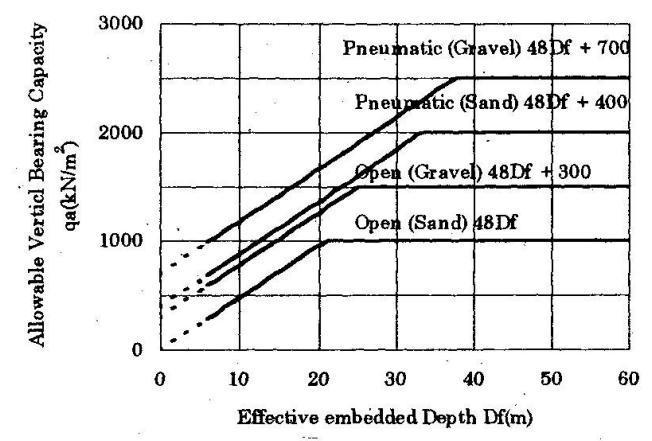
It has been pointed out that there are discrepancies between the measured and theoretical equation (1) values with the static

<u>Figure. 3</u> Maximum Value (Normal Conditions) of the Allowed Vertical Bearing Capacity of the Ground at the Bottom Surface of a Caisson Foundation

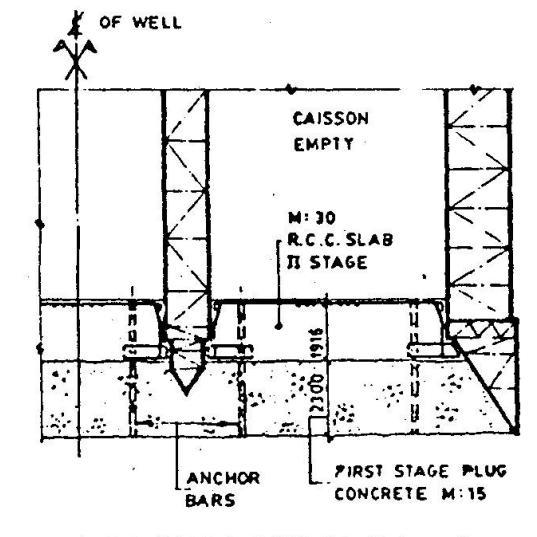
PART CROSS SECTION SHOWING BOTTOM SLAB REINFORCEMENT

BOTTOM PLUG FOR CAISSON OF F-3 FIG. 4

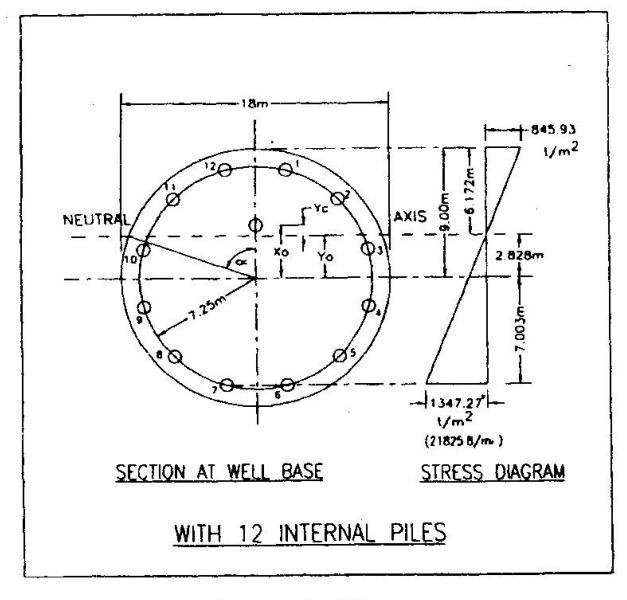
Fig:4

The maximum tension in the piles is 1200t. Depending upon the earthquake direction, any pile can be subjected to the uplift of 1200t and hence all the piles have to be designed for the same capacity. The bottom plug and the piles are designed with M-30 grade concrete for which permissible stress under seismic condition is $1.333 \times 100 = 133.3 \text{ kg/cm}^2$ under bending compression and $1.333 \times 85 = 113.3 \text{ kg/cm}^2$ under direct compression. The maximum compressive stress in the bottom plug as well as pile concrete is well below these values and hence safe. The design of the anchor piles for the uplift capacity is given below :

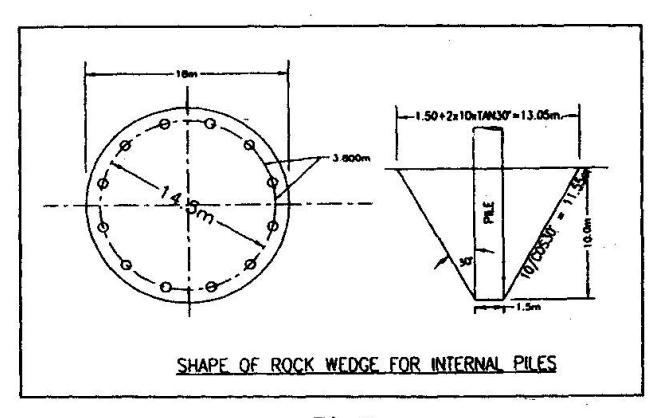
Fig:5

The piles have been provided essentially for resisting the tension developed at the base of the well caused due to overturning moments and resultant uplift under seismic conditions. The base of the well is treated as the solid circular section with each pile acting as steel reinforcement resisting the tension. The socket length inside the rock and the bond length of pile within the well steining have to provide adequate safety against the uplift. The brief computations are given below.

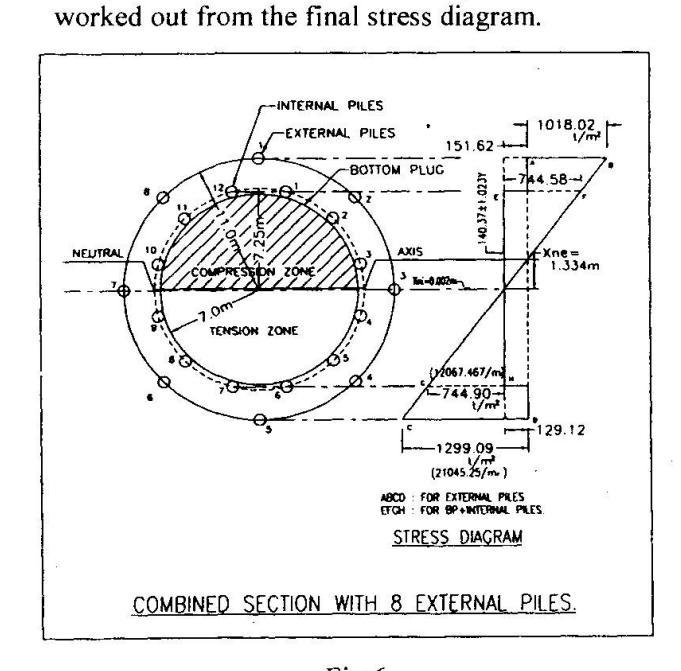
Fig:6

The second stage of loading will consist of the dead loads of external piles and the extended portion of the well cap, the live loads and seismic forces. At this stage, the external piles shall also be effective. The incremental effect of the second stage loads will be resisted by the composite section comprising of truncated bottom plug, internal piles and the external piles. Only the uncracked concrete along with the steel in the internal and external piles shall be effective in the applied loads. Because of the resisting composite action and the two stages of loading, the combined section will have two neutral axes. one for the initial section consisting of bottom plug and the internal piles and the other for the group of external piles. Both the stages of loading have been superimposed to obtain the final stress diagram. The position of the neutral axes has been found by trial and error. The compatibility of internal and external forces acting on the combined section of bottom plug and piles has

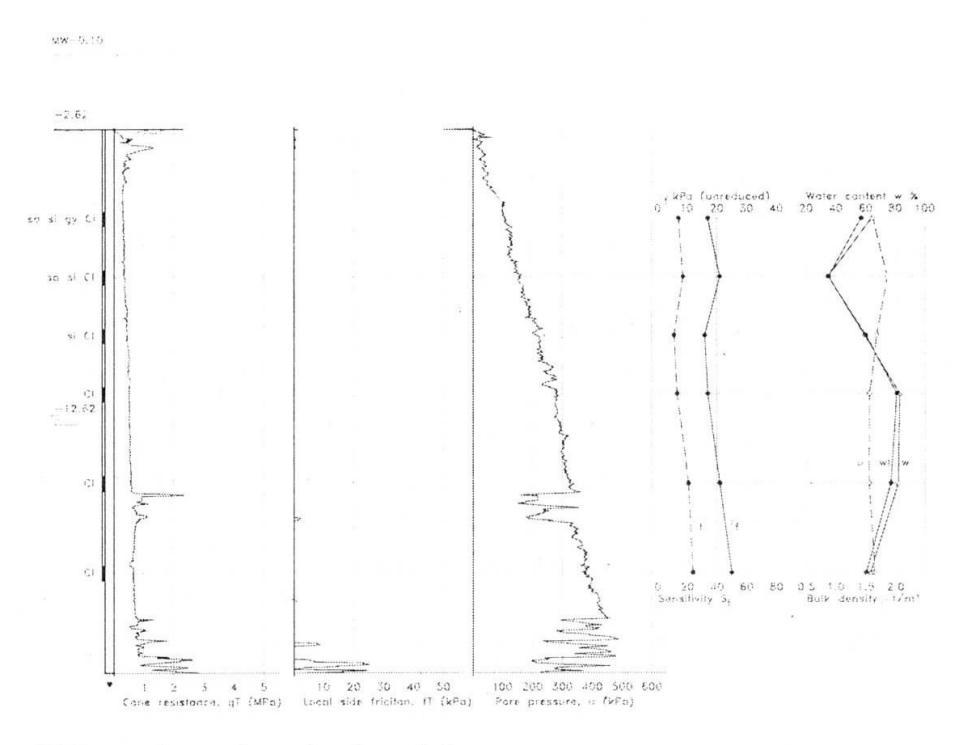
Figure 2 CPT-results and results from laboratory investigations at support N6

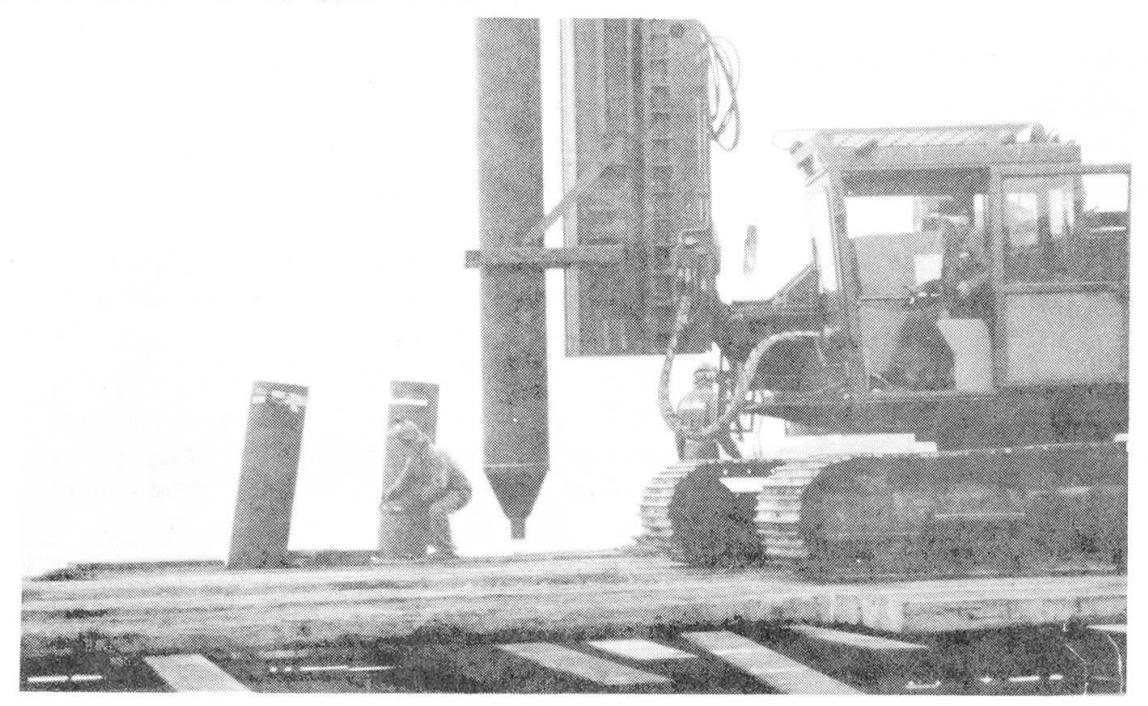
To increase the capacity of the pile driving it was necessary to take alternative measures to decrease the amount of blows for the installation with the originally selected equipment or change the equipment to a more efficient one. However the allowed noise level was reached (and in some cases exceeded) with the initially selected pile driving equipment. To avoid exceeding the stated noise level the first alternative was to reduce the amount of blows during the installation through drilling beside the pile during the driving. High water pressures had been observed during the pile driving. The drilling reduced the pore pressure and had a good effect on the capacity of the pile driving, but not good enough. Hence it was decided to add an equipment with a more efficient hammer to make the final driving of the piles. That implied that it was also necessary to take additional measures to increase the noise damping. These were performed in two ways. The first was a tube of concrete with a length of 5 m placed around the pile and the hammer during the final pile driving. The second way was a wall of normal transport containers with a height of about 10 m placed on three sides of the foundation area. Together these measures were efficient to reduce the noise level so it was possible to perform the piled foundation without exceeding the stated

Figure 3. Pile driving equipment used for foundation at support N6 and N7.

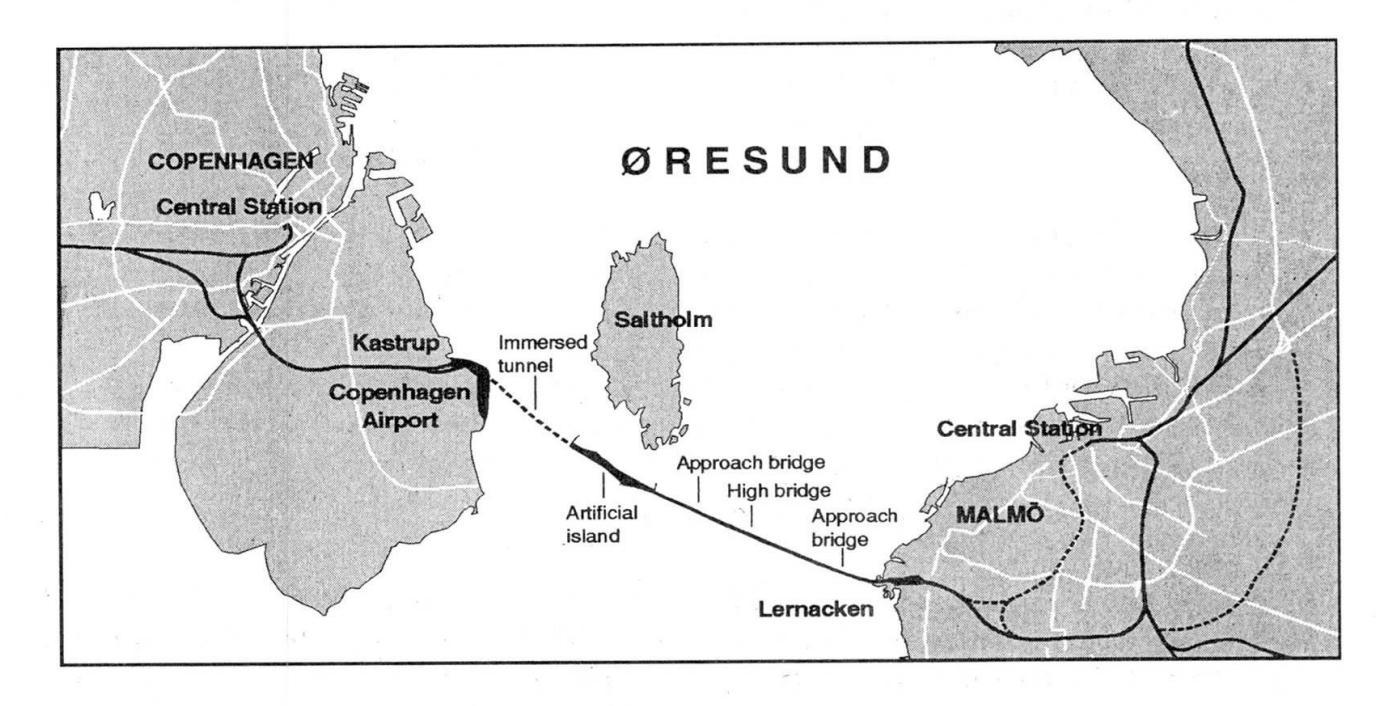
Plan of the Øresund Link Fig.1.

The 15.8km Link comprises, from Copenhagen Airport in Denmark to Lernacken in Sweden, the following main parts (Fig.1):

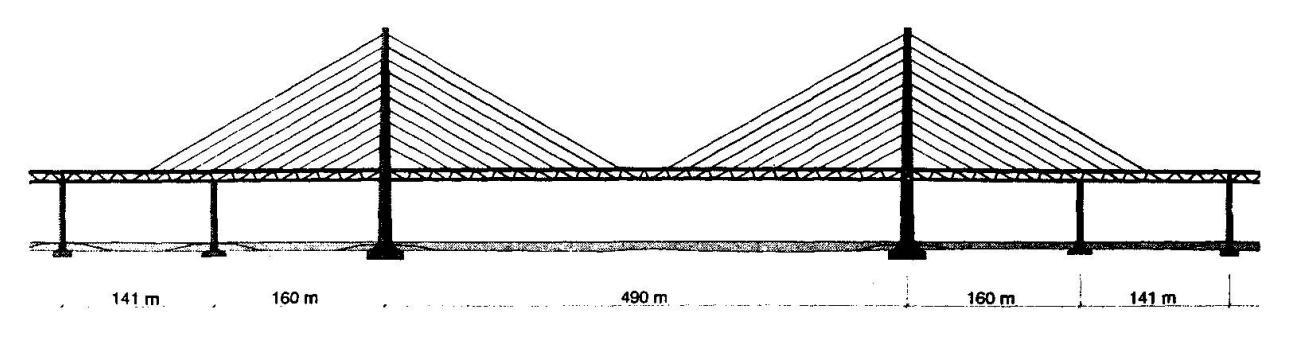
Fig.2 The 490m Main Span crosses an international Shipping Lane

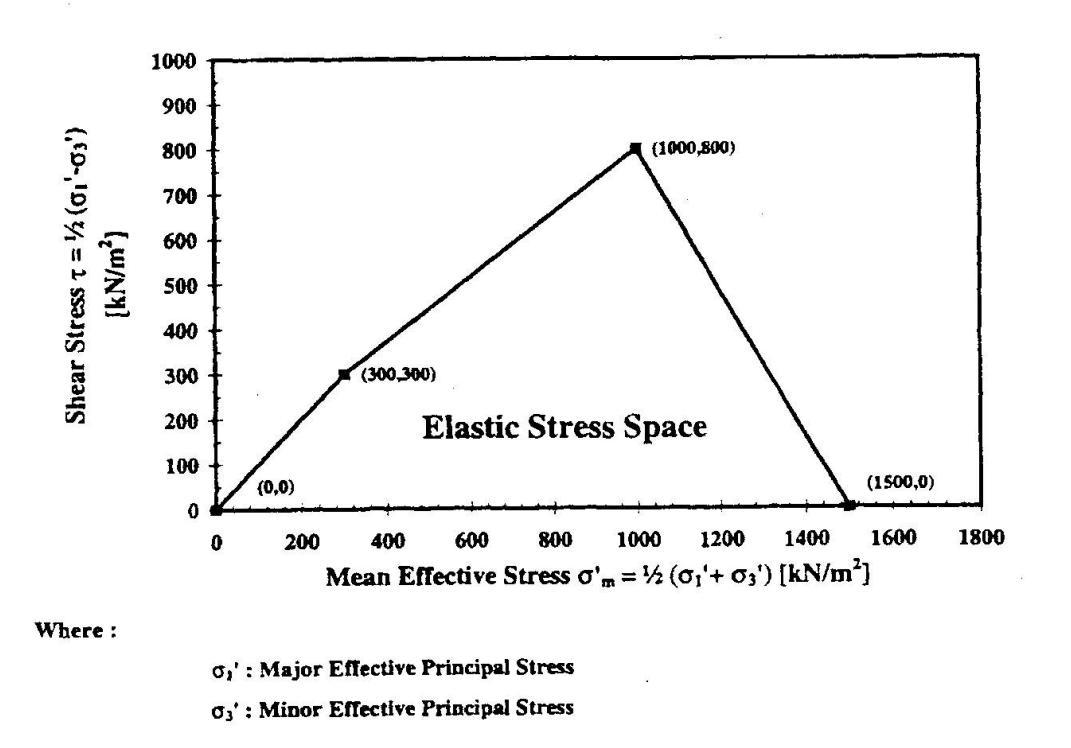
Fig.3 Definition of Elastic Stress Space for Limestone Formation

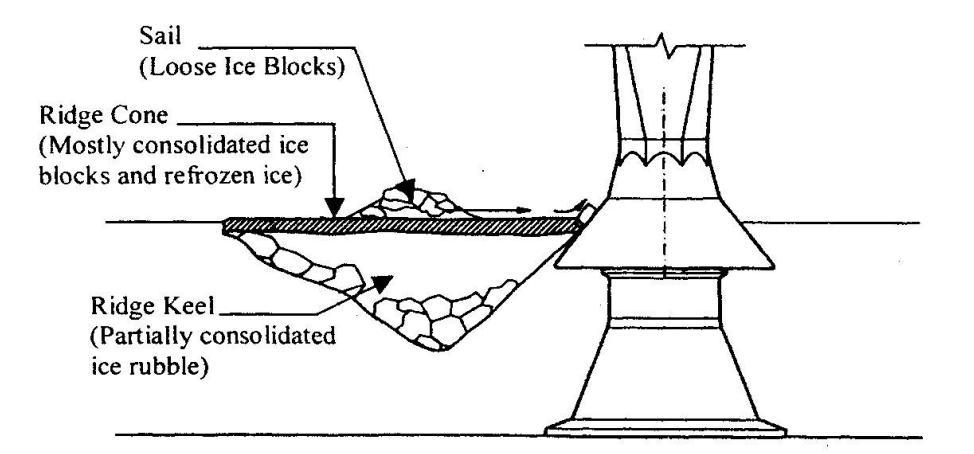
Generally, the ice season in the Northumberland Strait begins in December or early January, and conditions worsen until late March. The maximum thickness of ice floes, i.e. floating pressure ridges formed from large sheets at the surface of the sea, is about 0.30 m. Floes may occasionally extend over 500 m with a mean of 118 m.

Figure 1: Ice Formations

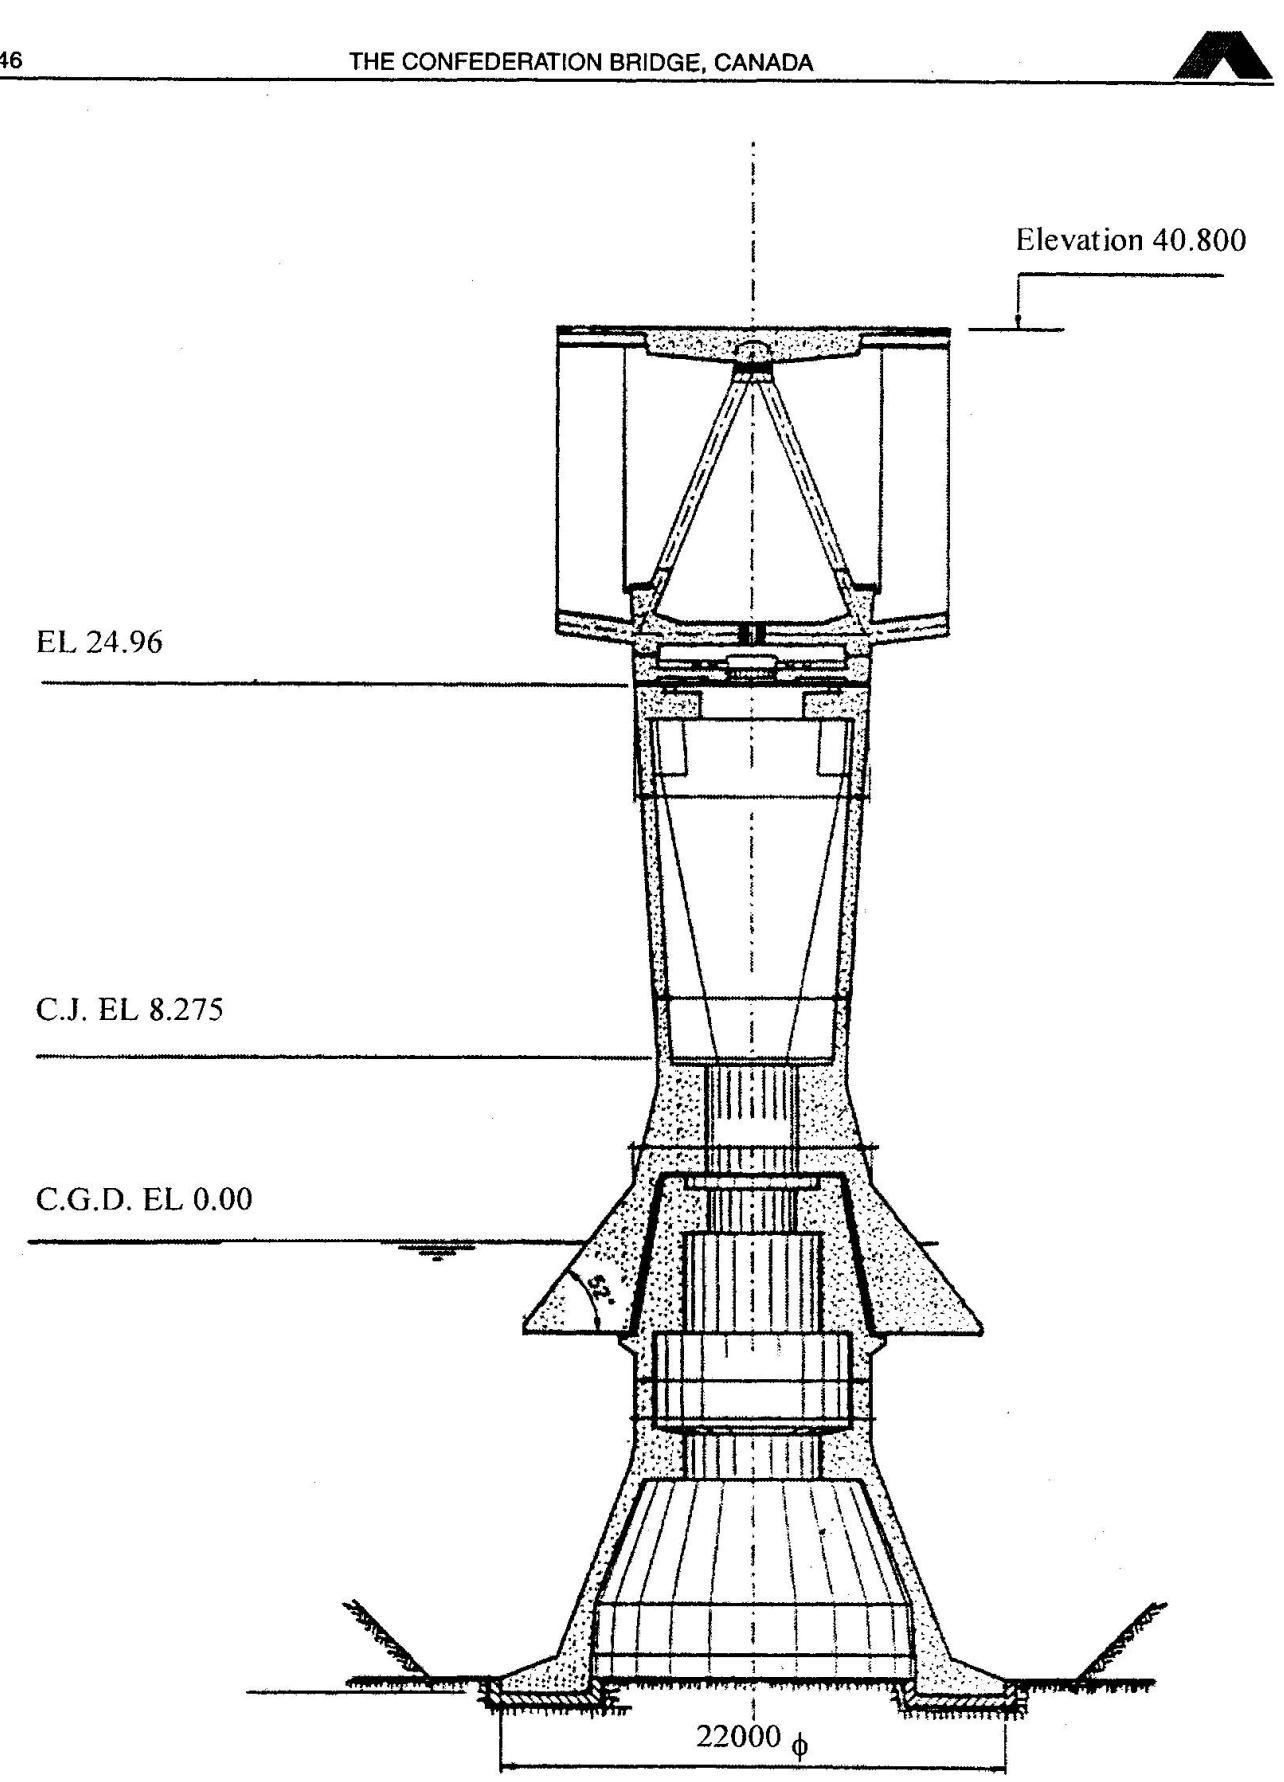
Figure 2: Longitudinal Section
