| Swiss express : the Swiss Railways Society journal |

# Inching Along Through the Lötschberg Tunnel

By George M.Hoekstra Photographs by the Author

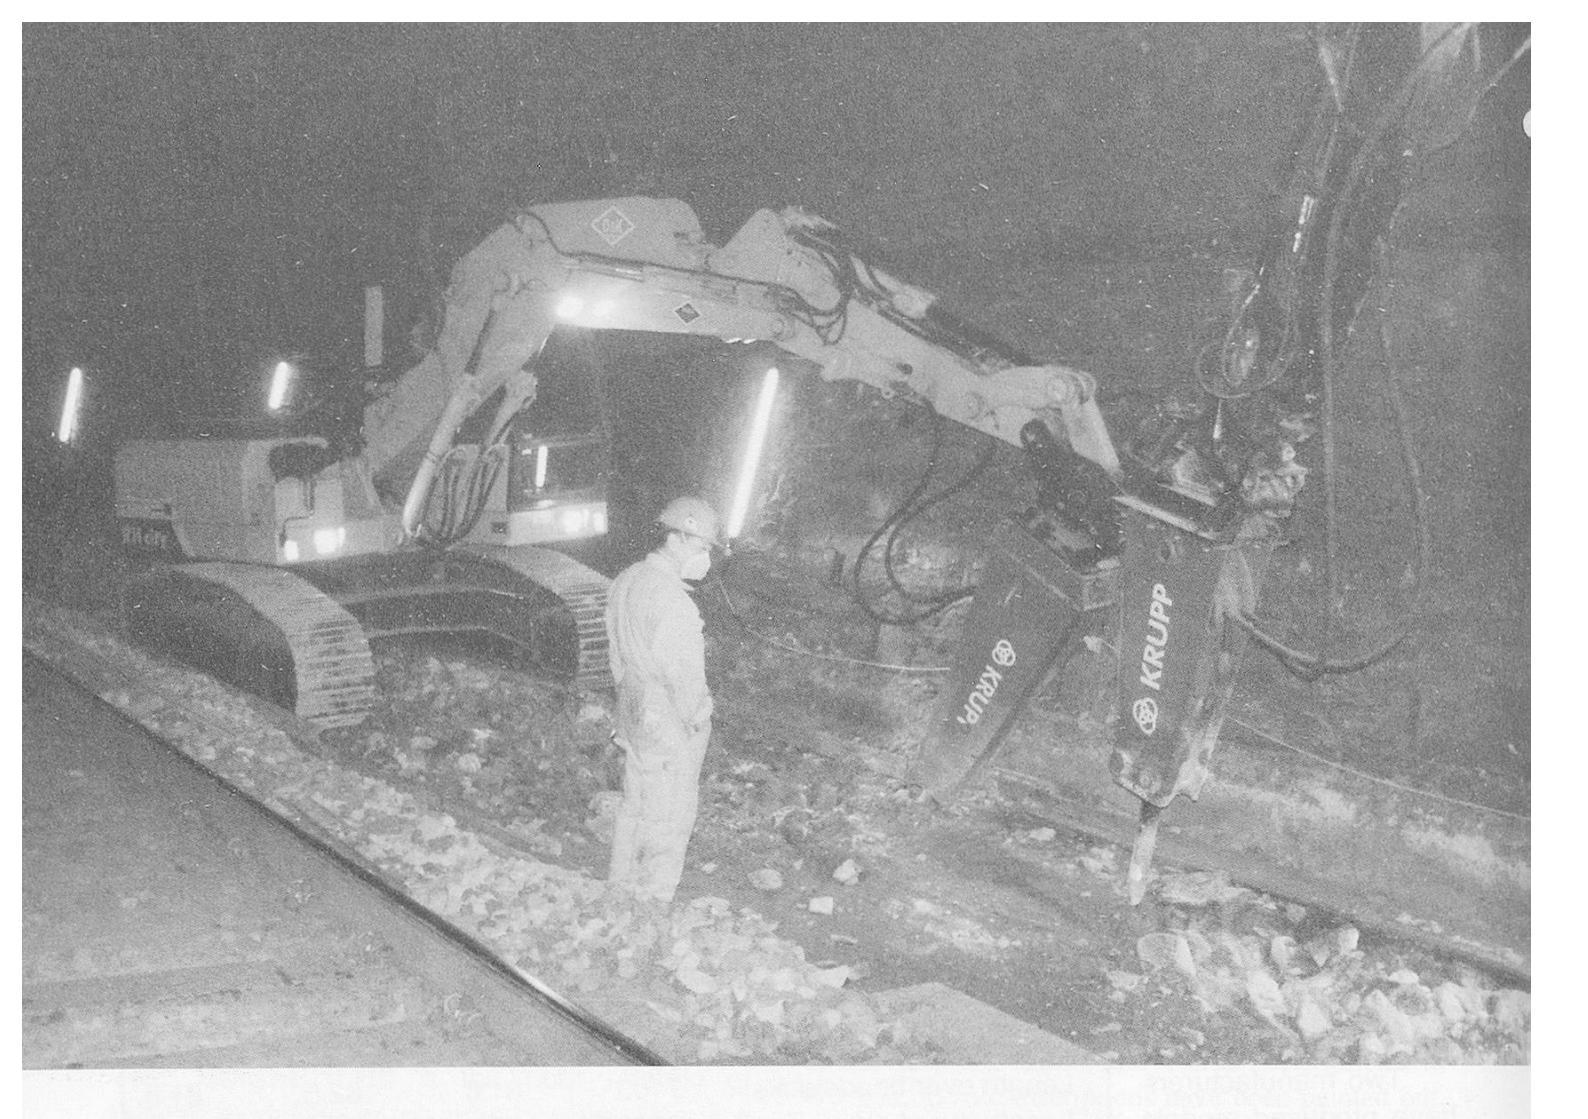
Lowering the track base with hydraulic hammer drill. Note how close the running tracks are to the work site.

The right-hand track is worked on initially. The track is cut into sections 18 m long, lifted and removed from the tunnel. Useable sleepers are stored. Then the old ballast is removed and the rock floor of the tunnel is lowered. All this spoil is loaded by a conveyor belt into waiting hopper wagons. The work is extremely dusty, so apart from the operators wearing special *Airstream* masks and other personnel wearing face dust masks, the BLS has installed a special vacuum cleaner wagon, capable of filtering 120,000 cubic metres of air each eight hour shift. No less that 12 kilogrammes of very
