Ultrasonic methods for damage evaluation in limestone columns

Autor(en): **Benedetti, Andrea / Barboni, Marco**

Zeitschrift: **IABSE reports = Rapports AIPC = IVBH Berichte**

Band (Jahr): **70 (1993)**

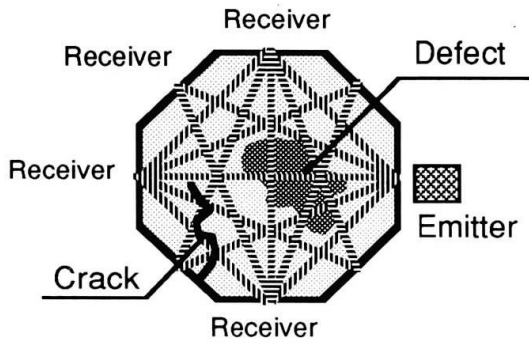
Fig. 1 : Multi path scanning for defect positioning

More precisely, in presence of rough localised cracks, ultrasonic scanning can be used in a way similar to tomography, by means of several intersecting travelling paths, which enable to draw information on the geometry of cracks [9] (fig.1).

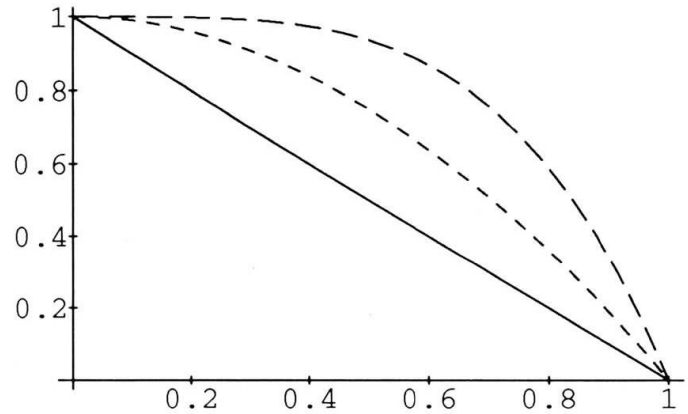
Fig. 2 : Damage index as a function of the proposed velocity relations

In fig. 2 the results of the presented damage laws are compared; As is clearly apparent, the different order of the exponent gives rise to a divergence of the indices; on the other hand, each definition is tailored on a different parameter and this should be taken into account when a damage measure has to be kept.

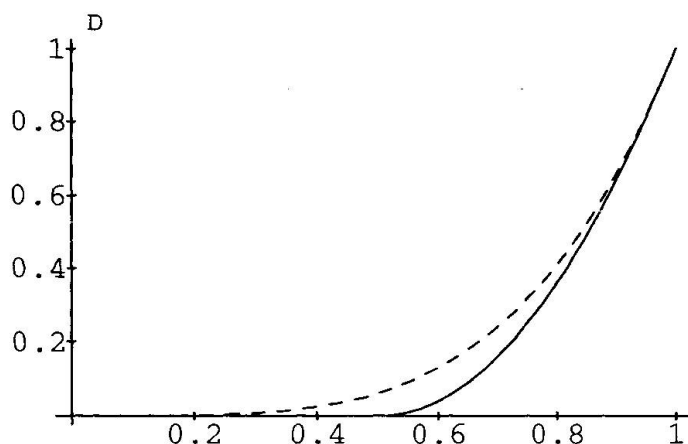
Fig. 3.a : Damage evolution as a function of stress level σ/f_k , as predicted by dilatancy

A drawback of rel. (5) is the need of the value of σ_{vc} which is of difficult definition indeed. However, contrary to the linear damage law, this type of representation involves a filtering (due to the exponent m), which runs finally to a step damage function; in fig.3 the results for $m=2$ and $m=4$ (solid lines) are compared with the case $\sigma_{vc}=0$, showing a relative insensitivity to the choice of the various constants.

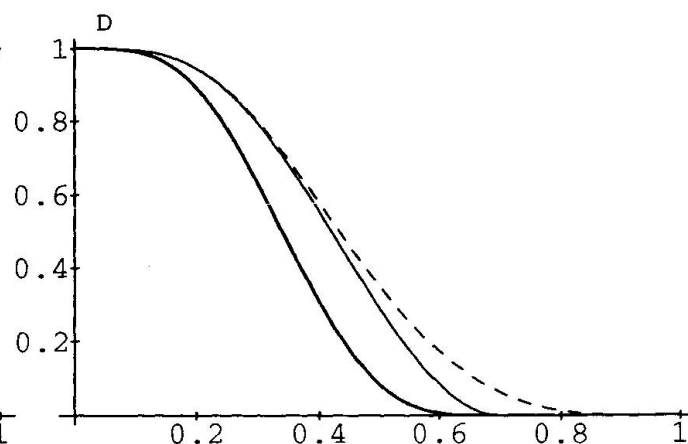
Fig. 3.b : Damage evolution as a function of the ultrasonic velocity ratio v_{us}/v_0

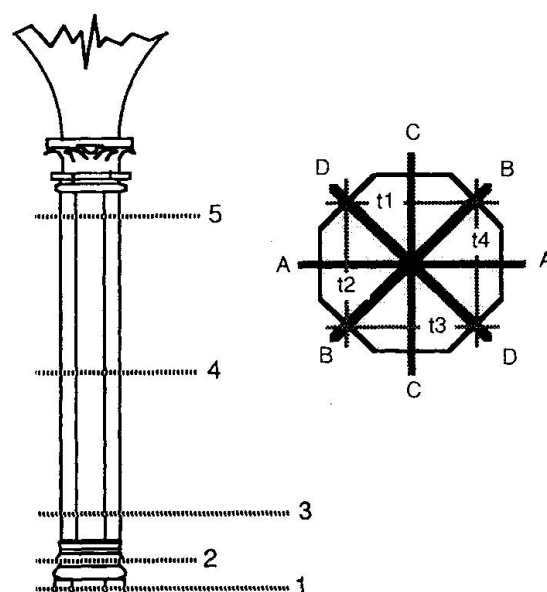
Fig. 4 : Representation of the measure paths

microcracks are present resulting in the ultrasonic velocities reported in fig.4.

In the table of fig. 4 the values of the ultrasonic velocities measured after the filling operation are shown; as is apparent, the major change involves the sections what initially were not transparent.

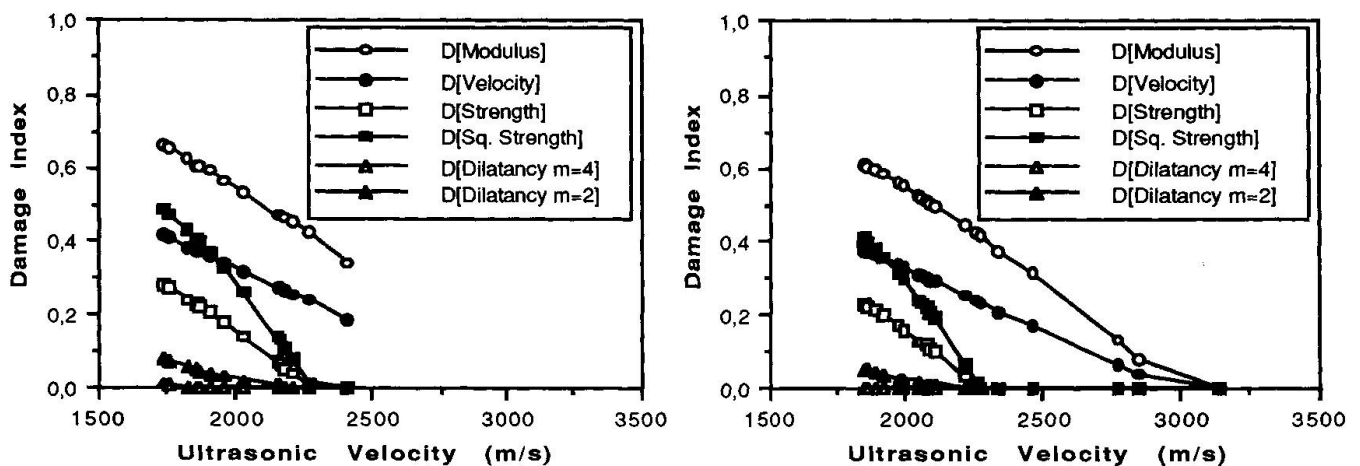
Fig. 5 & 6 : Damage indices resulting from the various formulations for the damaged and restored column

In fig.s 5 and 6 the computed damage indices are compared for both conditions, before and after repair. As we said before, the various statements differ dramatically and is difficult to extract the correct one.

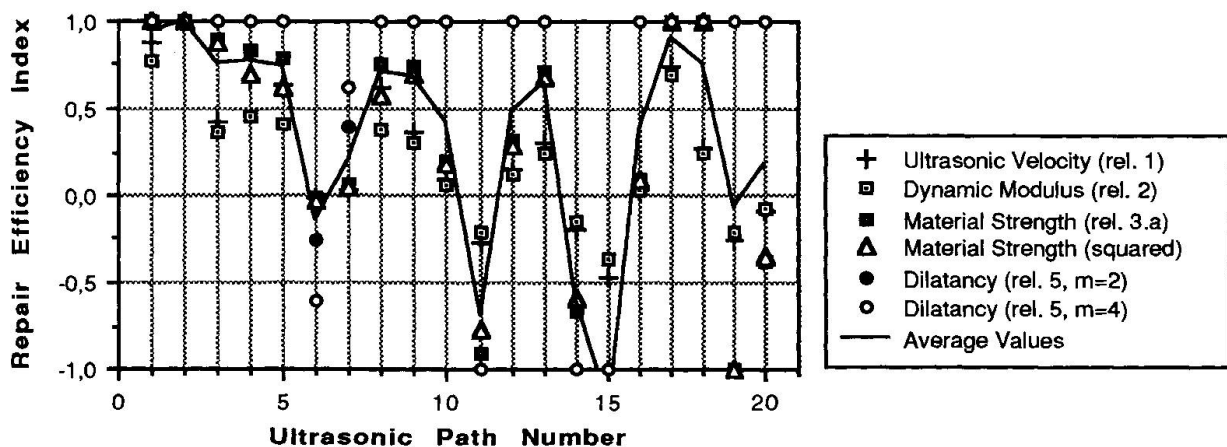
Fig. 7 : Repair Efficiency as computed from the ratio of damage indices, before and after the strengthening

On the contrary, expressing the efficiency of the strengthening by means of the ratio of the relevant damage indices we can observe a significant agreement of the introduced indices. In fig. 7 the efficiency ratios for the various measurement paths are compared.
