Extending the lifespan of the North Anchorage Housing of the Golden Gate Bridge

Zeitschrift: **IABSE reports = Rapports AIPC = IVBH Berichte**

Extending the Lifespan of the North Anchorage Housing of the Golden Gate Bridge

Fay BERNSTEIN

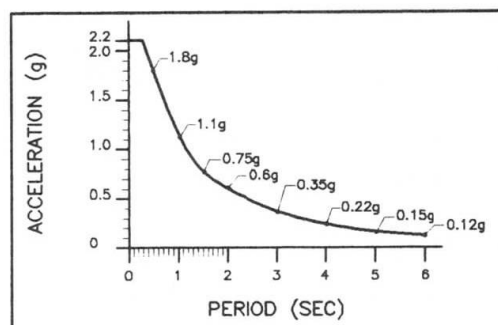
FIGURE 1

A state of the art seismic retrofit is being performed on the bridge and a project specific retrofit criteria has been developed. The site specific response spectrum shown in figure 1 is being used for the retrofit with a demand/capacity analysis similar to current AASHTO requirements.

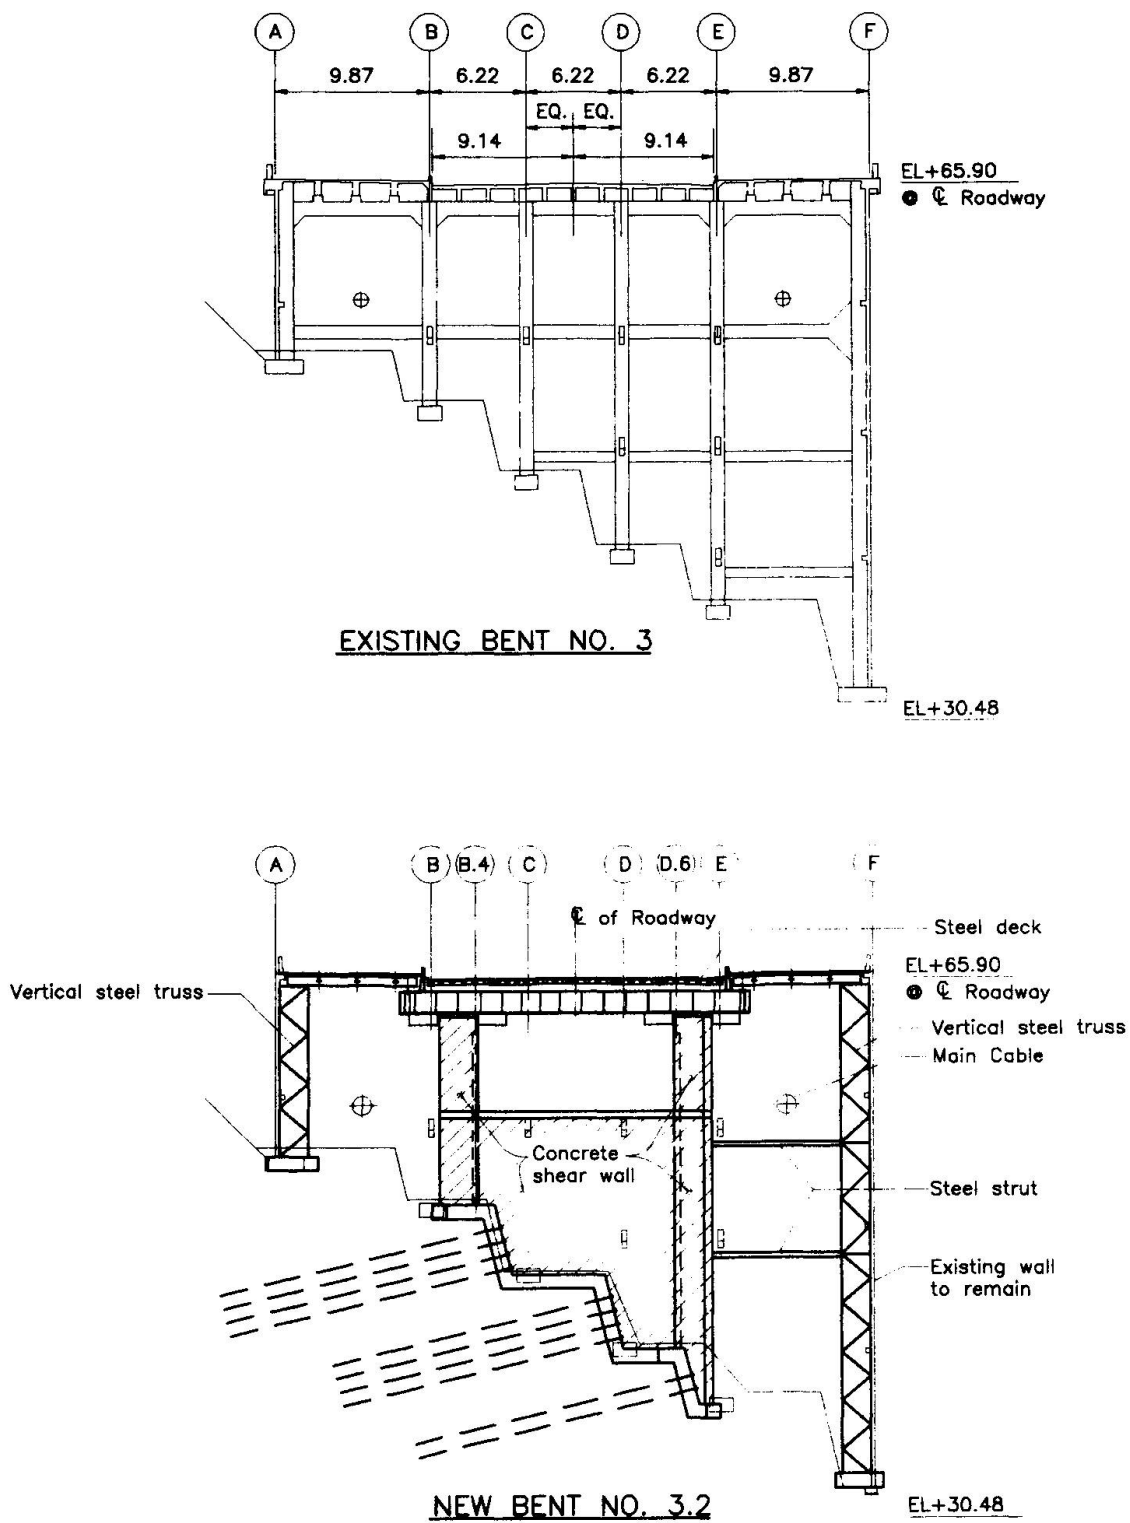
FIGURE 2

BENTS ON NATIVE ROCK AT SOUTH SECTION

At project start, retrofit of the housing appeared to require simple straight-forward modifications to a box type structure. But as the design process evolved, the housing retrofit became more complex. One reason for the complexity was the configuration of the housing. Vertical loads are supported on a series of transverse bents. The bents on the south end of the housing rest on the native rock while the ones on the north end are supported on the mass concrete anchor blocks. When the potential for rocking of the anchor blocks was identified, the housing retrofit required division of the housing into two distinct structures; north and south. The south end included the structure founded on native bedrock materials south of the anchor block region. The north end included the structure atop the anchor blocks. Since the east and west anchor blocks are not connected, they are free to rock independently under seismic excitation. As a result of this rocking potential, the north end was further divided into east and west structural sections. The structural separation was to be accomplished by providing new transverse roadway girders spanning between blocks, detailed to allow for differential movement.

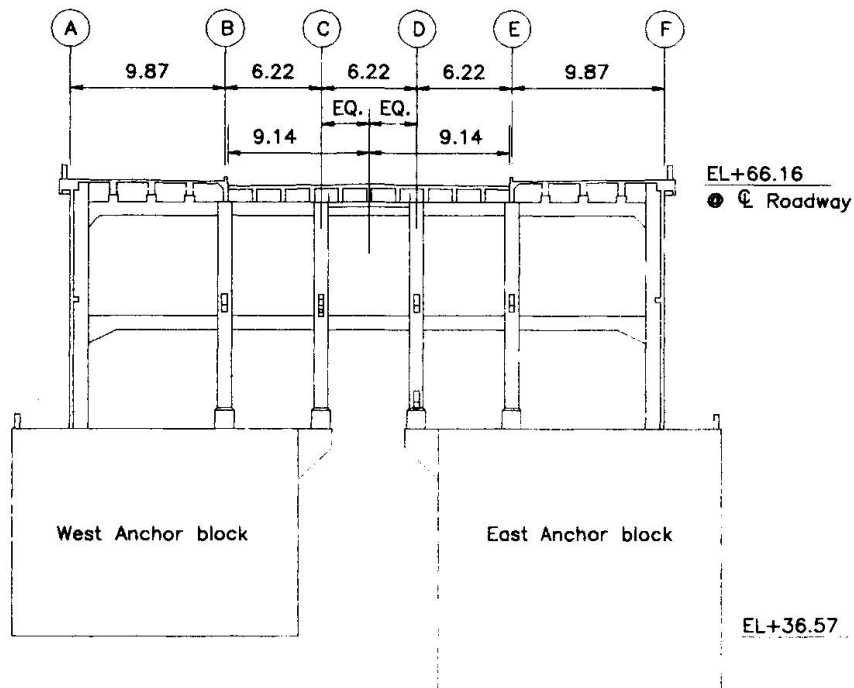
EXISTING BENT NO. 8

BENTS ON ANCHOR BLOCKS AT NORTH SECTION

The proposed deck replacement will be done at night. To temporarily retain the existing vertical support system, new bents adjacent to existing ones will first be installed. The new bents allow for easy removal of existing deck sections while providing a new modern support structure with simple seismic details. Each night a portion of existing roadway deck will be removed,
