From Structural Assessment to Appropriate Preservation Strategies

Thomas VOGEL

Associate Professor
Swiss Fed. Inst. of Technology
Zurich, Switzerland

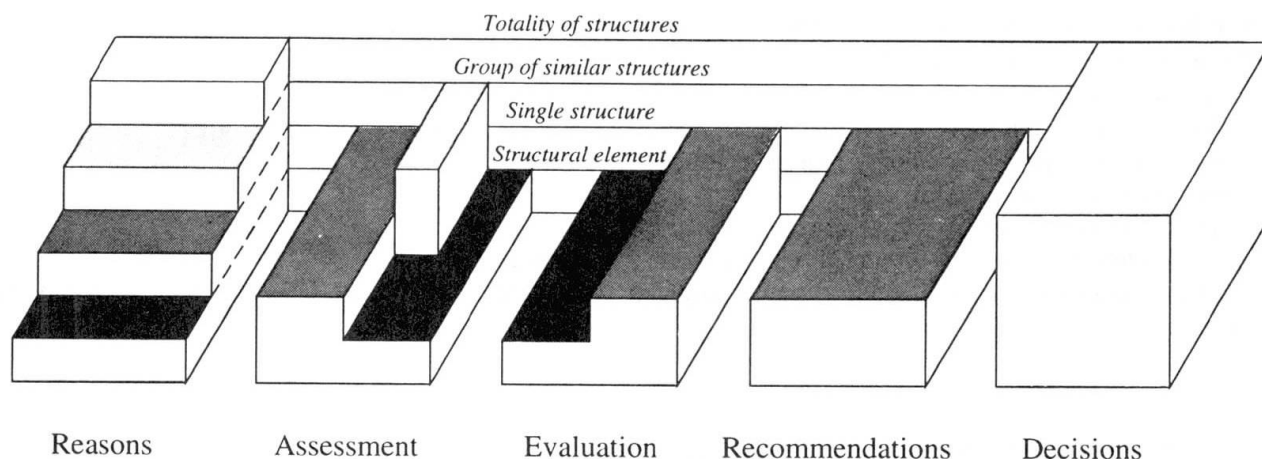
Fig. 1 Procedure with levels of considerations and decisions

On which level the procedures described hereafter are situated, is shown by Fig. 1.

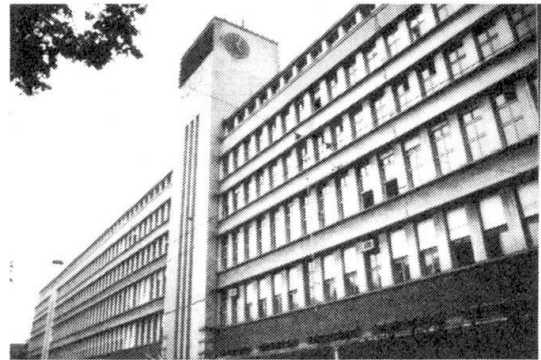
Fig. 2 SE-façade of the Sihlpost building

The main post office of Zurich built in 1928/29 with a structure designed by Robert Maillart was enlarged from 1986-92. Before offices of other postal and railway services are incorporated, the building including the exposed concrete façade (Fig. 2) is being presently restored.

Structural element	Concrete cover	Carbonation depth	Comment
Piers between window openings	27 - 55 mm	35 - 57 mm	increased carbonation risk
Lintels of recessed NW-façade	0 - 65 mm	28 - 56 mm	concrete spalling, first reinforcement layer corroded at any grade

The piers between window openings were repaired locally concentrating on corroding areas of reinforcement by a polymer-cement-concrete-(PCC) mortar. An elastic coating on the whole surface will complete the rehabilitation work.

- Removing of carbonated concrete following a corrosion criteria by high-water pressure.
- Replacing with spraying concrete.
- Levelling out of the surface by a PCC-mortar.
- Coating, able to bridge future cracks.

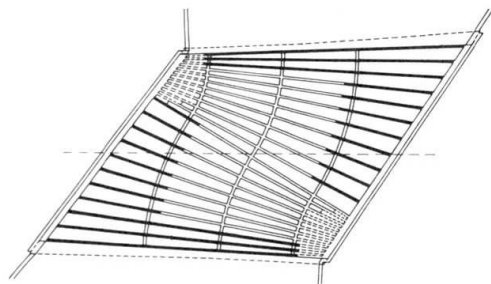
Fig. 3 Plan view of Dünnerbrücke

At Oensingen (SO) an access road to the Swiss national highway N1 crosses the Dünner creek in a skew angle on a grillage, spanning 24 m with curved girders (Fig. 3) built in 1963/64.

Structural assessment showed a deteriorated slab due to de-icing salt ingress and lack of waterproofing, an insufficient capacity for shear forces and a minimal capacity for bending moments.

The beams were strengthened by steel plates glued on the underside in mid-span and diagonal prestressed bars on either side close to the abutments.

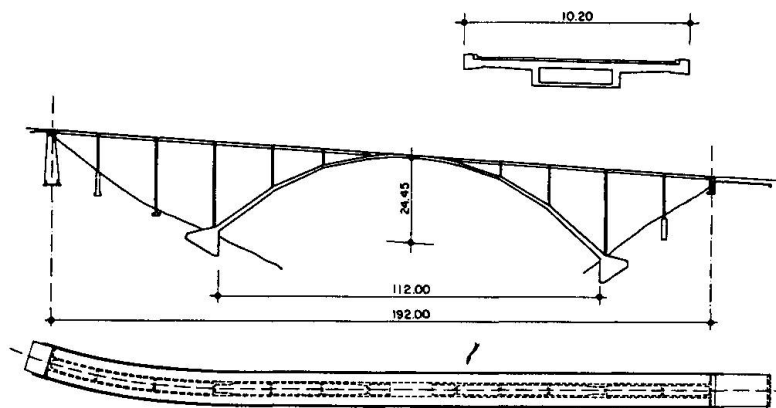
Fig. 4 Section, elevation and plan of Nanin Bridge

The Swiss national highway N13, traversing the Alps at the San Bernardino pass, crosses at its southern ramp the Moesa creek twice on elegant arch bridges designed by Christian Menn and built in 1966-68. In 1986/87 first preservation activities like removal of the interior formwork of the box girders, improving the drainage system and replacing the bearings took place.

In spite of severe deterioration of the steeper parts of the arches due to dropping water of the road draining system, the bridges still behave perfectly elastically and fulfil structural safety. In the transverse direction, however, the deck slab has inadequate load bearing capacity.

The actual rehabilitation started with the Cascella bridge in 1994 and will end up with the Nanin Bridge in 1996, including replacement of parapets and asphalt layer, strengthening of the deck slab by an additional concrete surfacing with additional reinforcement, fixing the downhill bearings to the abutments and enclosing the steeper parts of the arches with shotcrete on the lower and special cast concrete on the upper side.
