The charterhouse of Roermond and its urban setting and development

Autor(en): **Dukers, Birgit**

Zeitschrift: Cahiers d'archéologie romande

Band (Jahr): 160 (2016)

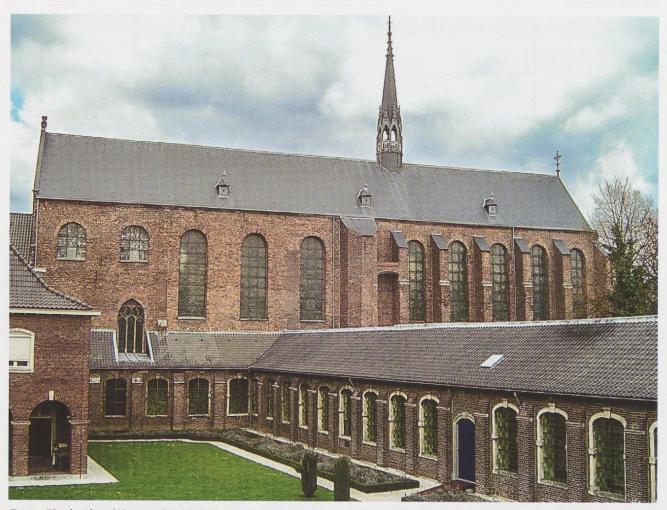
Fig. 1 - The church and cloisters of the charterhouse of Roermond. B. Dukers.

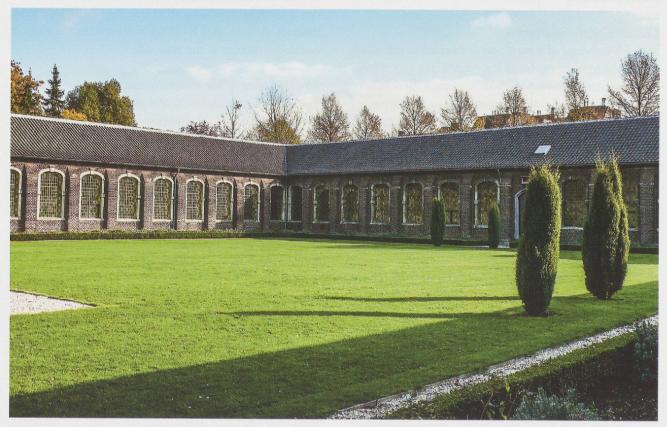
Fig. 2 - The cloisters (renovated 1750). B. Dukers.

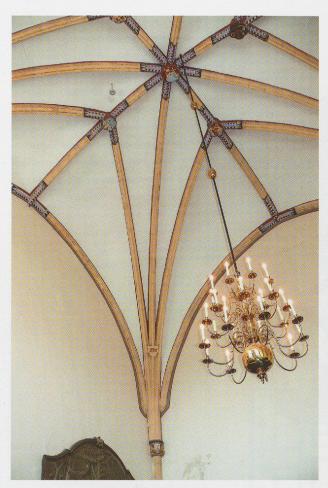
Fig. 3 - Stone vault of the chapter house (1556). B. Dukers.
