Zeitschrift:	IABSE congress report = Rapport du congrès AIPC = IVBH Kongressbericht
Band:	14 (1992)
Artikel:	Earthquake hazard mitigation in new and existing structures
Autor:	Seible, Frieder / Priestley, M.J. Nigel
DOI:	https://doi.org/10.5169/seals-853133

#### Earthquake Hazard Mitigation in New and Existing Structures

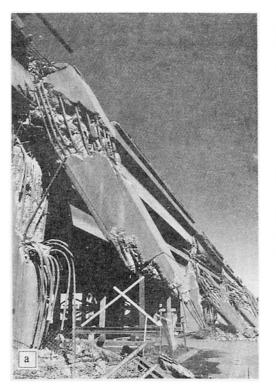
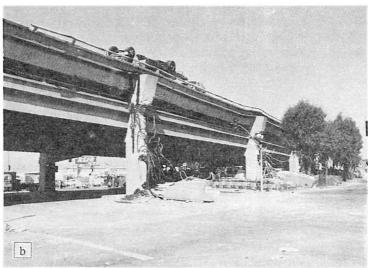
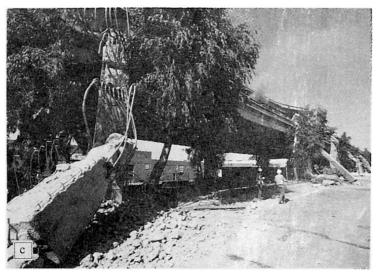
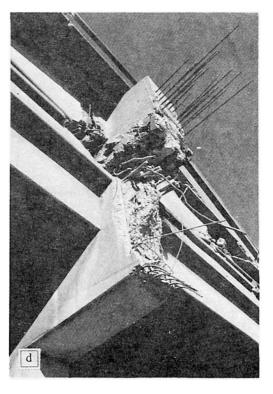
FIG 1. Bridge Damage During the 1989 Loma Prieta Earthquake

I-880 Oakland, CA October 1989

and detailing measures, [1]. Primary seismic problems in bridge structures include foundation and footing problems (e.g. liquefaction), expansion joint and seating problems due to lack of seat width and/or force constraint across the joint, inadequate member capacities in flexure and/or shear, lack of redundancy in the structural system to allow alternate load paths, and the detailing of joints between primary structural members such as footing/column connections, column/cap beam and cap beam/superstructure connections.

Bridge damage and/or collapse is noticed mostly due to its impact on traffic circulation patterns following a major earthquake. Quite often, it is the bridges most needed for post-earthquake search and rescue and relief operations which are collapsed or have to be closed. The duration of closure directly impacts the economic post-earthquake recovery of the affected region. Again, while many seismic bridge problems (see Fig. 1) can be associated with the choice of the structural system, the earthquake hazard also could have been mitigated by appropriate design

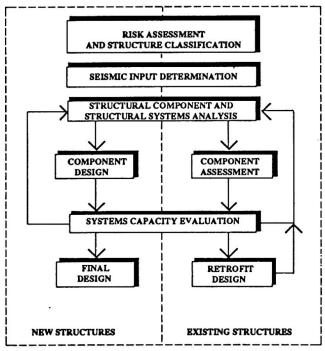
A comprehensive seismic structural hazard design approach should include the components of (1) Risk Assessment, (2) Equivalent Seismic Load Input, (3) Component Assessment and/or Design (4) Systems Evaluation, (5) Final Design or Retrofit. These components are schematically outlined in Fig. 2.

7. The derived lateral load and expected deformation capacity for the structural system can now be compared to the required seismic load demand and the associated deformation or ductility design limit state as outlined in Fig. 2 to determine appropriate retrofit measures, as summarized by Priestley and Seible [5].

While the above capacity based assessment examples were performed for existing bridge structures, similar capacity based procedures should also be employed in new structural systems design, see Fig. 2, to ensure ductile structural systems which allow seismic energy dissipation through well defined and appropriately detailed ductile mechanisms.

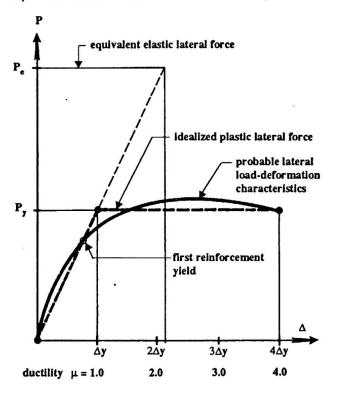
FIG 4. Load Deflection Behavior and Equivalent Elastic Forces

The derived elastic force reduction can now be used to establish an appropriate deterministic load input for the structural system in the form of acceleration response spectra which determine equivalent static seismic loads on the system.

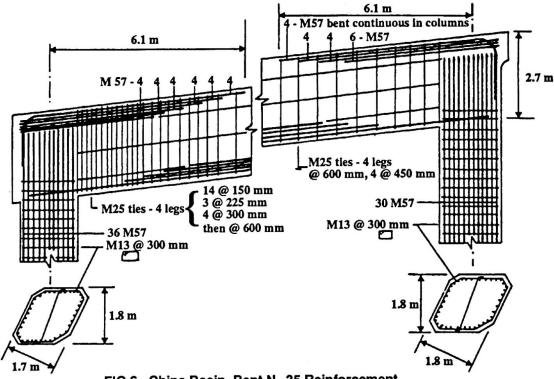
A general overview of the first outrigger bent on I-280 (China Basin Viaduct, San Francisco) is shown on Fig. 5a and damage patterns encountered during the earthquake are depicted in Figs. 5b and c. The as-built reinforcement details of the bent cap and columns are depicted in Fig. 6 and moment capacities and demands in the cap beam for separate and combined gravity and seismic loading are shown in Fig. 7.Following the outlined procedure, the bridge bent, shown in Figs. 5 to 7, was assessed [1]. Cap beam capacities were found well below corresponding column capacities and were thus critical for the overall seismic assessment. Member shear capacities were found to exceed flexural plastic shears. A unit lateral (seismic) load was applied to the bridge bent model and scaled to levels  $\varepsilon_{I}$  and  $\varepsilon_{II}$  where combined seismic and gravity loads form sequential mechanisms in the cap beam as shown in Fig. 7.

Lateral response force levels of  $\vec{E} = 0.63$  g and  $\vec{E} = 0.69$  g in the two directions, respectively, were found to cause complete global flexural mechanisms to develop. Particularly under loading to the right, see Figs. 6 and 7, the termination of negative or top reinforcement at a distance of 6.1 m from the column centerline is cause for the onset of a negative moment crack which propagates toward the column in shear aided by the lack of cap beam shear reinforcement in this region, see Fig. 6. A wide flexural-shear crack was observed in this region, as predicted, see Fig. 5c.

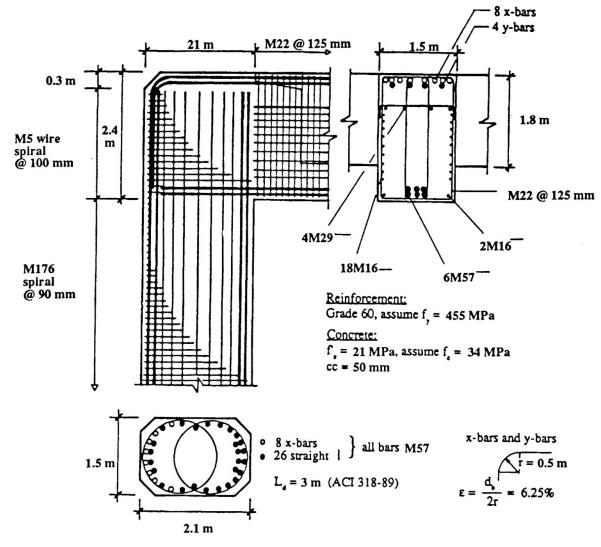
FIG 8. I-980, Bent #38 Reinforcement Details

The second outrigger bent assessment example from the 89 Loma Prieta earthquake was performed for bent #38 on the I-980 southbound connector in Oakland, CA. Reinforcement details and dimensions of the critical knee joint are shown in Fig. 8. Based on capacity checks for both cap beam and columns, as outlined above, and from subsequent sequential failure mechanism analyses [1], the joint shear stress levels in the knee joint at the collapse limit state were found to be in excess of  $0.5\sqrt{f_c}$  and  $0.35\sqrt{f_c}$  [MPa] for closing and opening knee joint moments, respectively. Thus, joint shear damage can be expected prior to the development of any flexural ductile beam or column mechanism as demonstrated by the encountered distress patterns during the Loma Prieta earthquake, depicted in Fig. 9. Since existing beam and column capacities and reinforcement detailing were satisfactory to allow limited ductile performance, repair and retrofitting of the joint was performed by complete removal of the joint concrete, added joint shear reinforcement and an increased joint size.
