**Zeitschrift:** IABSE congress report = Rapport du congrès AIPC = IVBH  
Kongressbericht

## **Plenary Session 2**

### **Structural Contribution to Natural Disaster Reduction**

## Natural Disaster Reduction through Structural Quality

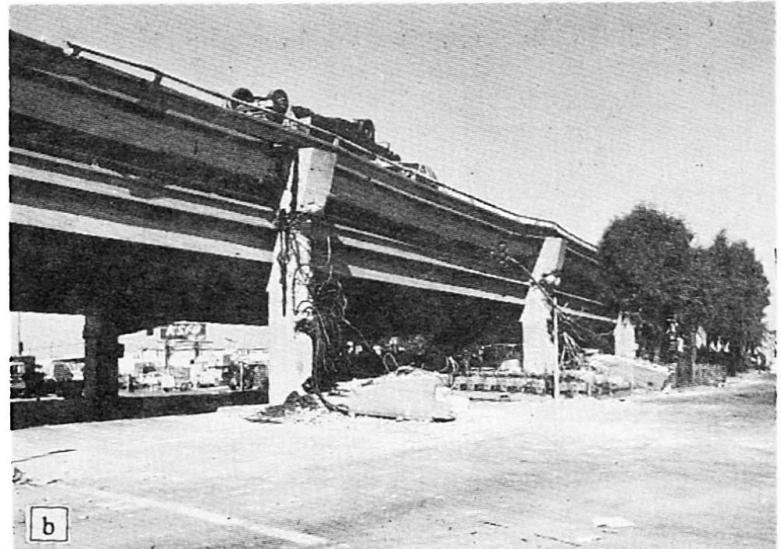
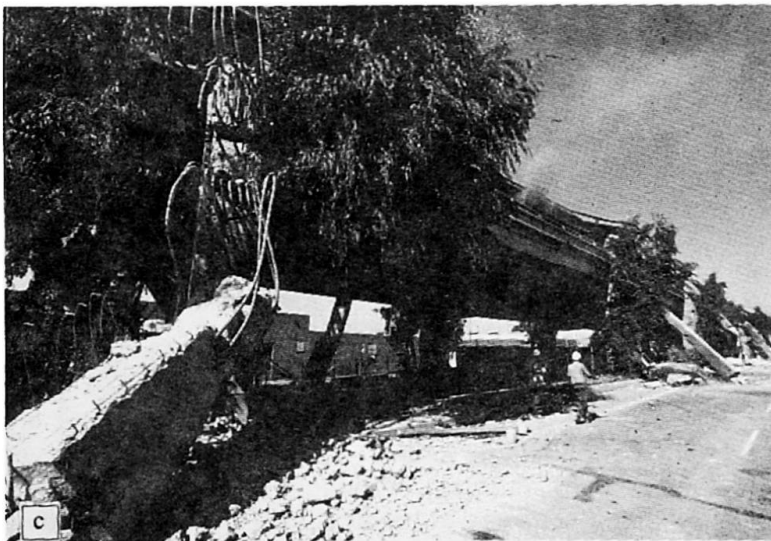
**FIG 1. Bridge Damage During the 1989 Loma Prieta Earthquake**

I-880  
Oakland, CA  
October 1989

Bridge damage and/or collapse is noticed mostly due to its impact on traffic circulation patterns following a major earthquake. Quite often, it is the bridges most needed for post-earthquake search and rescue and relief operations which are collapsed or have to be closed. The duration of closure directly impacts the economic post-earthquake recovery of the affected region. Again, while many seismic bridge problems (see Fig. 1) can be associated with the choice of the structural system, the earthquake hazard also could have been mitigated by appropriate design
