Zeitschrift: IABSE congress report = Rapport du congrès AIPC = IVBH
Kongressbericht

Structural Contribution to Natural Disaster Reduction

Natural Disaster Reduction through Structural Quality

Alan G. DAVENPORT

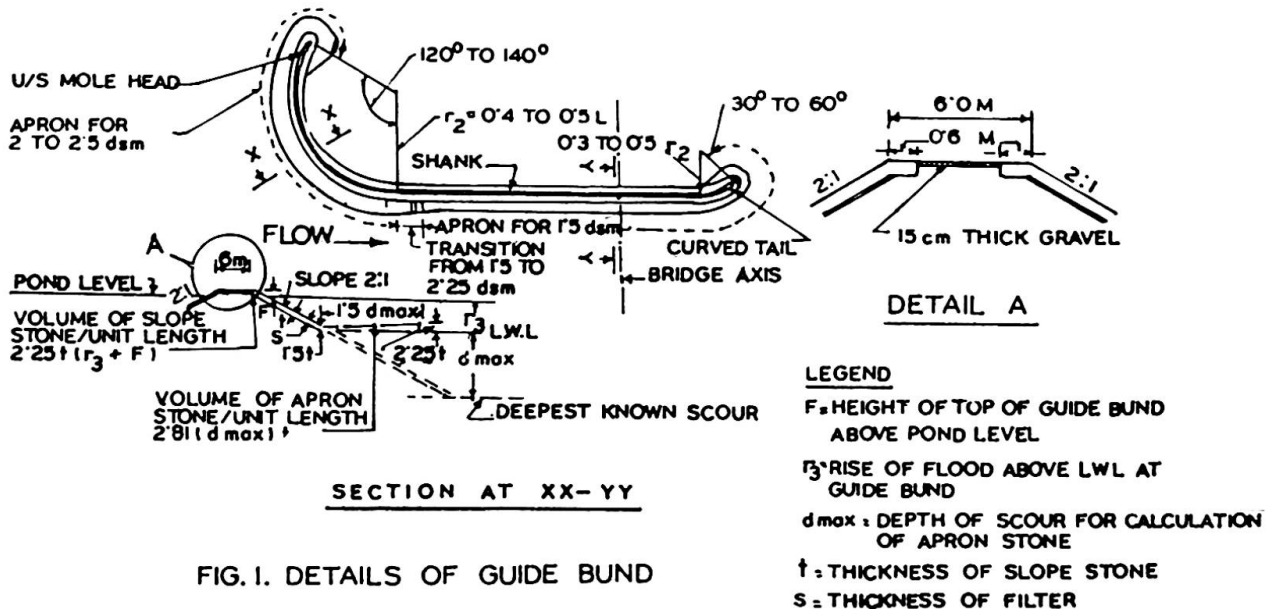
FIG.1. DETAILS OF GUIDE BUND

2.1 Guide bunds may be defined as artificial earthen embankments constructed in the river bed whose main functions are firstly to train the river and induce it to flow axially

through the constricted width of the bridge and secondly to protect the approach embankments from river attack. Guidelines for fixing the salient features and configuration of the guide bund system (Figure 1) required for efficient training of the river have been established and are as follows:

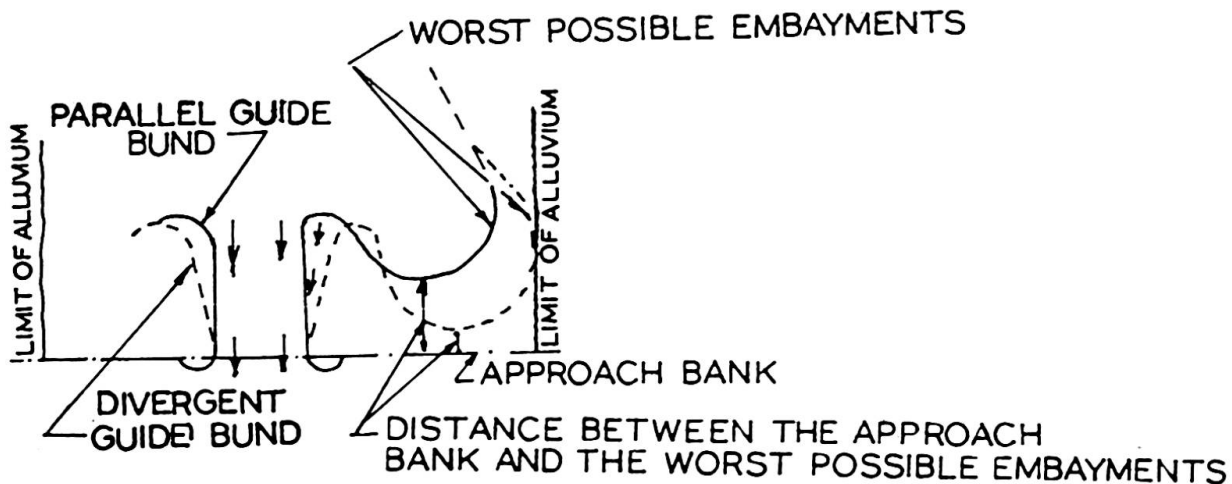
FIG. 2. EMBAYMENT

namely, the maximum obliquity of the current and permissible limit of embayment of the main channel of the river near the approach embankment behind the guide bund (Figure 2). It is generally fixed on the basis of the radius of the sharpest loop, which the river is capable of taking as shown by the data of the acute loops formed by the river in the past.

If survey plans do not indicate the presence of the sharpest loops it may be derived from a mathematical model. After having determined the radius of the sharpest loop the single or double loops are laid out on a survey plan showing the alignment of the approach embankment and high banks. It is ensured that the distance between the anticipated sharpest loop and approach embankment is not less than $L/3$ where L is the length of the bridge. The upstream length of the guide bund is usually kept as $1.0 L$ to $1.5L$. Guide bunds are generally effective in protecting the approach banks beyond the abutments on either side for a length upto 3 times the length of the guide bunds. Where the constriction is large and the length of the approach banks are greater than three times the length of guide bunds, additional training/protective measures are required to be taken.

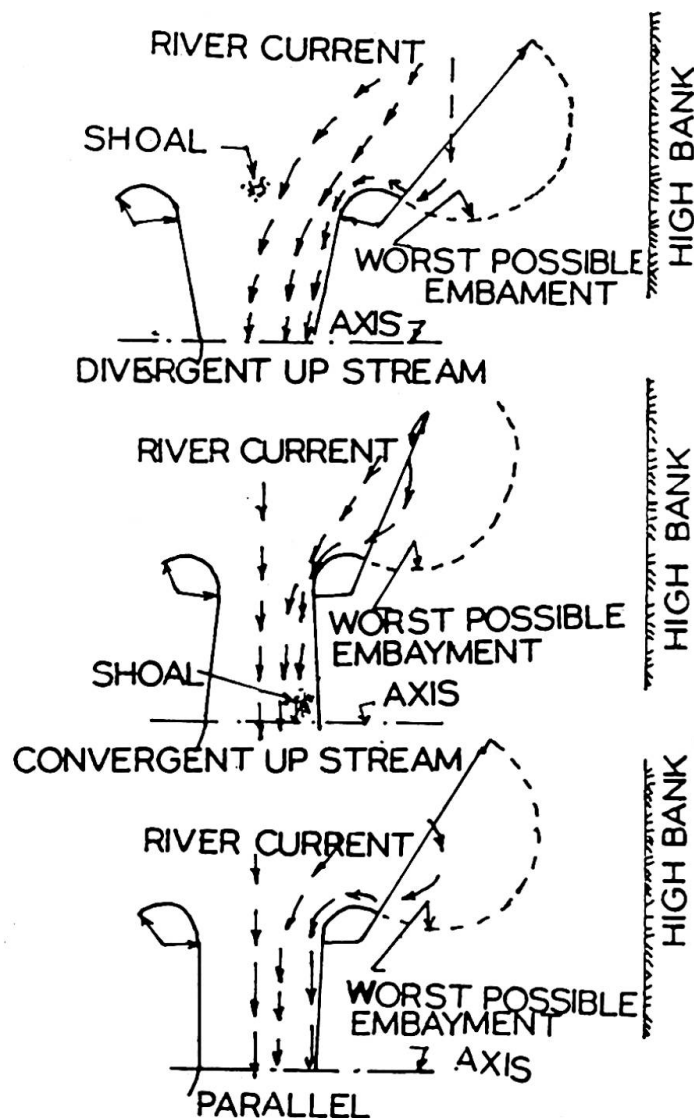
FIG. 3. DIFFERENT FORMS GUIDE BUNDS

2.15.1 Usually guide bunds are constructed in pairs to guide the river flow between them. Their relative disposition could be parallel, divergent or convergent, depending on river behaviour at the location. (Fig.3)

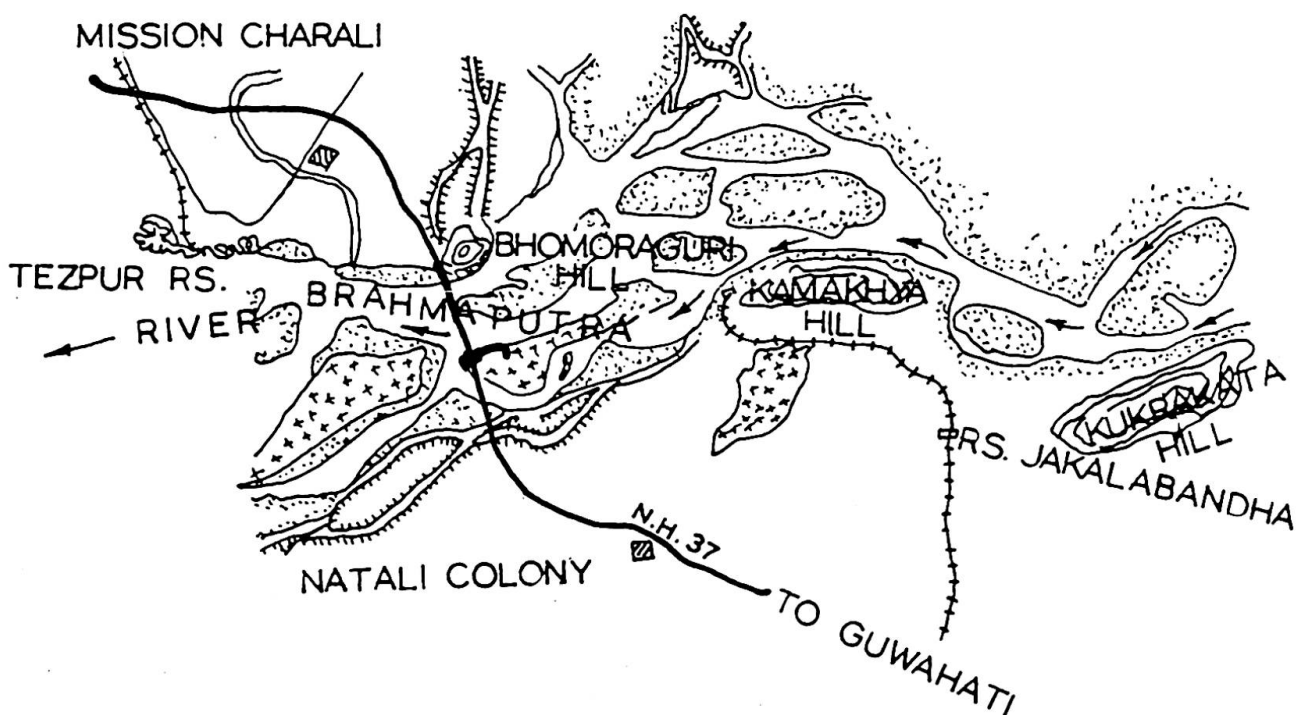
FIG. 4. LOCATION PLAN OF TEZPUR BRIDGE

Near Tezpur the river has a khadir width of approximately 5 kms. but the flood spill water extends far beyond this. The river is controlled on the north by Bhomoraguri hill and has a major tributary meeting it about 5 Kms. upstream on the north. These features have resulted in migration of the river to the south and there has been an active channel on the south side during the floods. Considering the facts that (a) any development in south channel may cause severe erosion of the south marginal bund and the river might outflank the bridge (b) large width may result in formation of shoals/islands at the bridge axis, and (c) development of concentration of flow in some bays may cause excessive scour, it was decided to construct a major guide bund on the south side. (Refer Fig. 4)

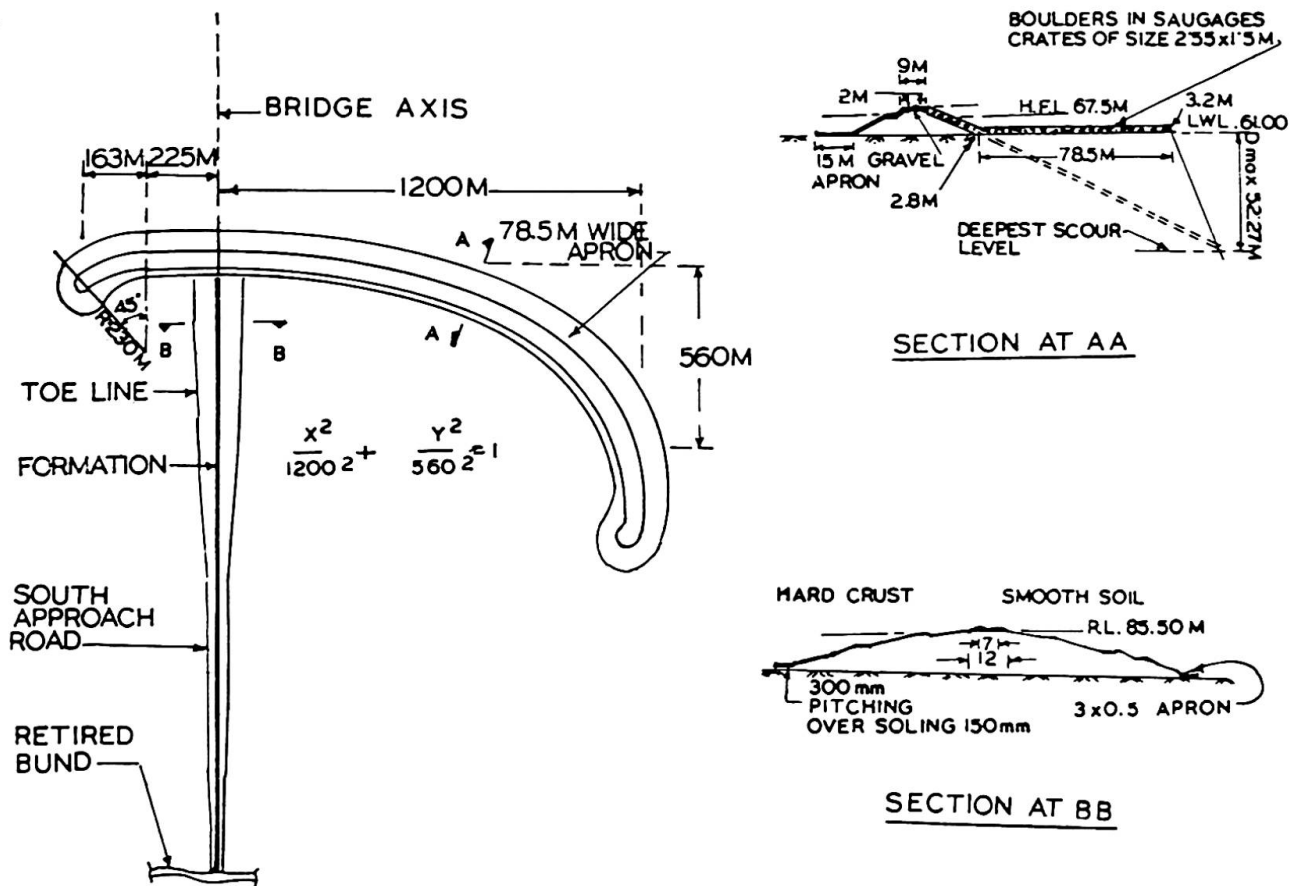
FIG. 5. GUIDE BUND DETAILS OF TEZPUR BRIDGE.

Technical features of guide bund as constructed are as detailed below: (Also ref. Figure 5)

Discharge:	92,278m ³ /Sec.
Max. Velocity:	4 m/Sec.
Type	Elliptical with $\frac{x^2}{(1200)^2} + \frac{y^2}{(560)^2} = 1$ equation
Length	2000 m
Max. Scour depth below LWL	
(a) at the u/s shank	36.24 m
(b) at the mole head	52.27 m
Apron Width	
(a) at the u/s shank	54.50 m
(b) at the mole head	78.50 m
Apron material	Man size boulder (40-60 Kg.) placed in GI wire crates.
Apron thickness	Approx 3 m.
Slope pitching	1.5 m thick with 0.3 m of filter medium
Side slopes	River side 1:2.5 rear side 1:3
Top width	9.0 m.

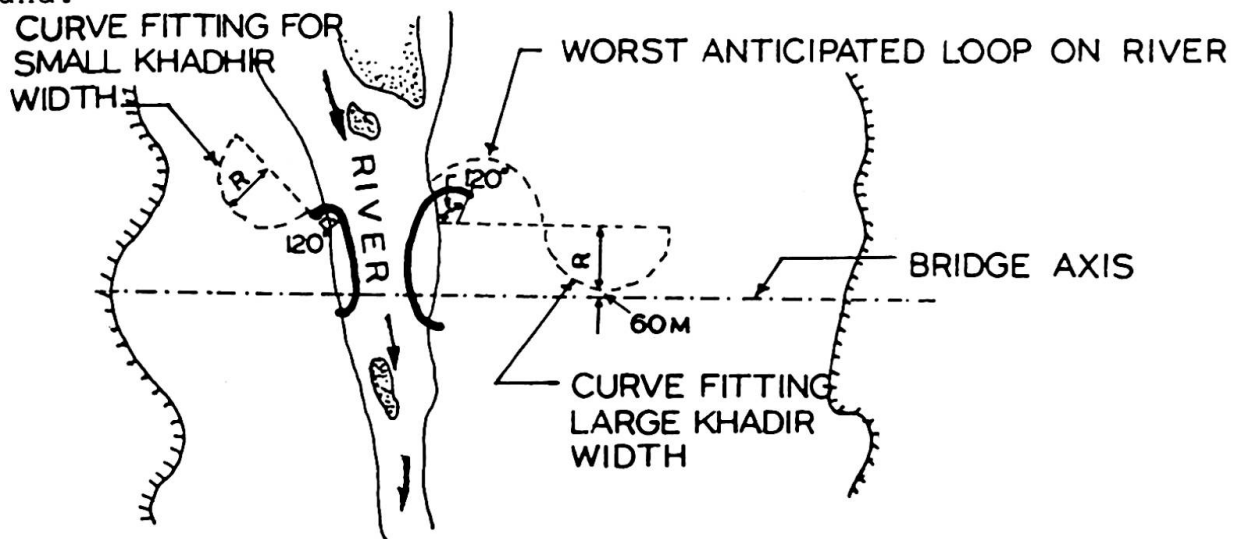
FIG. 6. DESIGN OF GUIDE BUND FROM LOOP CONSIDERATION

Since the khadir is very wide length of guide bund fixed according to the criteria does not provide enough protection to the approach embankment. It has been observed that the approach embankment is attacked by a single or double loop formation between the khadir edge and the guide bund (Fig. 6). In view of this it was necessary to study the river geometry on the upstream side particularly in the vicinity of the hillock or permanent point in the left bank and also take into account the radius of the worst embayment for deciding the length of guide bund.

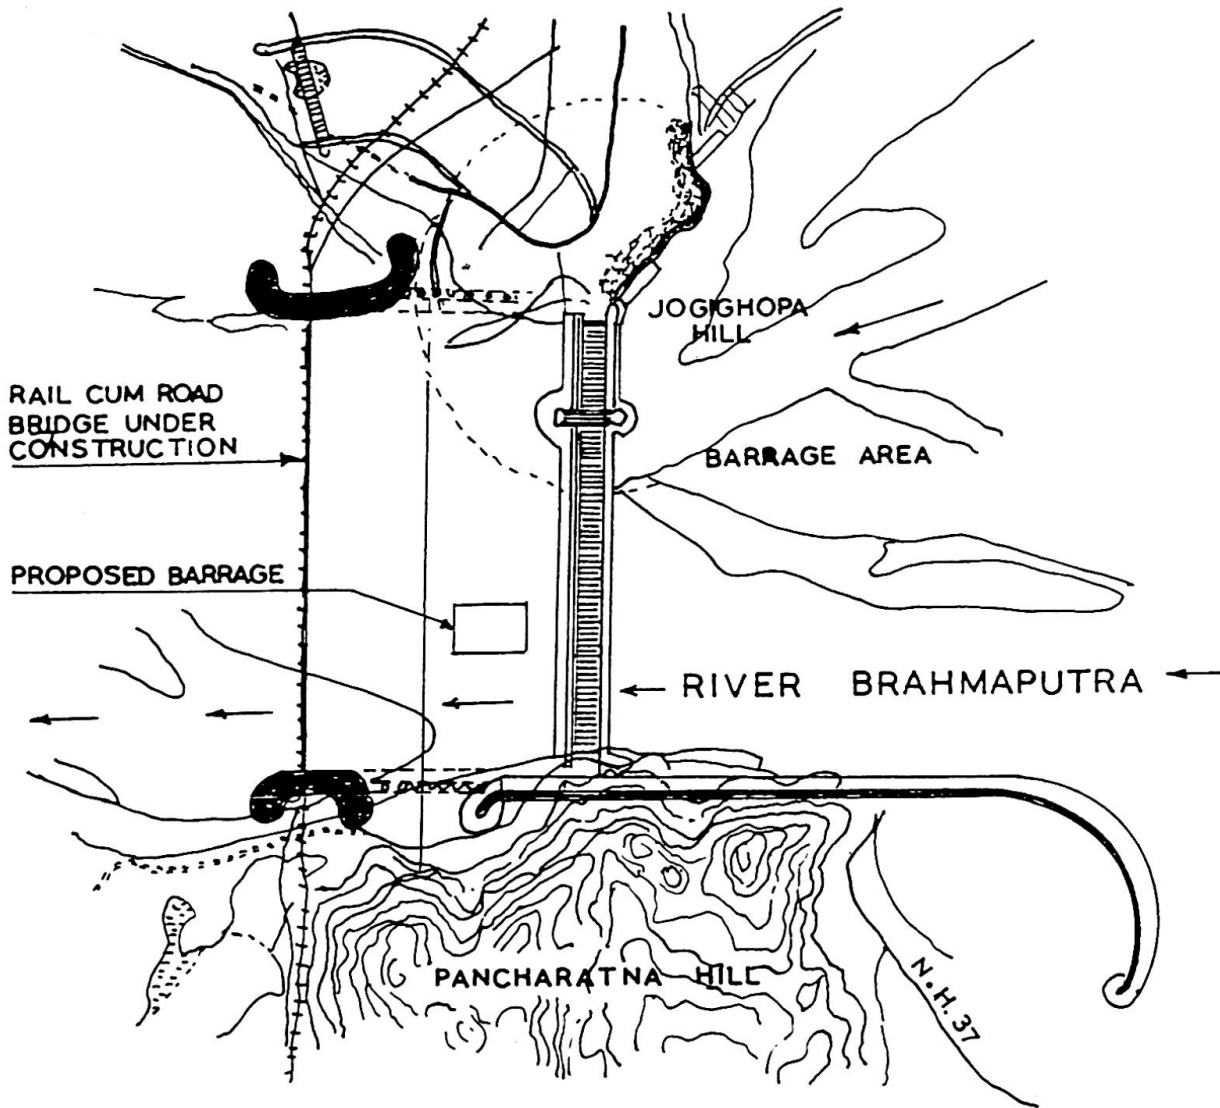
FIG. 7. LOCATION PLAN OF JOGIGHOPA BRIDGE
(UNDER CONSTRUCTION)

3.2.1 From hydraulic constructions, the river is stable at Jogighopa due to presence of two hills namely Jogighopa on the

north and Pancharatna on the south (figure 7). However, this stability is limited to a very small area between the hill noses where the site of the future barrage is located. Immediately after leaving the nose of the Jogighopa hill the river has a tendency to sway towards the north and horizontal control is necessary for any structure to be constructed on the downstream of the proposed barrage. Jogighopa rail-cum-road bridge is sited at 1350 m downstream of the barrage axis. In between, the proposed barrage and the bridge axis, an inland port is to be developed. Combination of the requirements of these multiple structures namely barrage, port facilities and rail-cum-road bridge needed extensive hydraulic model studies for designing length and shape of river training works. A number of combinations (figure 8) were tried out by the research station, with the following terms of reference

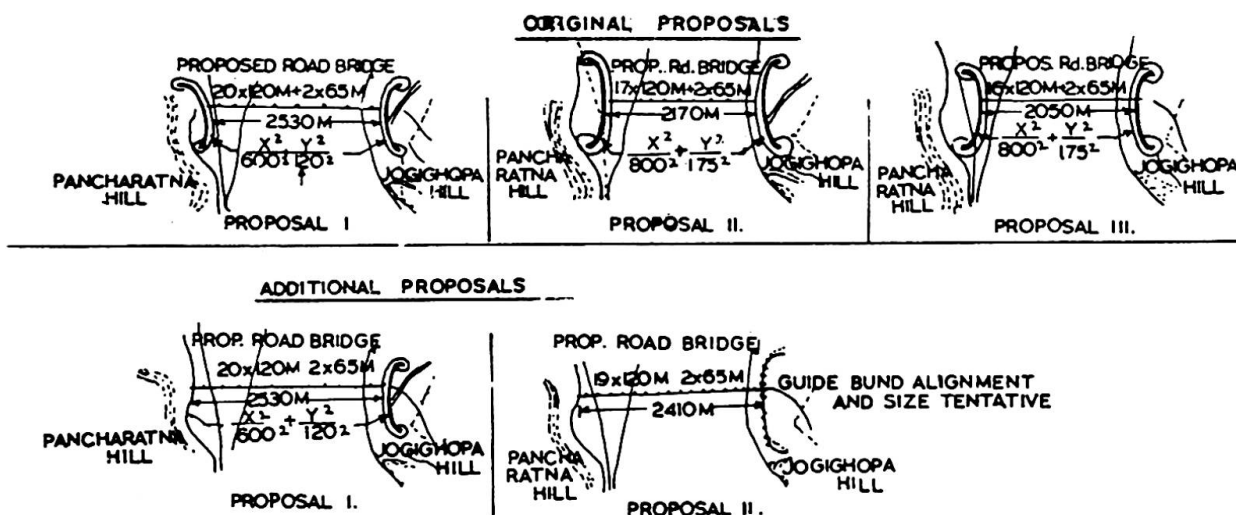
FIG. 8. ALTERNATIVE CONFIGURATIONS OF GUIDE BUNDS FOR JOGIGHOPA BRIDGE.

3.2.2 Model studies indicated that though the river has fairly uniform/stable flow conditions at the location, it is important to provide horizontal control with well designed guide bunds on either side.

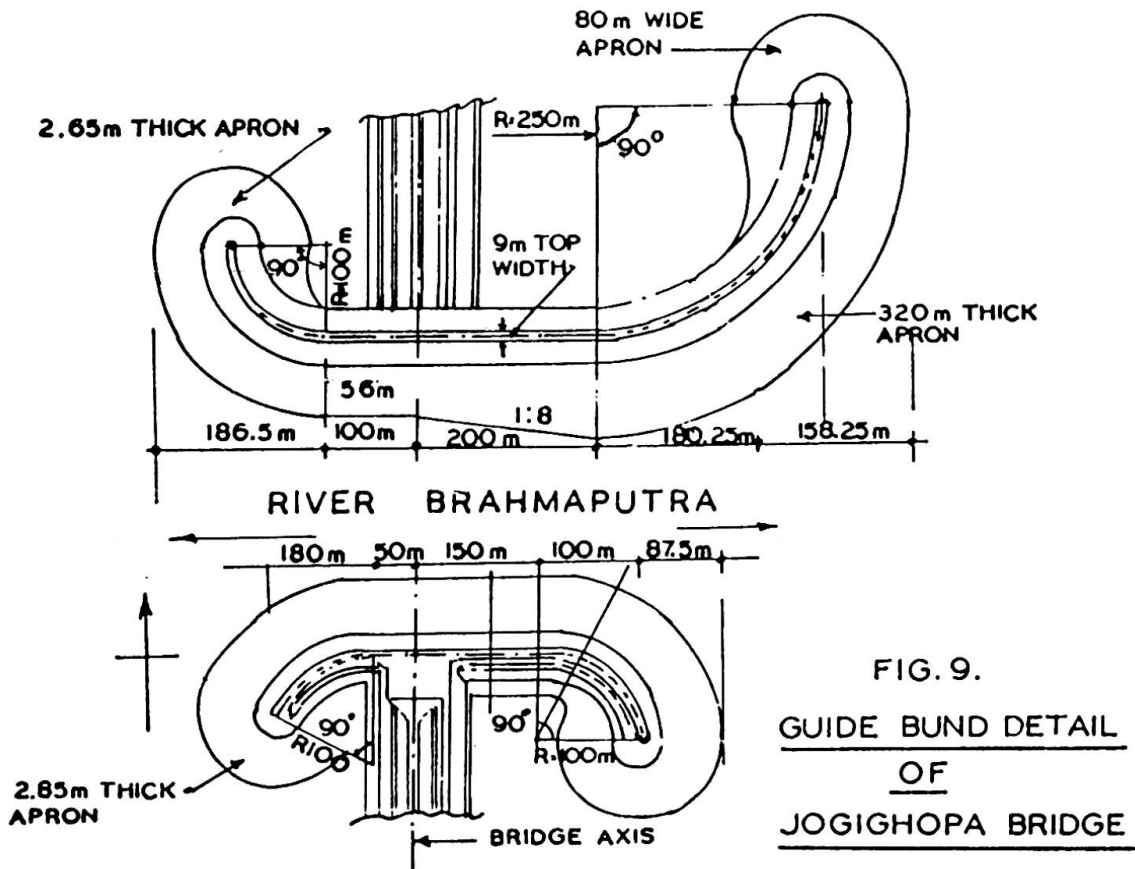
3.2.3 Since on the north bank, port facilities are to be developed, a shorter guide bund of 450 m length has been designed. Model studies have also confirmed that due to the two control points, namely, Jogighopa hill and north guide bund in close vicinity, the river does not have any probability of developing full embayment and thus endangering the safety of rail/road approach to the bridge. Both the guide bunds have also been located in line with the planned guide bunds of the barrage so that there is a stable flow condition immediately down stream of barrage. At Jogighopa, south guide bund has been completed in 1990-91 and work on the north guide bund started in Nov. 1991 is expected to be completed by April, 1992. Construction of these bunds is highly mechanised and involved extensive logistic support. Important technical

features of Jogighopa guide bunds are as showing in figure 9.

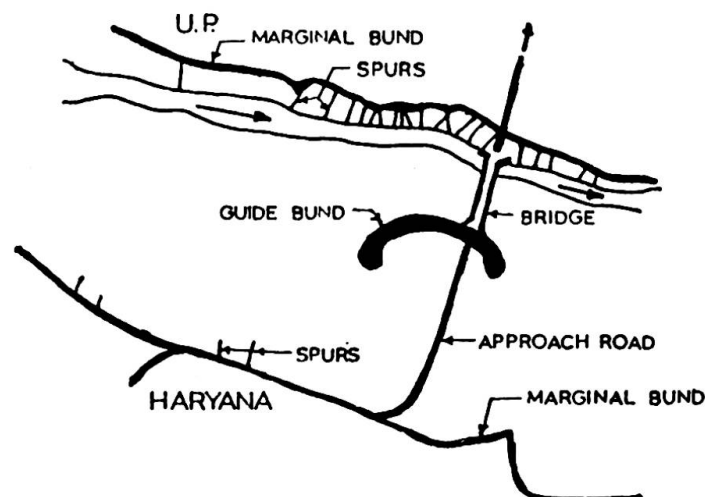
FIG.10. LAYOUT PLAN OF YAMUNA BRIDGE AT KARNAL

3.3.2 It was decided that the marginal embankment and spurs on the left hand side would be raised and strengthened and no guide bund would be provided on that side. On the right hand side an elliptical guide bund with straight lengths of 400 m and 87 m on the upstream and downstream respectively was provided. The radii of curvature and angles of sweep were respectively 215 m and 90° on the upstream side of guide bund and 90 m and 45° on the downstream side. (Fig. 10)

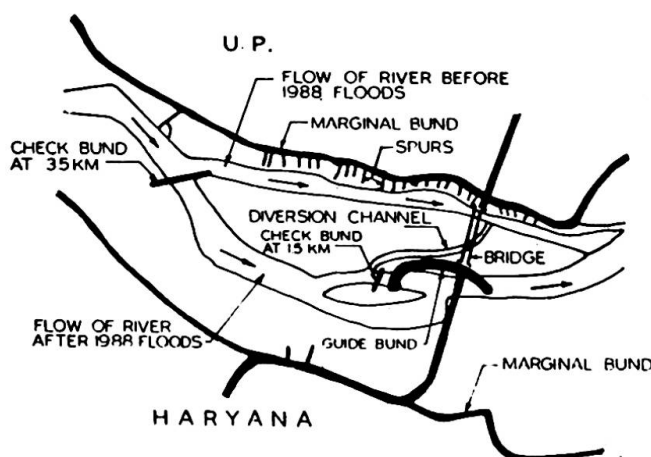
FIG.12 REMEDIAL MEASURES ADOPTED TO DIVERT THE FLOW OF RIVER

3.3.4 During the dry period, a diversion channel was cut in the bed of the river to guide the dry weather flow under the bridge. To achieve this, the flow in the main channel was blocked by construction of a 'check bund' or embankment. The first such 'check bund' constructed about 3.5 Kms. upstream of the bridge site was not successful in diverting the flow and a second check bund about 1.5 Kms. upstream of the bridge site had to be constructed. (refer Fig. 12)

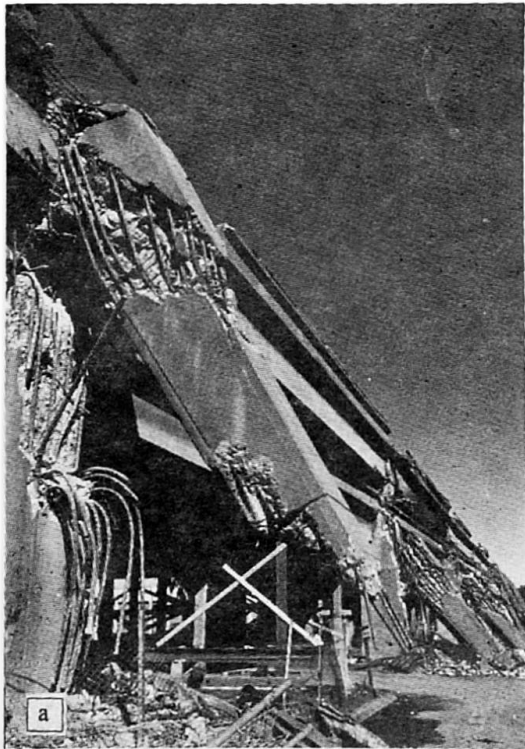
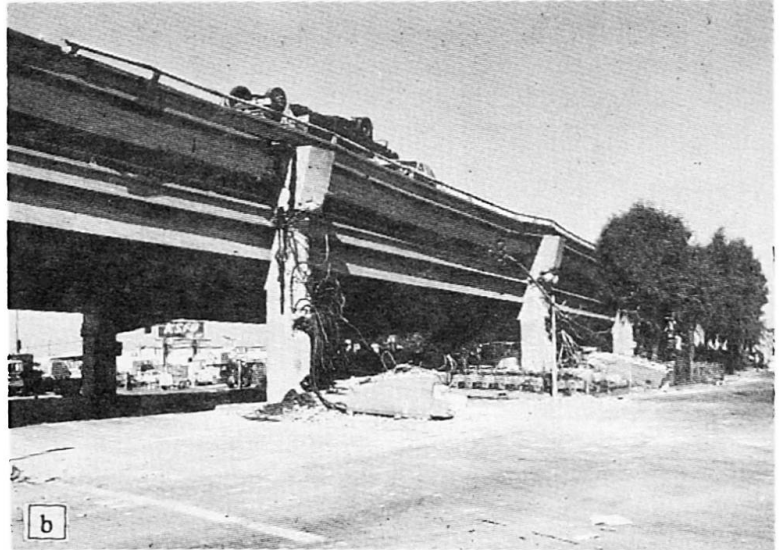
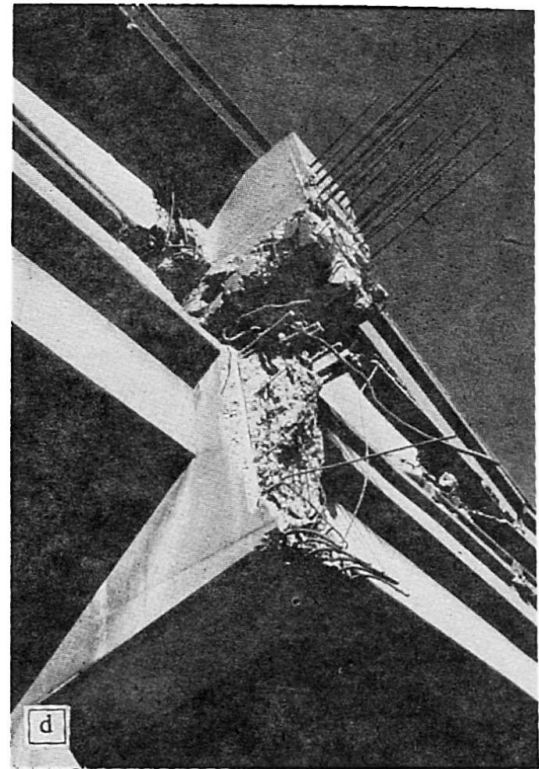
FIG 1. Bridge Damage During the 1989 Loma Prieta Earthquake

I-880
Oakland, CA
October 1989

Bridge damage and/or collapse is noticed mostly due to its impact on traffic circulation patterns following a major earthquake. Quite often, it is the bridges most needed for post-earthquake search and rescue and relief operations which are collapsed or have to be closed. The duration of closure directly impacts the economic post-earthquake recovery of the affected region. Again, while many seismic bridge problems (see Fig. 1) can be associated with the choice of the structural system, the earthquake hazard also could have been mitigated by appropriate design

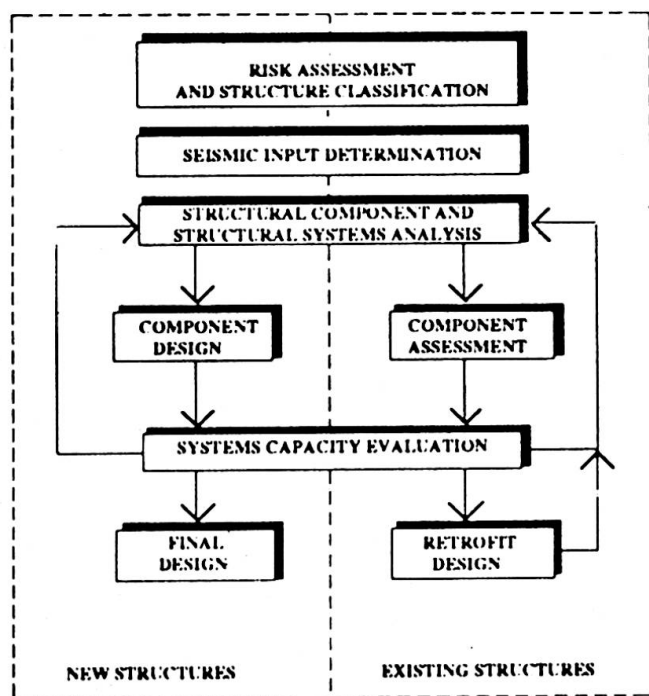
FIG 2. Seismic Design Process

A comprehensive seismic structural hazard design approach should include the components of (1) Risk Assessment, (2) Equivalent Seismic Load Input, (3) Component Assessment and/or Design (4) Systems Evaluation, (5) Final Design or Retrofit. These components are schematically outlined in Fig. 2.

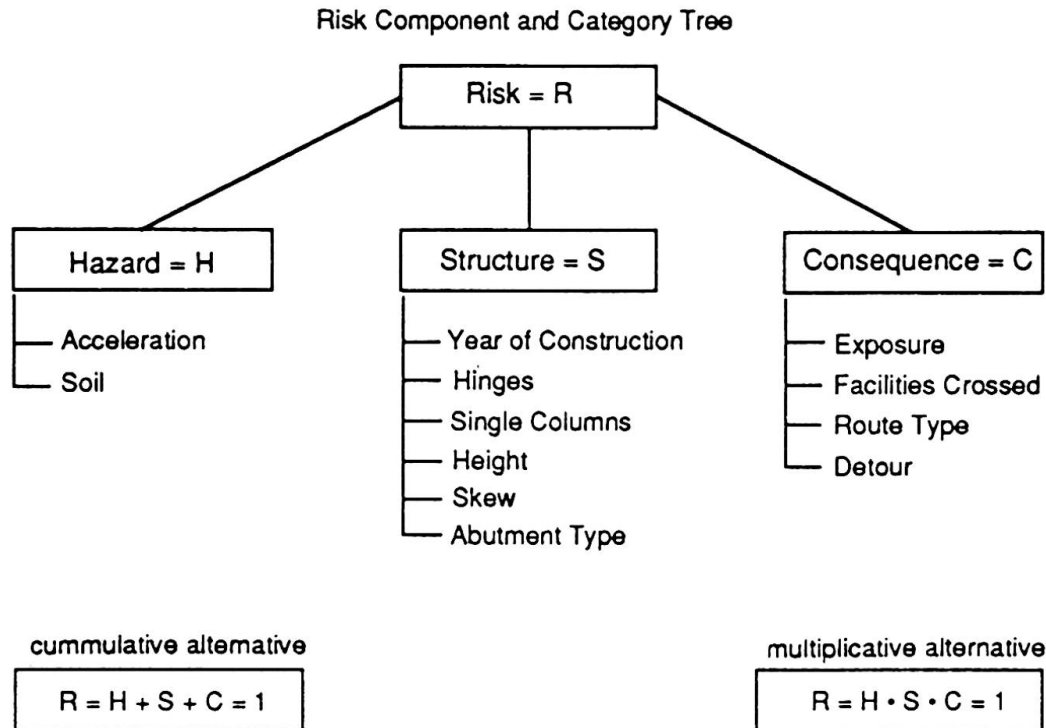
FIG 3. Seismic Risk Assessment Algorithm

The seismic risk assessment for a structure should involve the three principal components of hazard, structure and consequence. The hazard component reflects the probabilistic seismic input in terms of magnitude, probability of occurrence and soil/geological characteristics of the most probable seismic ground excitation. The structure component should address structural performance characteristics in terms of redundancy, detailing for inelastic action and critical geometry. Finally, the consequence component should address the importance of the structure and provide input on potential for loss of life consequences of failure or closure of the structure under evaluation. These three categories can be combined in a cumulative or multiplicative weighted risk algorithm to determine an estimate of the seismic risk for the structure. As an example of a risk assessment algorithm Fig. 3 shows the component and category tree structure currently used by

California Department of Transportation (Caltrans) to assess the seismic retrofit priorities of over 24,000 bridge structures in California [3]. This risk evaluation can now be used to determine critical design limit states for the structural system and guidelines on how these design limit states should be achieved.

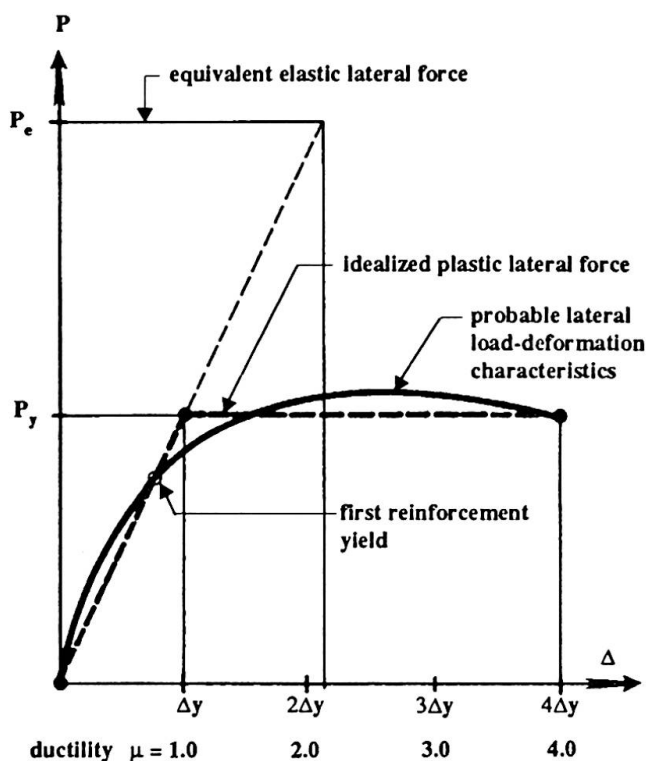
FIG 4. Load Deflection Behavior and Equivalent Elastic Forces

The derived elastic force reduction can now be used to establish an appropriate deterministic load input for the structural system in the form of acceleration response spectra which determine equivalent static seismic loads on the system.

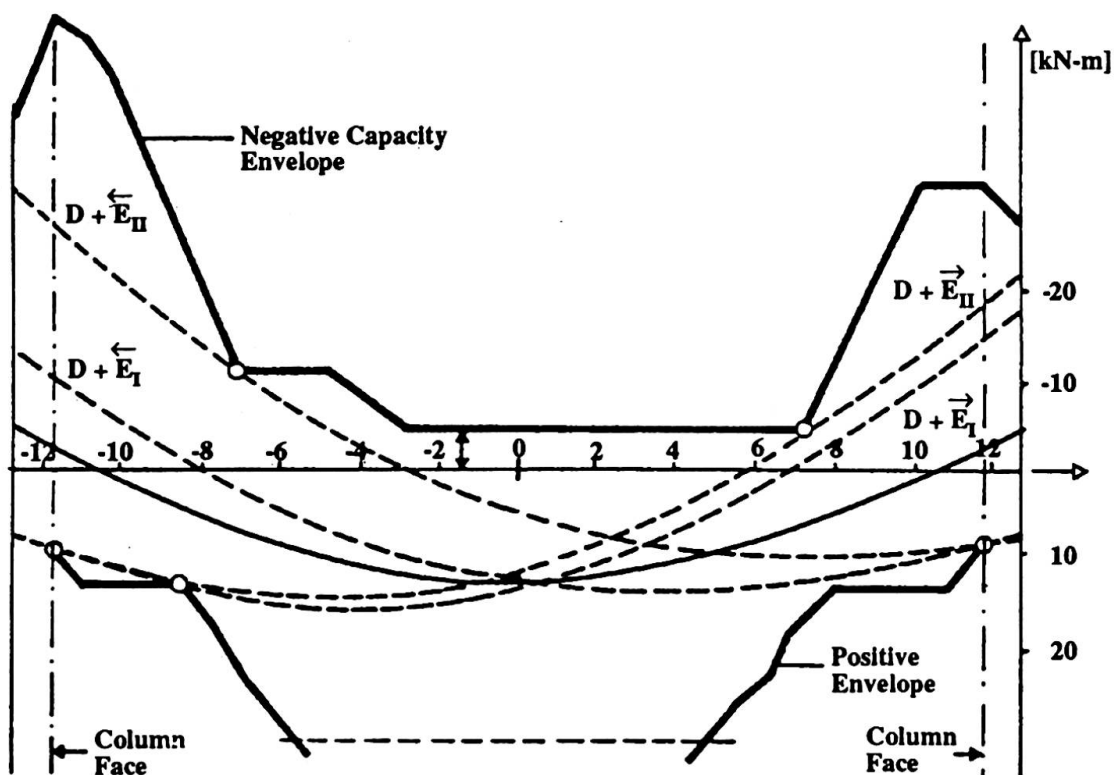
FIG 7. China Basin, Bent N₁-35, Moment Capacities and Demand

2. Flexural capacities for the individual beam and column members are determined using above material properties and section analysis techniques which are based on a realistic concrete stress-strain relationship including axial load, confinement effects, and strain hardening. Flexural member capacities need to be adjusted where inadequate development length of the main reinforcement (see Fig. 1d) or lap splices with insufficient lap length or confinement limit the full capacity development under fully reversed cyclic loads. Detailed guidelines on the proper assessment of reinforcement development were proposed by Priestley [4].

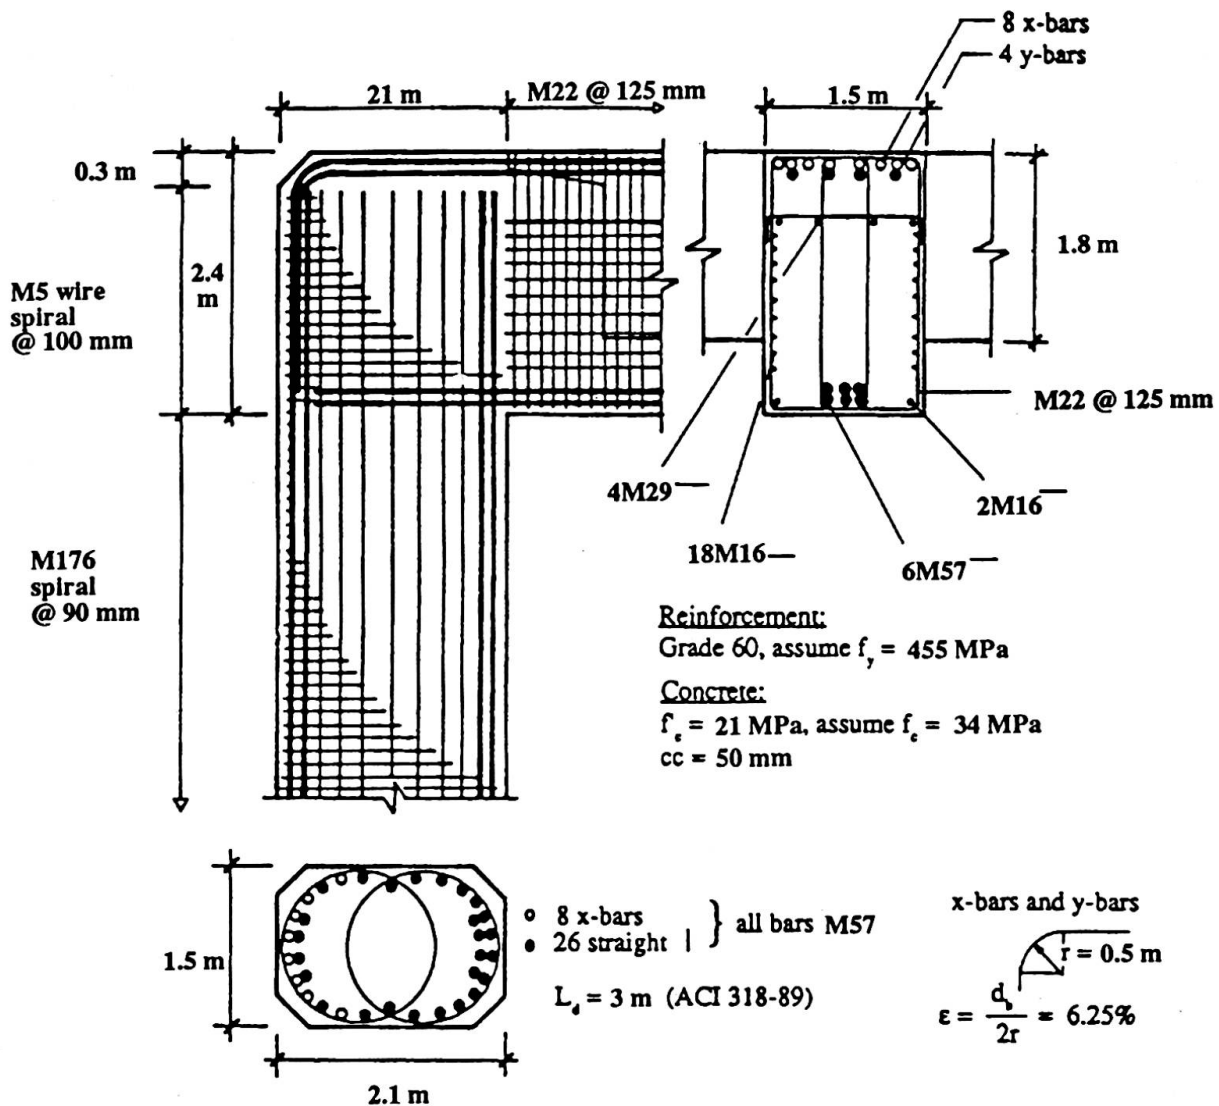
FIG 8. I-980, Bent #38 Reinforcement Details

The second outrigger bent assessment example from the 89 Loma Prieta earthquake was performed for bent #38 on the I-980 southbound connector in Oakland, CA. Reinforcement details and dimensions of the critical knee joint are shown in Fig. 8. Based on capacity checks for both cap beam and columns, as outlined above, and from subsequent sequential failure mechanism analyses [1], the joint shear stress levels in the knee joint at the collapse limit state were found to be in excess of $0.5\sqrt{f'_c}$ and $0.35\sqrt{f'_c}$ [MPa] for closing and opening knee joint moments, respectively. Thus, joint shear damage can be expected prior to the development of any flexural ductile beam or column mechanism as demonstrated by the encountered distress patterns during the Loma Prieta earthquake, depicted in Fig. 9. Since existing beam and column capacities and reinforcement detailing were satisfactory to allow limited ductile performance, repair and retrofitting of the joint was performed by complete removal of the joint concrete, added joint shear reinforcement and an increased joint size.
