Zeitschrift: IABSE congress report = Rapport du congrès AIPC = IVBH
Kongressbericht

Plenary Session 2

Structural Contribution to Natural Disaster Reduction

Natural Disaster Reduction through Structural Quality

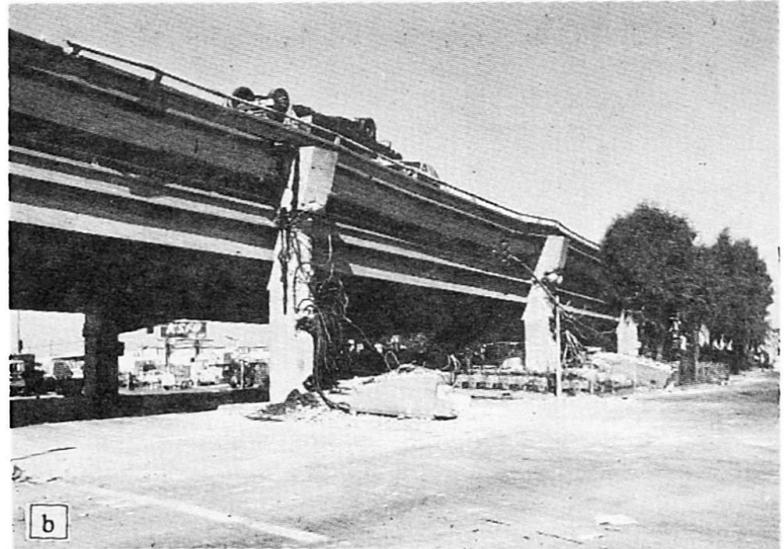
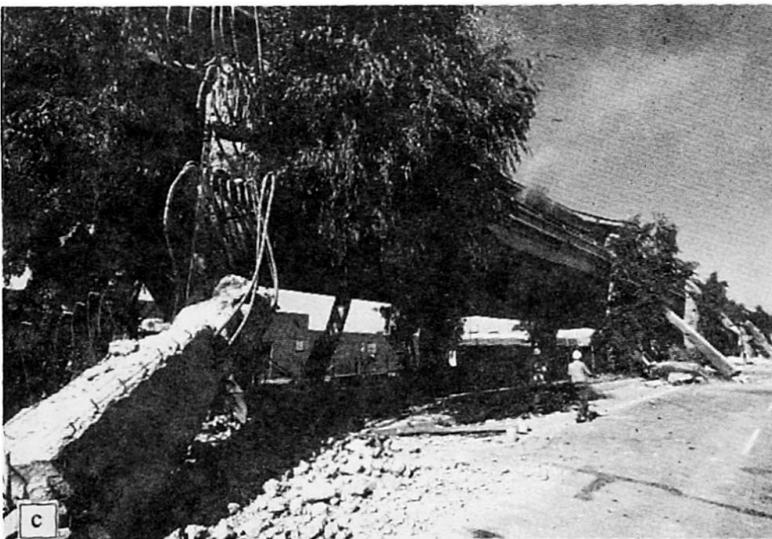
FIG 1. Bridge Damage During the 1989 Loma Prieta Earthquake

I-880
Oakland, CA
October 1989

Bridge damage and/or collapse is noticed mostly due to its impact on traffic circulation patterns following a major earthquake. Quite often, it is the bridges most needed for post-earthquake search and rescue and relief operations which are collapsed or have to be closed. The duration of closure directly impacts the economic post-earthquake recovery of the affected region. Again, while many seismic bridge problems (see Fig. 1) can be associated with the choice of the structural system, the earthquake hazard also could have been mitigated by appropriate design
