## **Fabrication Survey of Steel Components facilitates Quick Bridge Erection**

Contrôles de fabrication pour le Pont Hooghly à Calcutta

Details of the fabrication survey, allowable tolerances, measurements, trial assembly and their favourable effect on the speed and accuracy of erection are described for the second Hooghly Bridge in Calcutta.

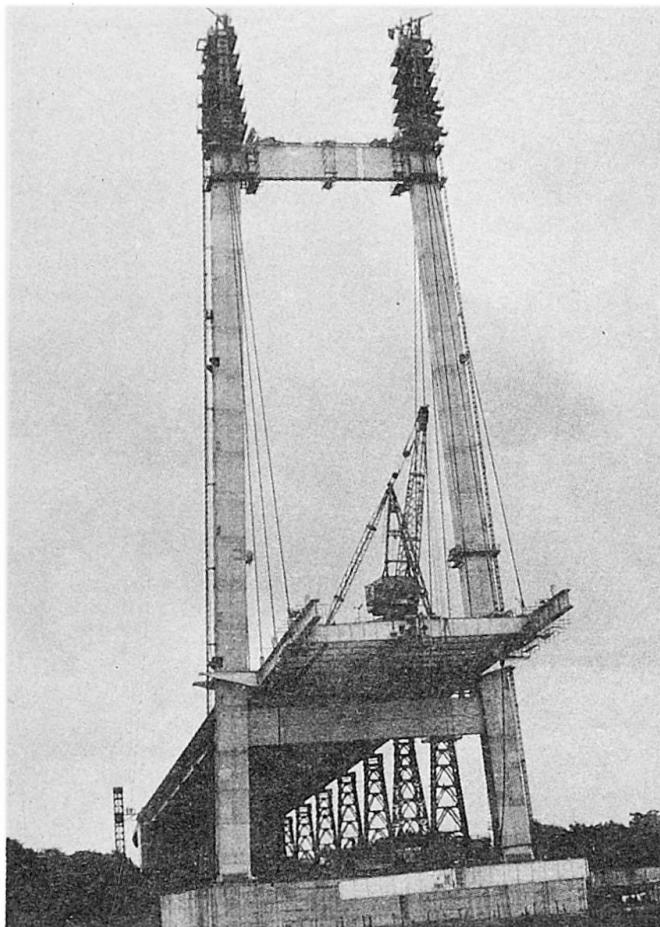
**Fig. 1**  
H-shaped, 122 m high pylon at  
Calcutta side

For the box sections of towers a fabrication survey procedure had to be established to control eccentricities of pylon axis either in longitudinal or in transversal direction of the bridge.

Space restrictions and progress of erection did not permit a full shop floor layout for the towers as it had been done for previous bridges. Transport and lifting facilities limited the length of a single box to a maximum of 6 m. Therefore one pylon leg comprises 19 sections up to the level of top portal.

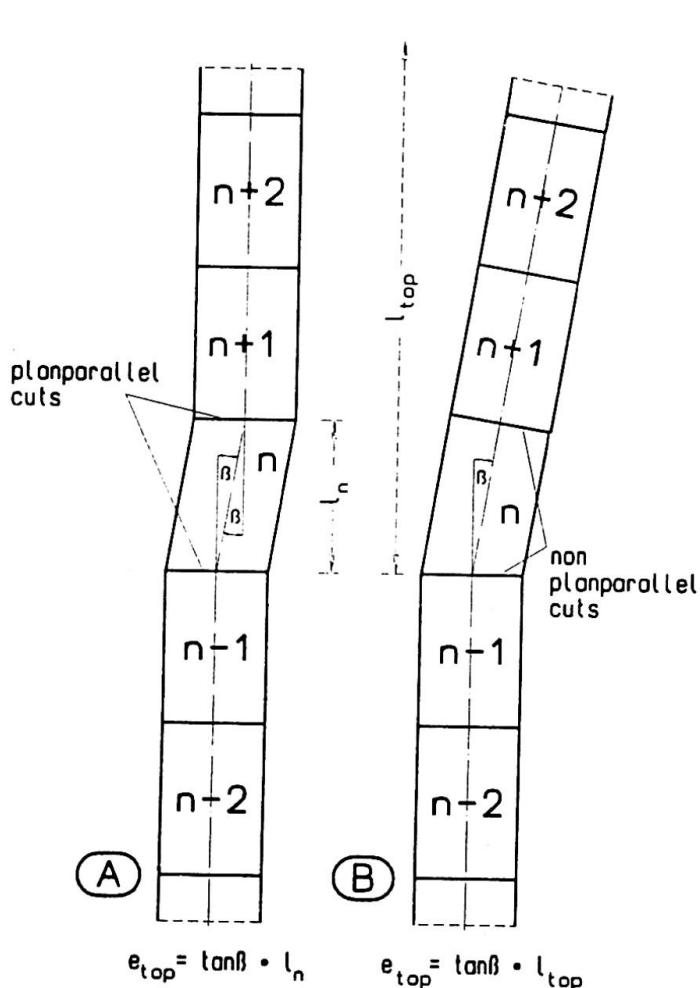
Fig. 2

Axis deviation due to skew cutting of individual section. For illustration (A) the skewed but planparallel cuts cause only a negligible shift of the axis.

If cuts of an individual box are not perpendicular but planparallel (see A in Fig. 2), the amount of deviation from nominal axis is negligible, whereas non-planparallel cuts may lead to unacceptable eccentricities (see B in Fig. 2).

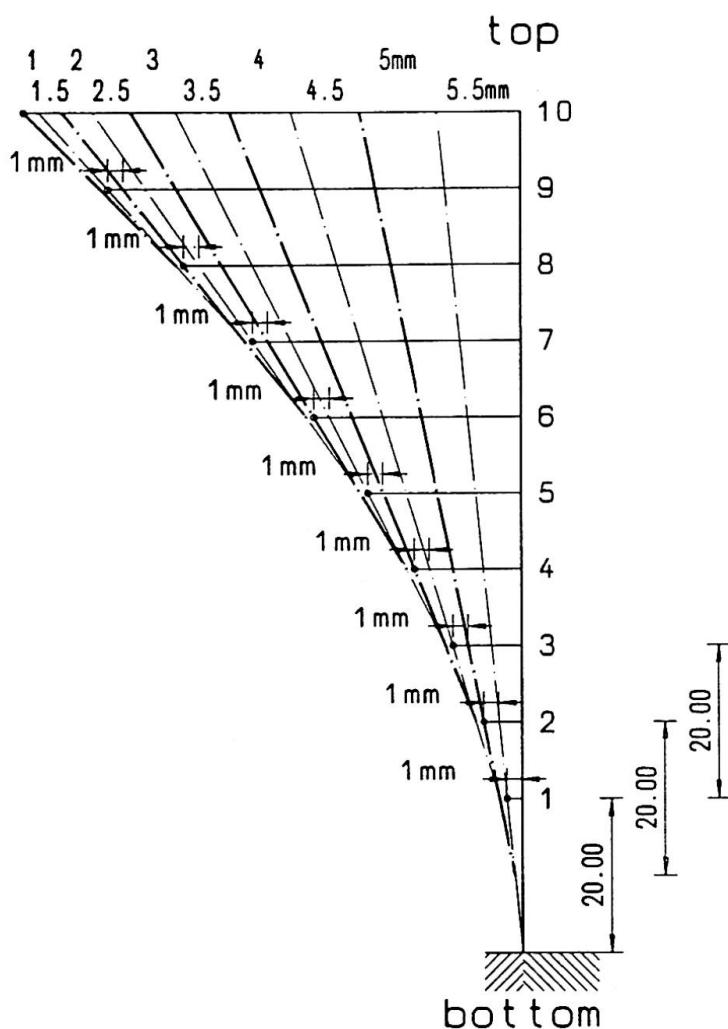
**Fig. 3**  
Undetected deviation from nominal axis due to accumulative built-in error in control assembly survey, 10 nos. of assemblies with reference length of 20 m for each assembly lead to an eccentricity of 32.5 mm at top if built-in error is 1 mm per assembly.

An additional, but undetected deviation from the axis occurs due to a built-in error in survey procedure. Considering a 1 mm error per control assembly survey and assuming that the error accumulates in same direction for further assemblies, the deviation from nominal axis at the top amounts to 32.5 mm taking entirely 10 nos. of assemblies and the reference length is 20 m per assembly (see Fig. 3).

The undetected deviation at the tower top will increase with less reference length per assembly and more numbers of surveys. For that reason it could not be agreed to control assemblies with 3 or even 2 sections only.

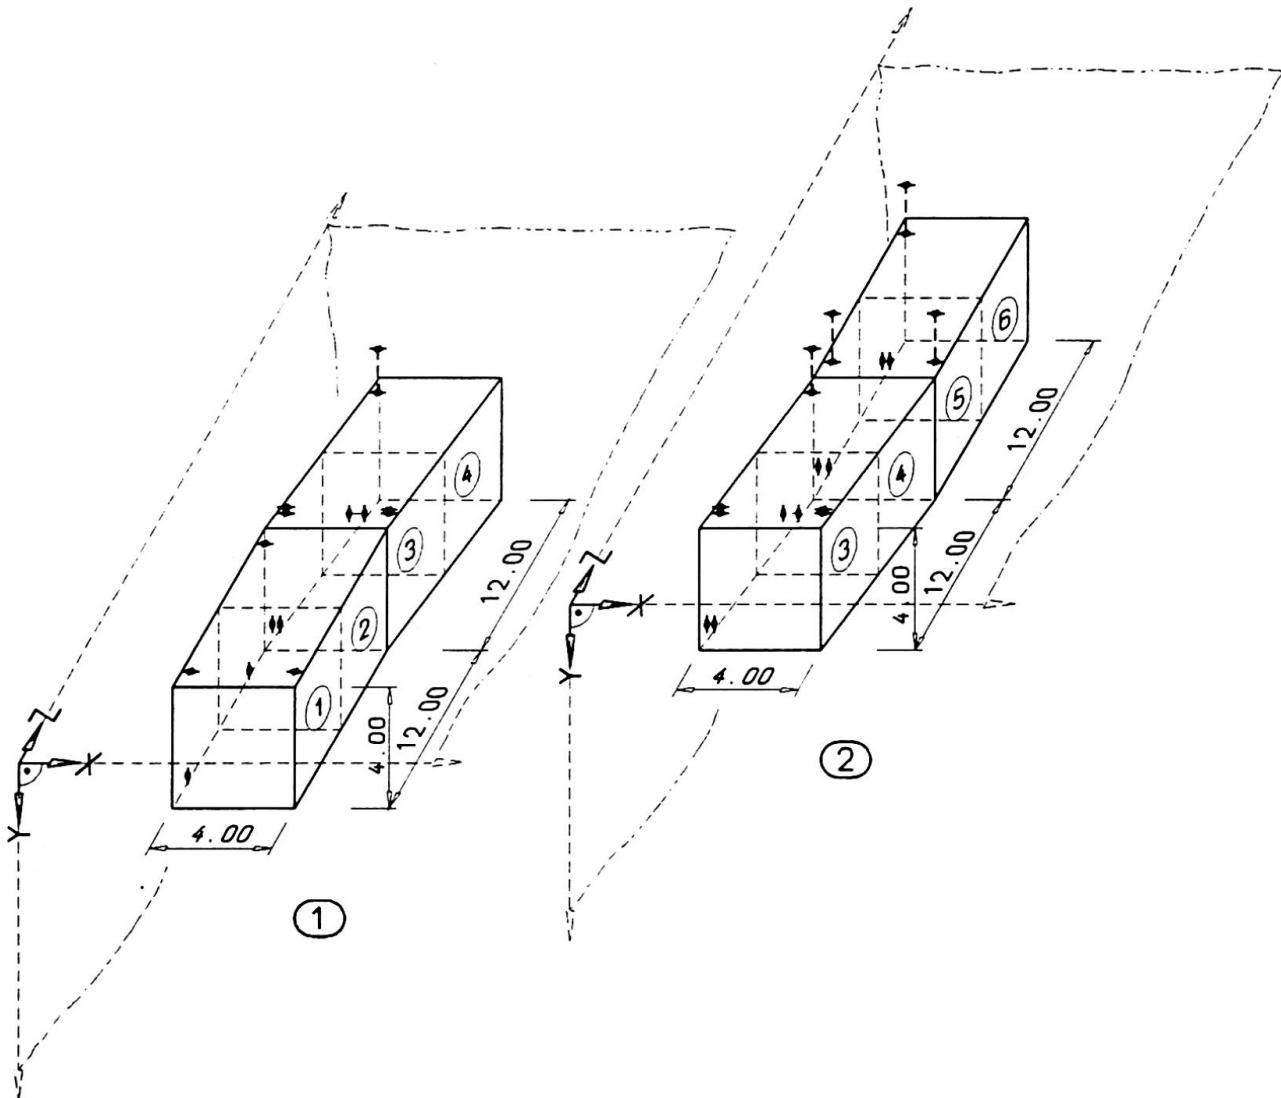
Sequence of control assembly for pylon leg, offsets at boxes 3 + 4 in assembly (1) are identical to offsets at same boxes in assembly (2) achieved by analytical transformation.

Shop floor survey for pylon legs has been executed with 4 sections per assembly horizontally laid out starting with base elements. By removing 2 rear sections and adding 2 sections at the front next assembly configuration was found. In Fig. 4 survey procedure for pylon legs is shown in principle for two subsequent assemblies. With a theodolite two perpendicular optical planes have been established. The intersecting line of these two optical planes represents nominal pylon leg axis. The offsets from the optical planes towards the wallplates of box sections were measured by scale in x-and y-direction. As a result, deviations from the axis were recorded.

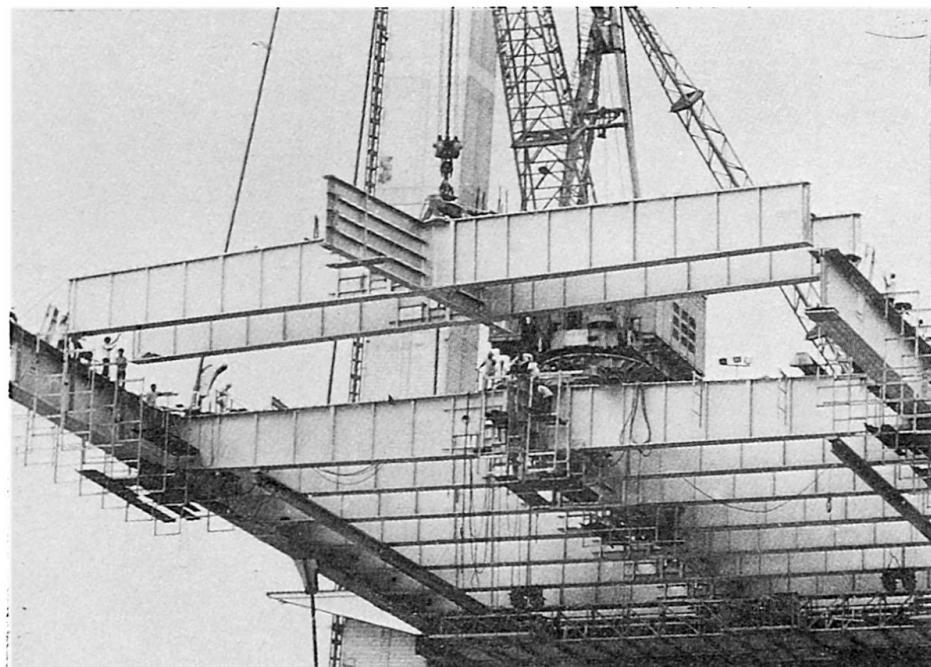
Fig. 5

Preassembly of middle girder and 4 cross girders being lifted. Both main girders are already in final position.
