**Artikel:** Use of concrete in dam construction in Germany

**Autor:** Ludin, A.

### Use of Concrete in Dam Construction in Germany.

Dr. Ing. Dr. techn. h. c. A. Ludin,  
ord. Professor an der Technischen Hochschule Berlin.

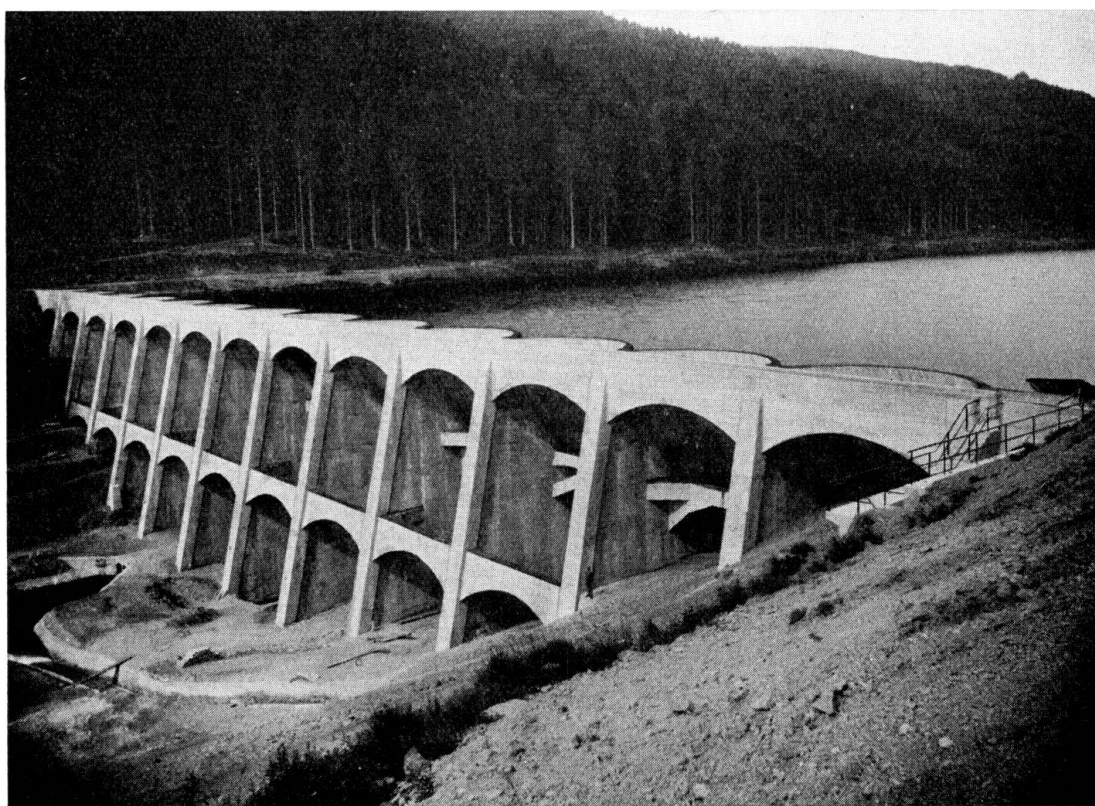
Fig. 3.

Linach barrage near Vöhrenbach

The *Linach Valley* dam at *Vöhrenbach* (Baden Black Forest) (Fig. 3) is the only dam in Germany built with buttress piers (with rows of arching) and in reinforced concrete. It is made of plastic tamped concrete of a composition in keeping with its closely spaced reinforcement. The upstream face of the arching has a layer of gunite rendering and several protective coats of paint.

The whole structure is watertight and does not appear to be defective in any way. If this style of construction has not been much in favour in Germany heretofore, no doubt it is due to the fact that it is an expensive method and building is complicated, so that little saving can be effected with it.
