**Artikel:** Typical methods of erecting four bridges across main rivers in the Netherlands

### Typical methods of erecting four bridges across main rivers in the Netherlands

HIR. H. TEN BOKKEL HUININK  
The Hague

and  
HIR. A. H. FOEST  
Utrecht

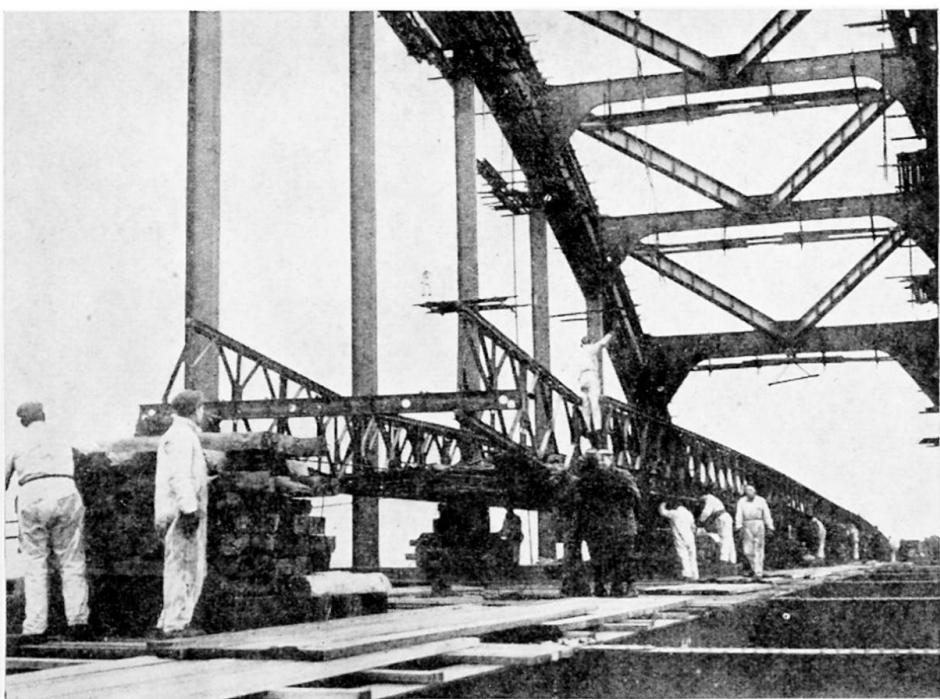
Fig. 3. Vianen Bridge

In September the first arch parts were placed. In the middle of November the pillars could be removed. In a short time the crossbeams and some of the floor-girders were erected; over this flooring a Bailey-bridge was laid 1.80 m. above the concrete flooring (fig. 3). Traffic could pass over the Bailey-bridge on the same day

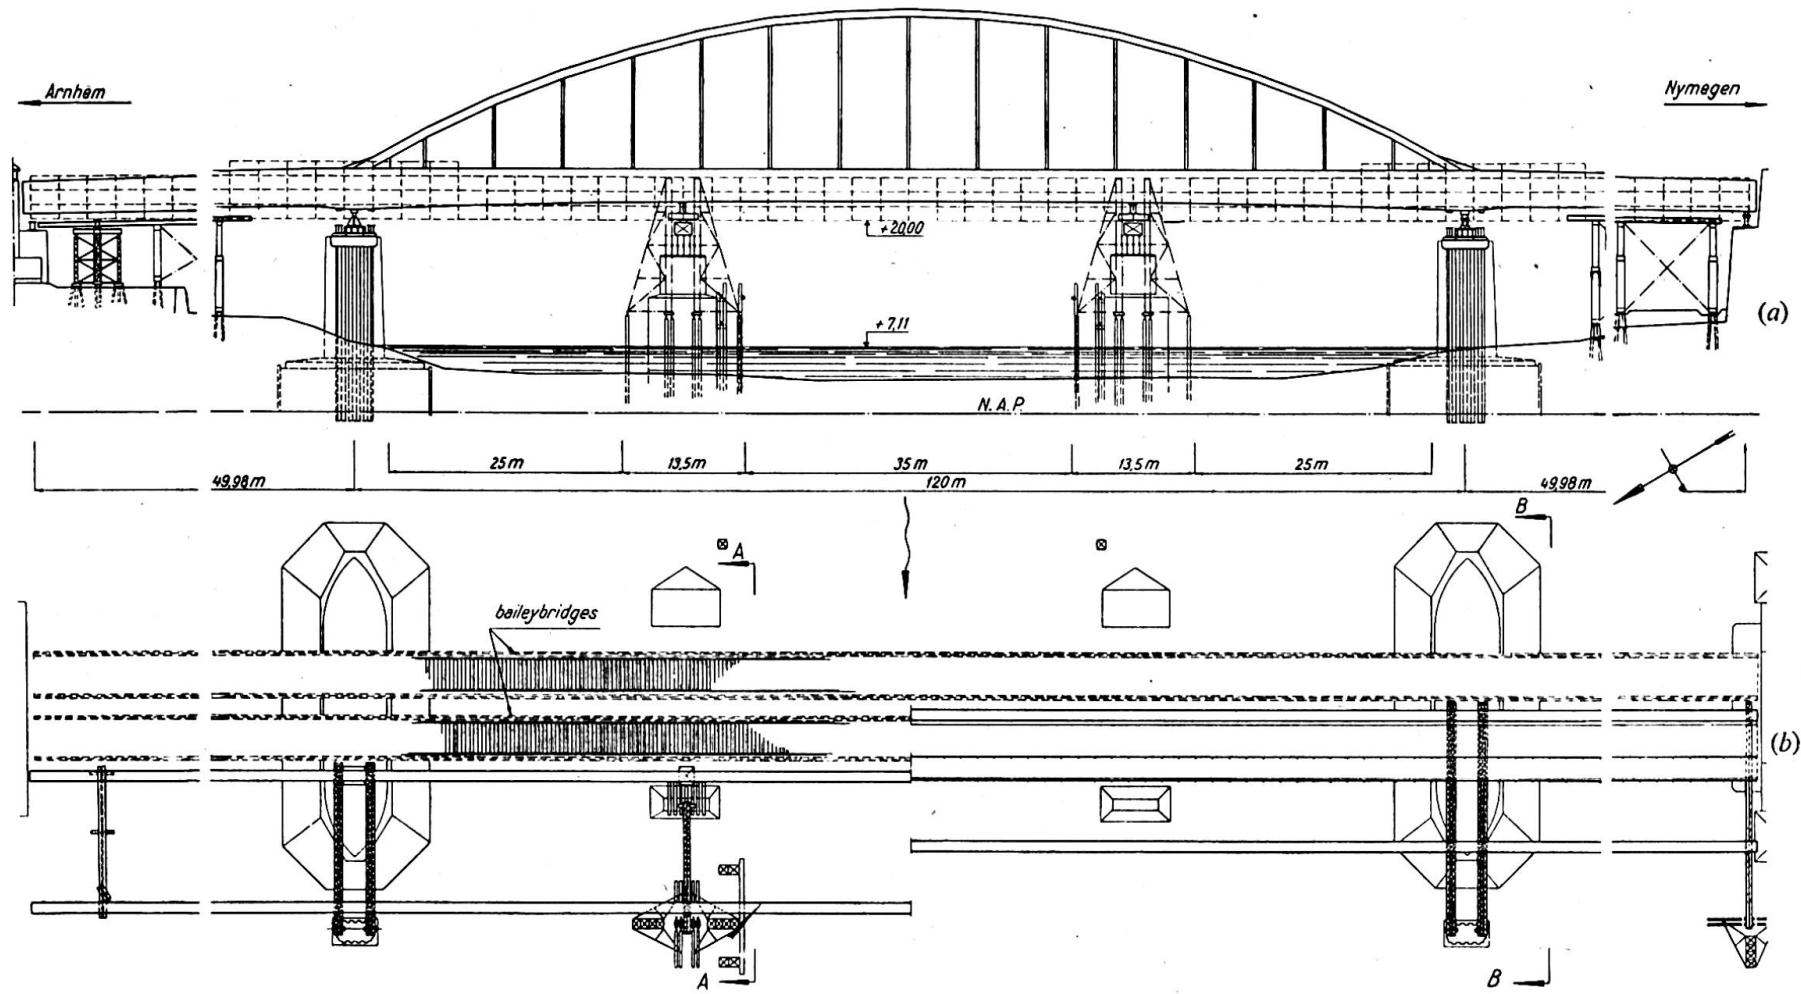
Fig. 5. Bridge over the River Rhine at Arnhem

The second reconstruction had some interesting features, as on the piers of the bridge two double-triple Bailey-bridges were laid. To reduce the span of the Bailey-bridges two auxiliary piers were placed in the river (figs. 4 and 5 (a)).

As the maximum weight was limited by the piling, the concrete slab could only be completed for one traffic lane (fig. 5(b) and (d)). The footway at the side of the

Bailey-bridges was not yet built and the footway at the other side was partly completed and provided with a wooden floor as a temporary passage. At this stage the Bailey-bridge downstream was removed and the new bridge was pushed sideways by hydraulic jacks over a distance of 7.40 m. Traffic could now use one Bailey-bridge

and the concrete floor. The second Bailey-bridge was removed and the permanent construction pushed into the right place while traffic continued. The total distance of rolling was 14.80 m. The force needed to roll the bridge totalled 75 tons divided over four jacks. Finally the concrete floor and the footways were completed.
