Band: 7 (1964)

The Behaviour of Steel Beams Under Slow Repeated Loading

J. W. RODERICK

B. RAWLINGS

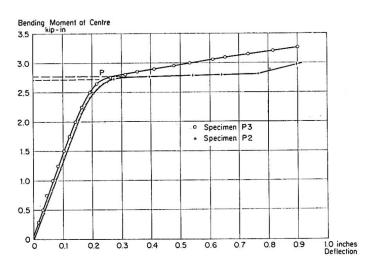
The details of the various specimens and results of static tests are summarised in Table 1. Typical curves plotted from these results are shown in Fig. 3. The value of full plastic moment accepted for the central point load tests was that corresponding to the point P (Fig. 3) at which the curve just entered the inclined region of strain-hardening behaviour. It will be seen that this value

agreed fairly closely with that obtained from a uniform flexure test on the same type of specimen.

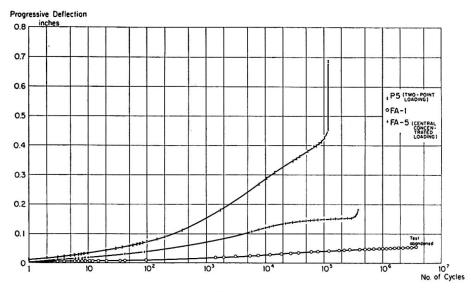
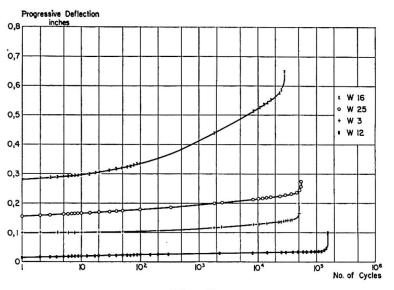
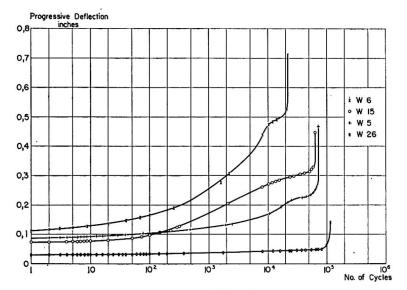
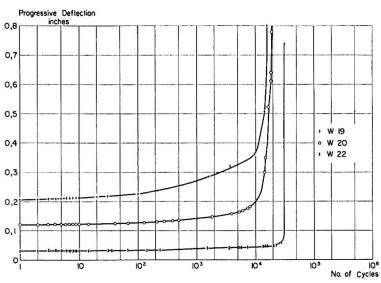
Fig. 4a.

It is convenient to represent the readings of progressive deflection against the number of cycles, as shown in Fig. 4, using a logarithmic scale as abscissa, and linear scale for ordinates. The graphs as shown are at arbitrary heights but the true initial values of deflection at the commencement of testing are given in Table 2.

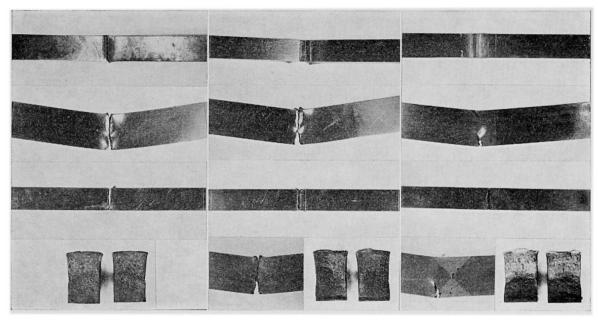
Fig. 5a.

A number of photographs of specimens after testing showing elevations, top and underneath views and fracture surfaces are shown in Fig. 5. It will be evident that in all cases the region of the specimen adjacent to the fracture underwent considerable plastic deformation, and this was accompanied by lateral flow of the material, resulting in the large distortions of the cross-sections. The distorted surfaces are also clearly seen in the elevations. In a number of specimens rippling of the compression face was evident, and in others, some fine transverse cracks could be observed in the compression face when the specimen was closely examined. It will be observed from the photograph of specimen W 20 (Fig. 5b) that, even when the specimen was broken apart prior to photographing, there was some ductility of the remaining material as the two parts do not mate together precisely at the top.

Under single point loading conditions, the cracks were located at a section near the centre, but in most cases displaced approximately $^{1}/_{2}$ inch away and near the extremity of the welded zone. In the case of the welded specimens subjected to two point loading, the cracks again frequently developed to one side of the centre line of the span, as is shown in Fig. 5c. (Specimen W 15.) The unwelded specimen subjected to two point loading developed a crack which originated under one of the loading points, in the tensile fibre. The crack propagated from one of the scribed lines used for marking out the

specimen prior to testing. Cracks in the specimens propagated vertically, and often appeared to emanate from a small weld defect such as an inclusion near the tensile face. It will be seen from the photographs in Fig. 5 which show elevations of typical welded specimens after etching with 10 per cent nitric acid in methylated spirit, that the cracks all originated within the welded zone, although in many cases they subsequently penetrated regions of unwelded material.

If attention is directed to the sectional views, which were taken after the specimens were broken apart in a vice, it will be observed that in some striations occurred consistent with the progressive nature of the cracking. These are particularly noticeable in the case of specimen FA-5. The fractures were crystalline in appearance, the lighter colour occurring in the region which was freshly broken.

cracking occurs is at the extremity of the weld as is suggested by the photographs of the etched specimens, it will be seen that at these sections, the moment is only 96 per cent of the central moment, consequently the curve in Fig. 7, for the welded central load tests will be displaced downwards to the position shown by the broken line. The results of the central load and two-point load tests then agree very closely.

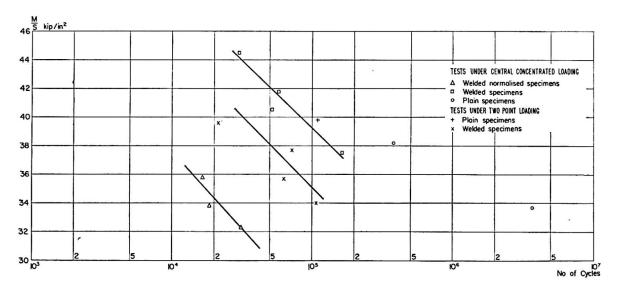
The test results are summarised in Fig. 6. Here, the number of cycles to failure are plotted on a logarithmic axis, against the applied maximum moment divided by the plastic section modulus of each specimen. These same results are plotted again in Fig. 7, the ordinate being the maximum applied moment divided by the full plastic moment of a specimen of the same dimensions, as determined from the static tests. In both figures the relationship between the logarithm of the life of a specimen, and loading, will be seen to be sensibly linear.

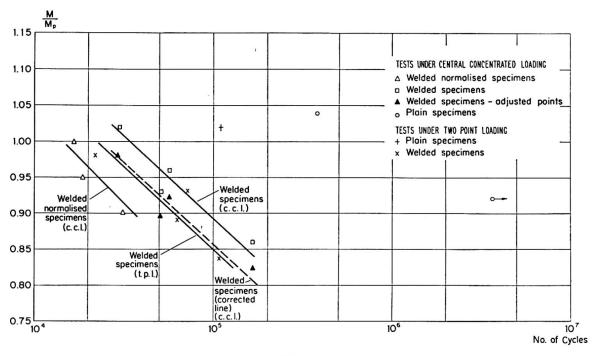
Fig. 7.

It will be observed that the curves for two point and central point loading specimens agree fairly closely, when allowance is made for the different values of full plastic moment of resistance. If it is assumed that the section where
