Zeitschrift: IABSE congress report = Rapport du congrès AIPC = IVBH
Kongressbericht

WORKING SESSION

Building under Extreme Conditions

V**Der Bau der Bergstation der Seilbahn Klein Matterhorn**

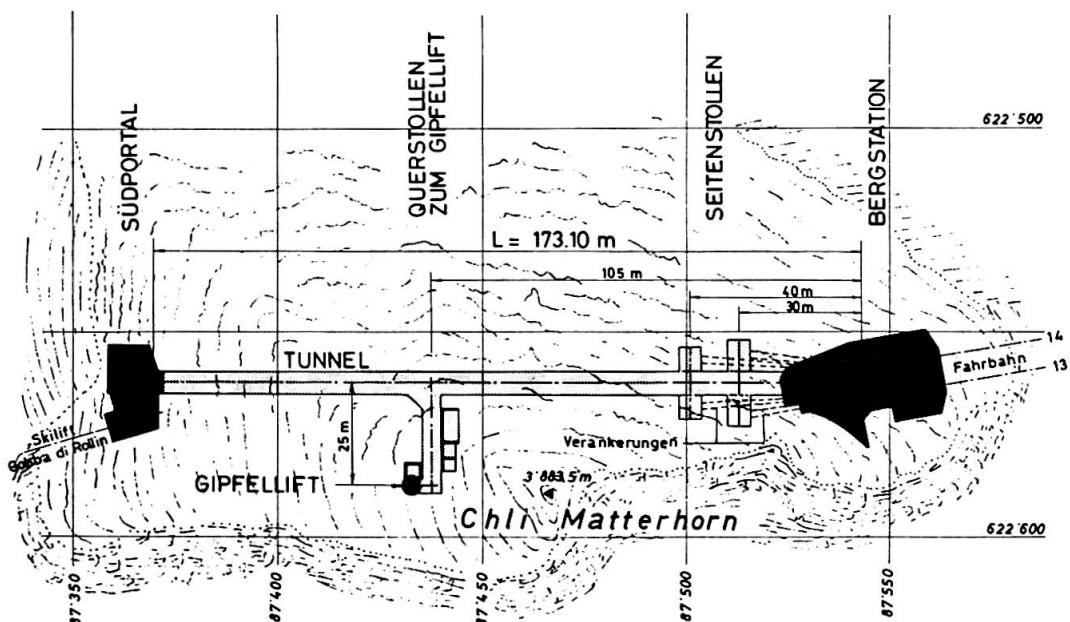
Abbildung 3 : Längsschnitt der Bergstation

Das Aufnahmegebäude der Bergstation Klein Matterhorn ist eine Massivbaukonstruktion in Stahlbetonbauweise, die ab Perrondecke eine maximale Höhe von 18.62 m und eine grösste Breite von 20.26 m aufweist.

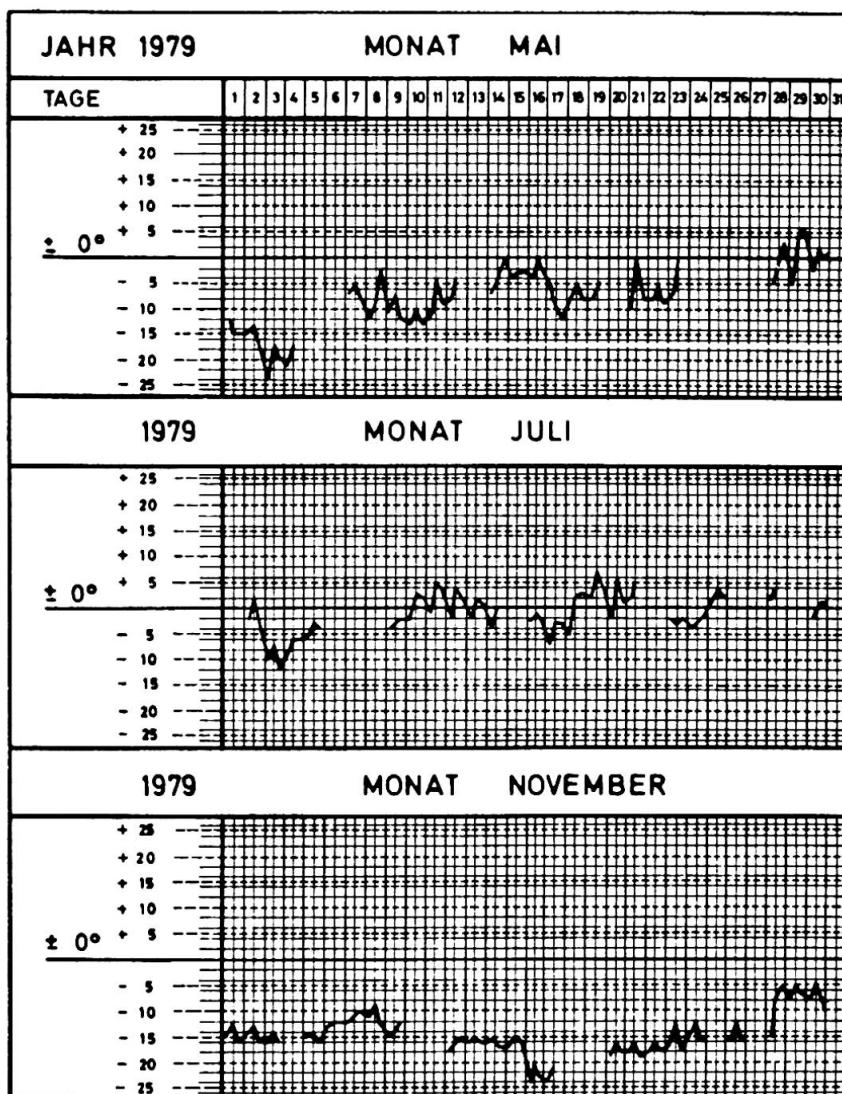
Abbildung 4 : Ausschnitte aus den Diagrammen der Tagestemperaturen der Monate Mai, Juli und November 1979

In Abb. 4 sind vergleichsweise Ausschnitte aus den Temperaturdiagrammen der Monate Mai, Juli und November des Jahres 1979 angegeben.

Die Temperaturverhältnisse entsprechen etwa dem, was vorausgesehen werden konnte auf Grund der Klimadaten der Wetterstation Plateau Rosa, 3'488 m.ü.M. Die Extremwerte der Lufttemperatur in den Jahren 1966 bis 1975 wurden wie folgt angegeben:

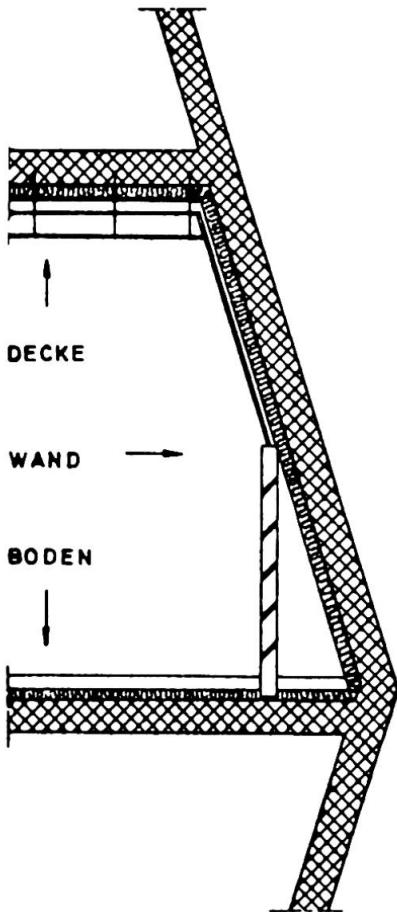
Im Uebergang zwischen Kalt- und Warmbereich wurde eine Wärmeisolation angebracht um ein Auftauen der vorhandenen Eislinsen zu verhindern.

Als Isolationsmaterial wurde Foamglas, bzw. Styrofoam verwendet.

Deckenisolation

- 80 mm dicke Foamglasplatten mit Foamglaskleber geklebt und mechanisch befestigt.
- Deckenverkleidung Nordfichtentäfer 13 mm stark, mit Nut und Kamm, mit Unterkonstruktion ca. 25cm heruntergehängt

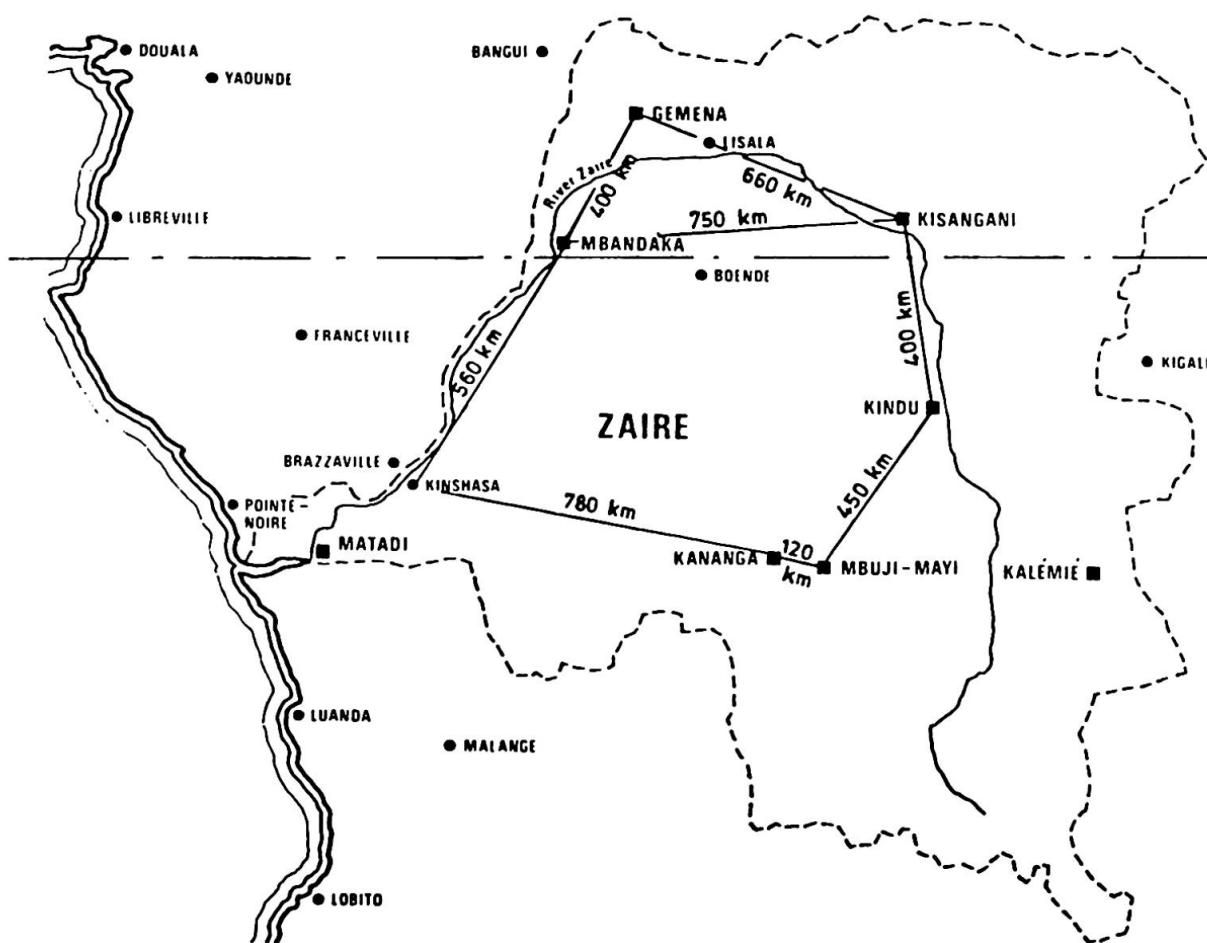
Airport construction in Zaire Layout

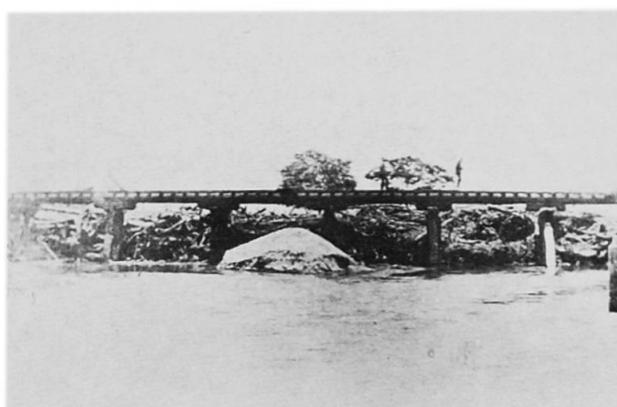
Figure 1
Spans too small

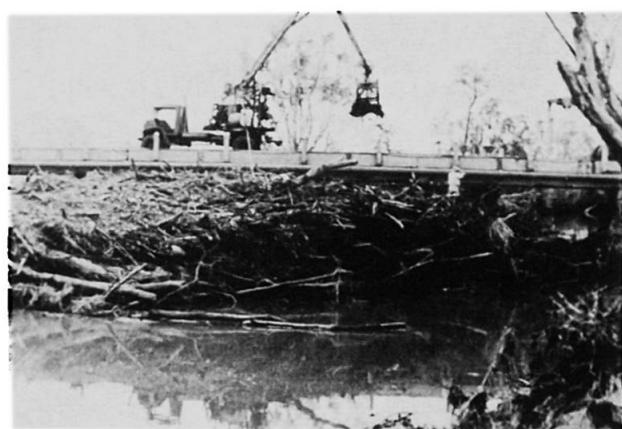
Figure 2
Spans too small
Deck at flood peak

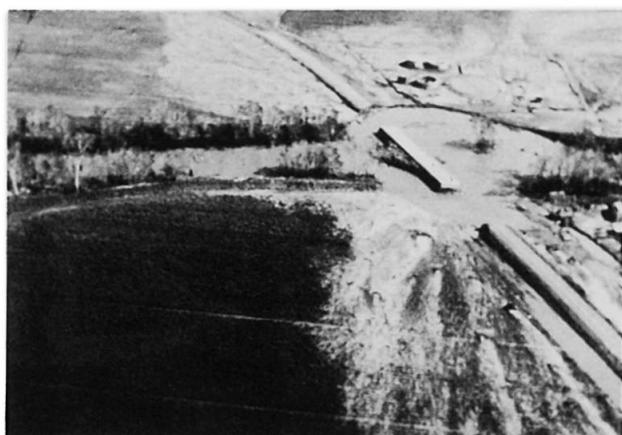
Figure 3
End scour after waterway blockage.

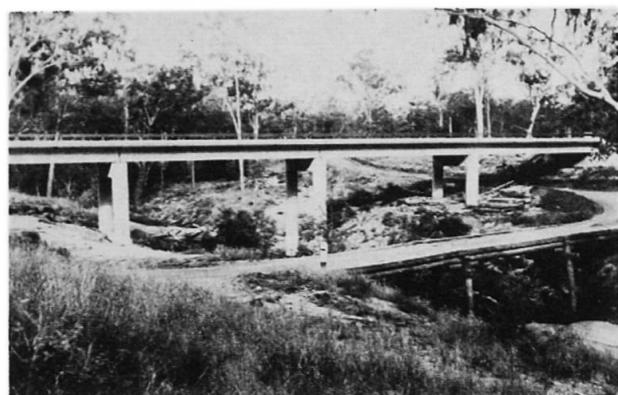
Figure 4
Submersible bridge replacing lower timber bridge

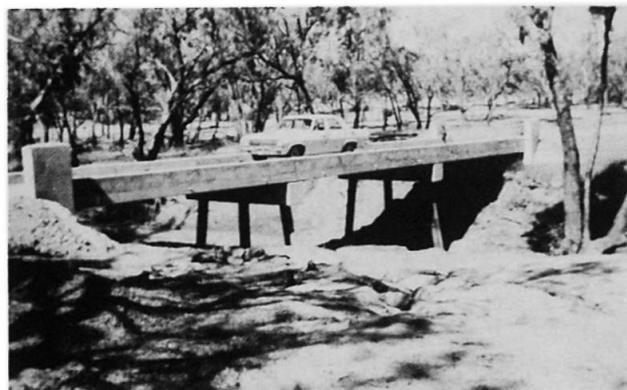
Figure 5

The type of bridge that results is frequently a small span (6-20m) reinforced cast insitu concrete slab; or a deck of prestressed concrete precast slabs (Fig.5,6) or a composite reinforced concrete deck with plated universal beam girders. Piers are frequently headstocks on steel or reinforced concrete piles or reinforced concrete columns. Geometric complications are avoided, and site construction details are as simple as possible.

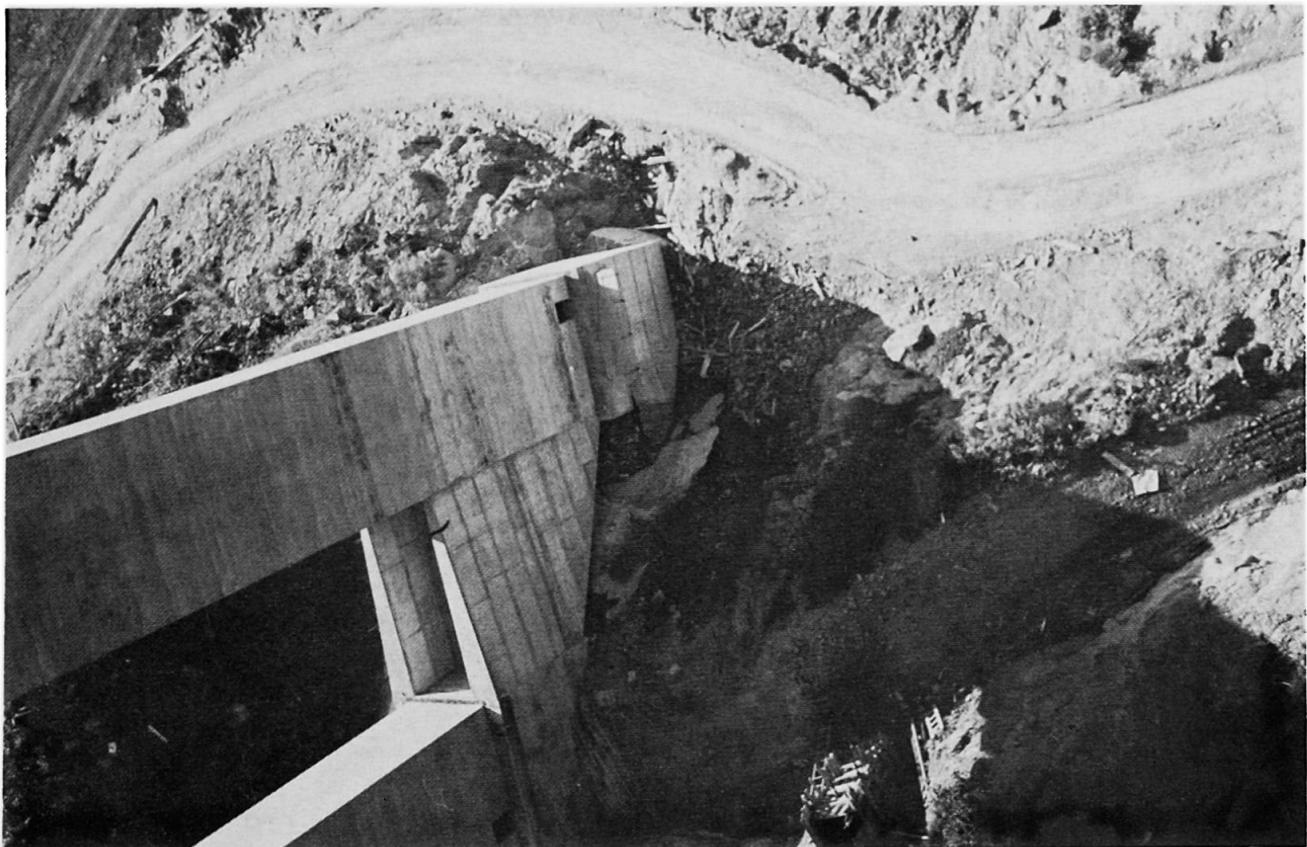
Bild 2 Pfeilerfuß mit Zufahrtsstraßen
(von der Brücke aus nach unten gesehen)

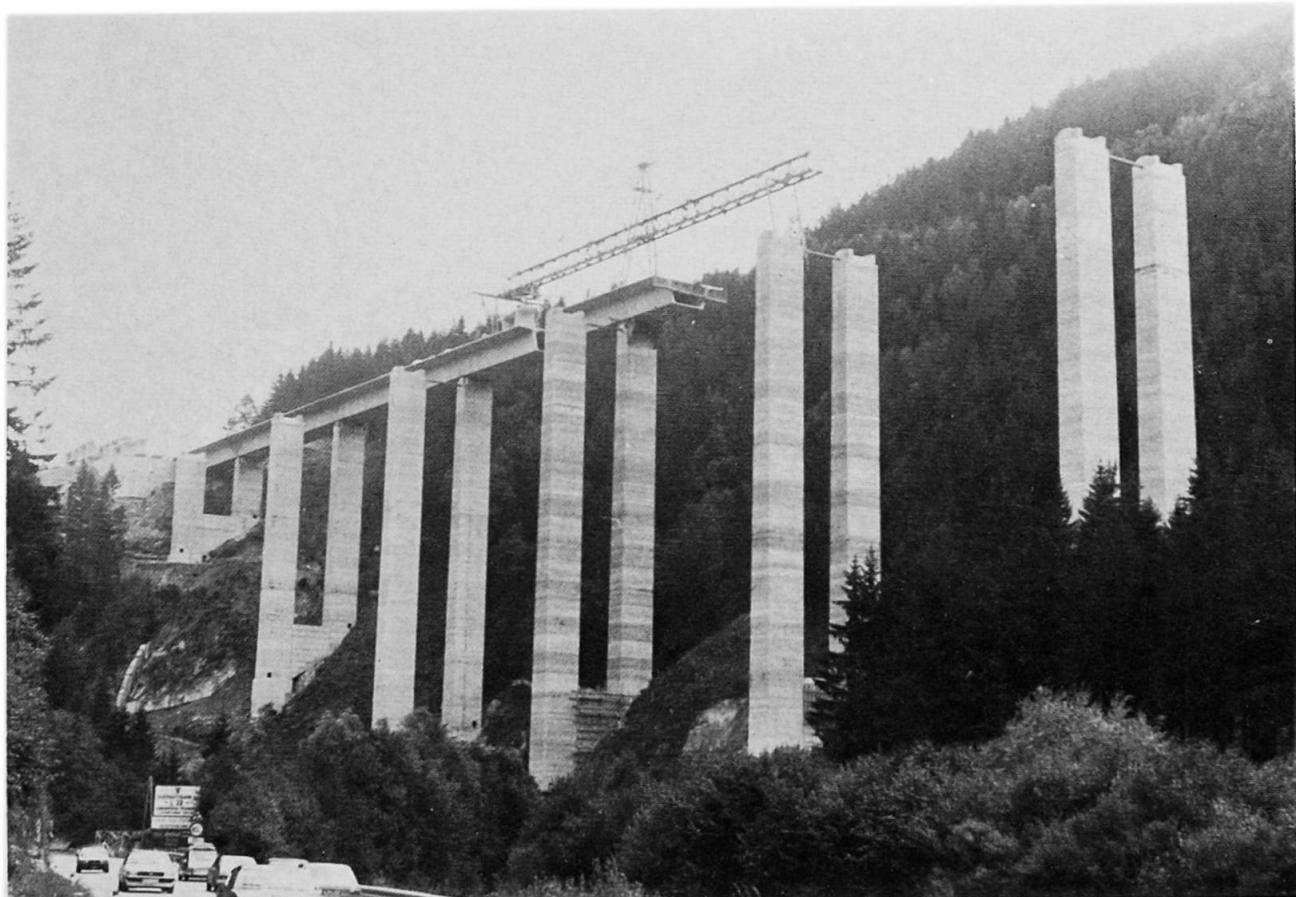
Als der Unterbau den nötigen Vorlauf erreicht hatte, wurden die Fertigteile nach dem Prinzip des Freivorbaues mit einem oben fahrenden Versetzgerät montiert.

Bild 3 Montage der Brückenfertigteile (Segmente)

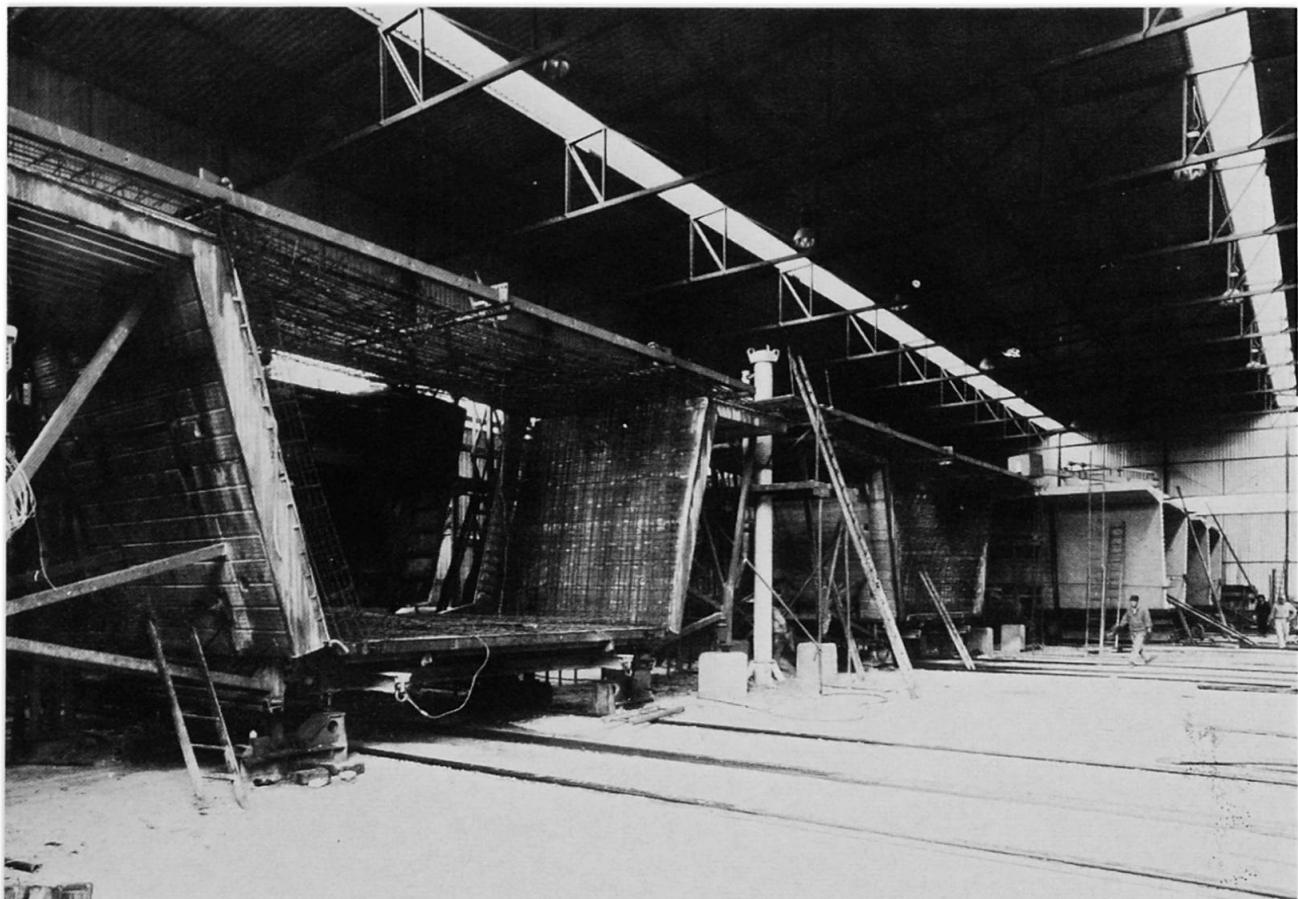
In einer eigenen Halle wurden querschnittsbreite Brückenfertigteile produziert und auf Lager gelegt, während die Gründungs- und Unterbauarbeiten im Gange waren.

Bild 4 Fertigung der Brückensegmente

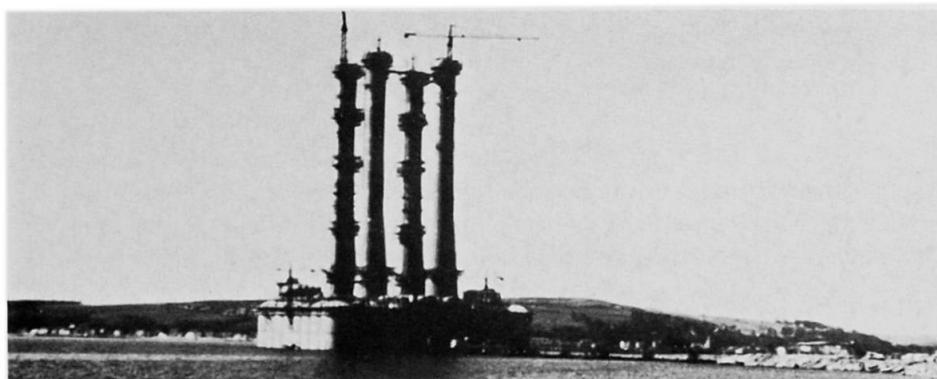
The Main Contract was for the construction by Sir Robert McAlpine & Sons Ltd., and Sea Tank Company of Paris of the North Sea oil production platform Cormorant 'A' for Shell Esso, fig. 1. The Main Contract programme required that the platform was completed and delivered to suit the North Sea weather window, i.e. a limited period in the summer months. Failure to meet this "window" would mean that oil production from the Cormorant 'A' platform would be delayed by 12 months, which possibility was unthinkable.

Fig. 1 The Cormorant 'A' Oil Production Platform.

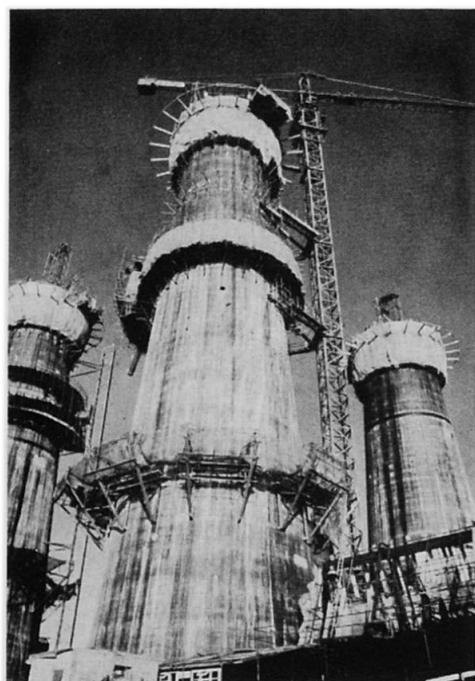
The Sub-contract was to install the prestressing tendons in each of the four 67m high towers whilst the towers were being constructed by the slipforming process, fig. 2. These Sub-contract works were completed by BBRV Marine which is a joint venture of the BBRV Licensees in Scandinavia (A/S Strangbetong), Switzerland (Stahltion AG) and the United Kingdom (Simonbuild Ltd.).

Fig. 2 Slipforming the 67m high towers.

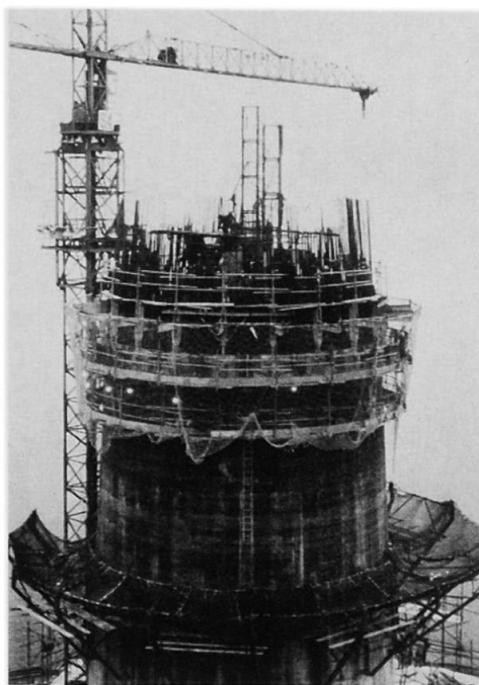
Fig. 3 The slipform platform

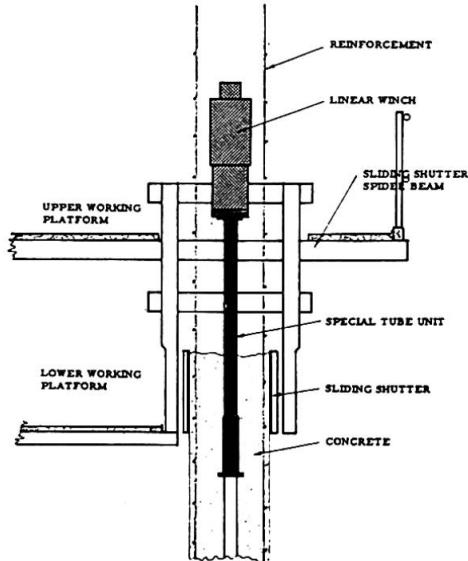
The tendon was installed along a tortuous route extending from the platform deck to the slipform platform as shown in fig. 5, by fixing a lifting device (a linear winch) to the top plate when the concrete had been placed to within 0.5m of the upper plate. At this stage the lower plate was 2.5m into the concrete and was bearing on concrete which had achieved sufficient strength to withstand the loads transmitted through the tube unit from the lifting device. When the tendon had been lifted to the correct distance above the top plate of the tube unit, chocks were positioned between the tube unit upper plate and the underside of the tendon fixed anchorage. The lifting device was then removed and the slipforming proceeded, without delay, past and covering the completed fixed end anchorage, fig. 6.

Fig. 4 Tendon lifting arrangements

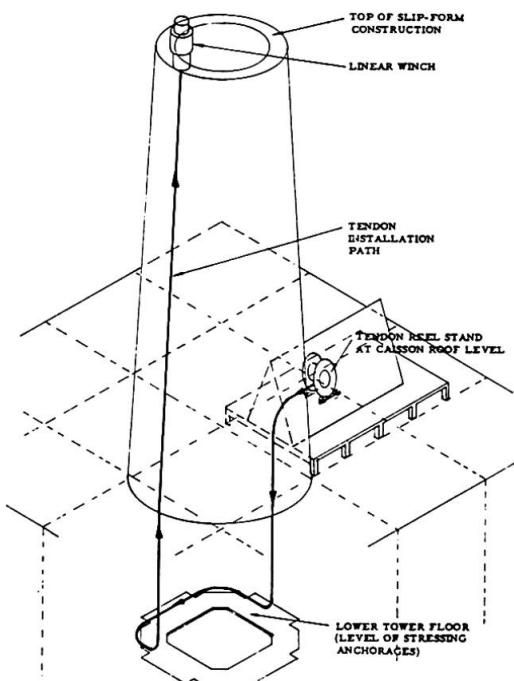
Fig. 5 Tendon installation route

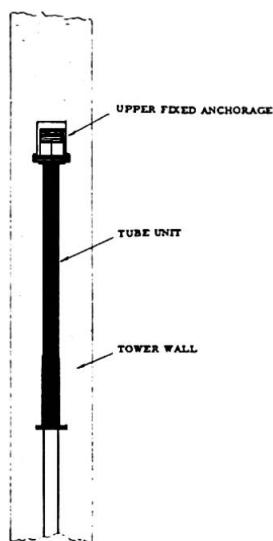
Fig. 6 Tendon fixed anchorage after passage of slipform
