**Artikel:** Construction of Usagawa long-spanned concrete arch bridge

**Autor:** Nakasima, Eiji / Uchida, Michio

## Construction of the Usagawa Long-Spanned Concrete Arch Bridge

Usagawa Bridge, built by Nihon Doro Kodan (the Japan Highway Public Corporation) in 1981, is a reinforced concrete arch bridge with a span of 204 m. The result of application of flowing concrete to the arch ring of the Usagawa Bridge is discussed. This concrete, to which is added a water-reducing agent with high performance, was used for the purpose of enhancing the concrete workability and quality.

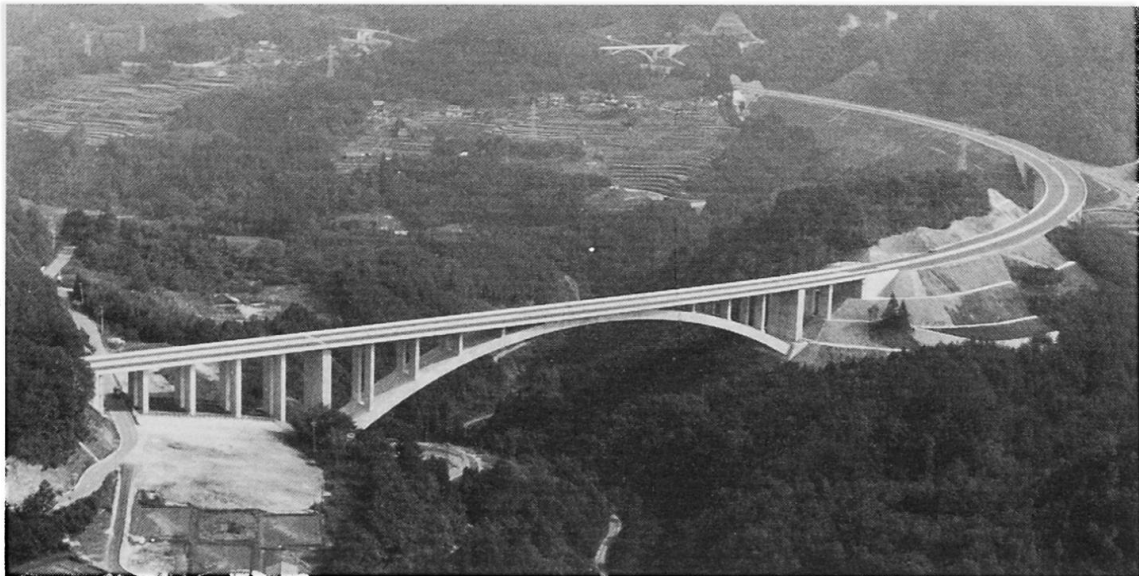
Photo 1, Appearance of Usagawa Bridge

Usagawa Bridge was constructed in 1981 as a part of the Chugoku Expressway. This bridge is a reinforced concrete arch bridge with 204m of an arch span. Since its arch ring has a large cross-section carrying four lanes (two lanes for each direction), various techniques have been incorporated in the designing, the quality control of materials and others to reduce the dead load. The arch ring was constructed with prestressed concrete using a cantilever method with temporary stays used prestressing bar together with a temporary steel girder arch. Having an experience in the construction of the same type of bridge with 145m of the arch span, Taishaku Bridge in 1978, the Japan Highway Public Corporation has realized the necessity of highly-workable concrete. Thus the flowing concrete was used with a view of enhancing the concrete workability and quality for the construction of Usagawa Bridge.

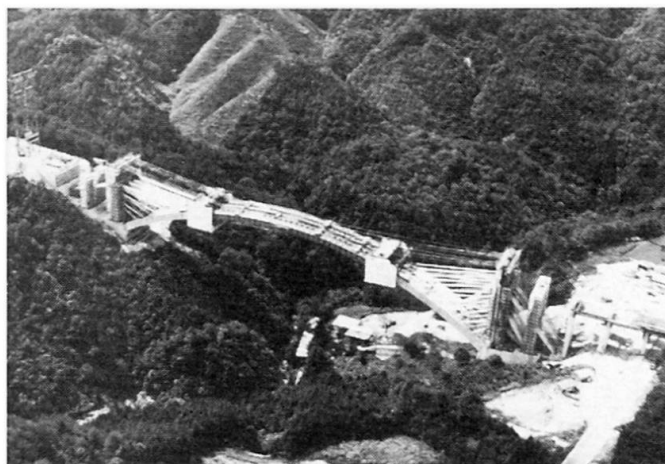
Photo 2, Construction of Arch Ring

The concrete for each block of the arch ring was cast first onto lower slabs, then web members and upper slabs. In particular, for the blocks of the steel girder arch section, smaller sized vibrators were applied at closer intervals with shorter vibration time in order to overcome the narrowness of the concrete-

casting space and avoid material segregation due to excessive vibrations. In addition, since the arch ring was inclined, the top covering up one by one as the concreting proceeded.
