Artikel: Dynamic response and subsequent retrofit of a tied-arch bridge

Dynamic Response and Subsequent Retrofit of a Tied-Arch Bridge

Two tied-arch spans carrying I-24 across the Ohio River near its confluence with the Mississippi River are experiencing severe distortional problems. These spans are 192 m and 223 m in length and of the bowstring-type tied arch in which the tie girder contributes insignificant bending stiffness to the span. The longitudinal bending stiffness of the spans is concentrated in the very significant arch rib. The spans are connected together and to the riverbanks by continuous plate-girder spans forming a river crossing totalling over 1,700 m in length. A photograph of one of these spans is shown in Figure 1. The resultant problems are twofold. The global vertical displacement field of the tied-arch spans is excessive and, due to the public's loss of confidence in the bridge, intolerable. Secondly, out-of-plane distortions of the floorbeams, which are related to the global displacement, have resulted in ever-increasing fatigue cracking in the webs of the welded floorbeams at locations shown in Figure 2.

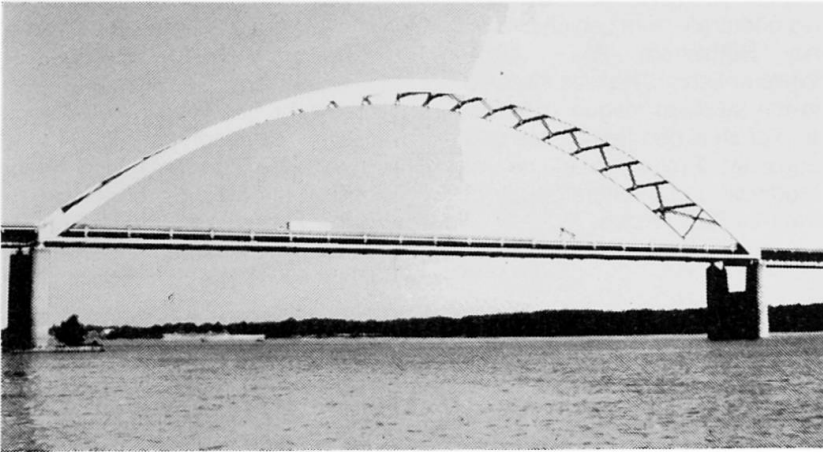
Figure 1 - View of 223 m tied-arch span.
