Zeitschrift: IABSE congress report = Rapport du congrès AIPC = IVBH
Kongressbericht

Artikel: Steel cover structures for the renovation of large temples

Autor: Arakawa, Harunori / Osaki, Yorihiro

Steel Cover Structures for the Renovation of Large Temples

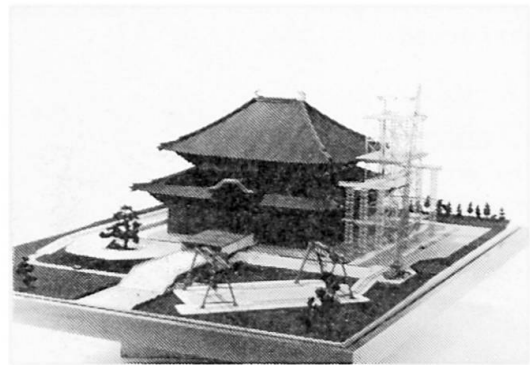
Fig. 5, SUYANE fabricate beside the temple was to moved over the building by rollers

- 1) Provide a temporary fabrication yard behind the temple.
- 2) Erect two spans of SUYANE at the fabrication yard.
- 3) Slide the fabricated element to the final position to cover the temple.
- 4) Erect further elements of SUYANE to slide to connect to the first element.
- 5) Repeat the process to complete the total SUYANE.

- *For slide; steel rollers were adopted.
- *For pushing; hydraulic jacks were adopted.
- *For the prevention of deflection of an element during slide; temporary steel members were provided to reinforce the element.
- *For tightening and untightening the steel bolts; a newly developed high strength bolt, called "Slope detection bolt" was adopted, which was by joint development between Kawasaki Steel Corp. and Mitsubishi Electric Corp.

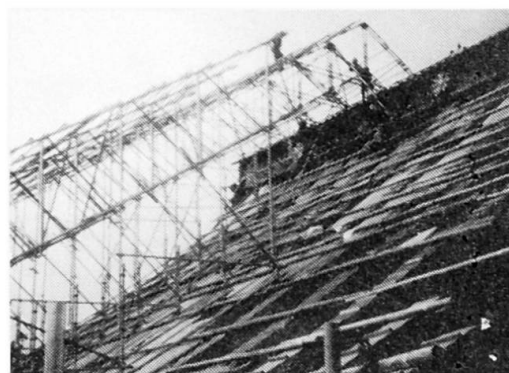
Fig.11, Kimpusanji temple, Zaodo Manual removal of roof

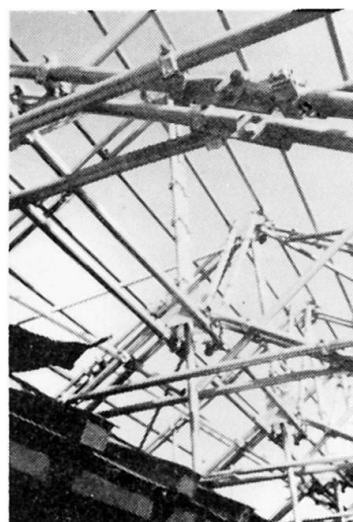
Fig.12, Kimpusanji temple, Zaodo SUYANE Plural pipes bundles

*For the lack of structural section of a single pipe, bundled plural pipes to be used as a single structural member.
