**Artikel:** Fabrication survey of steel components facilitates quick bridge erection

**Autor:** Bergermann, Rudolf / Dillmann, Ulrich

## **Fabrication Survey of Steel Components facilitates Quick Bridge Erection**

Contrôles de fabrication pour le Pont Hooghly à Calcutta

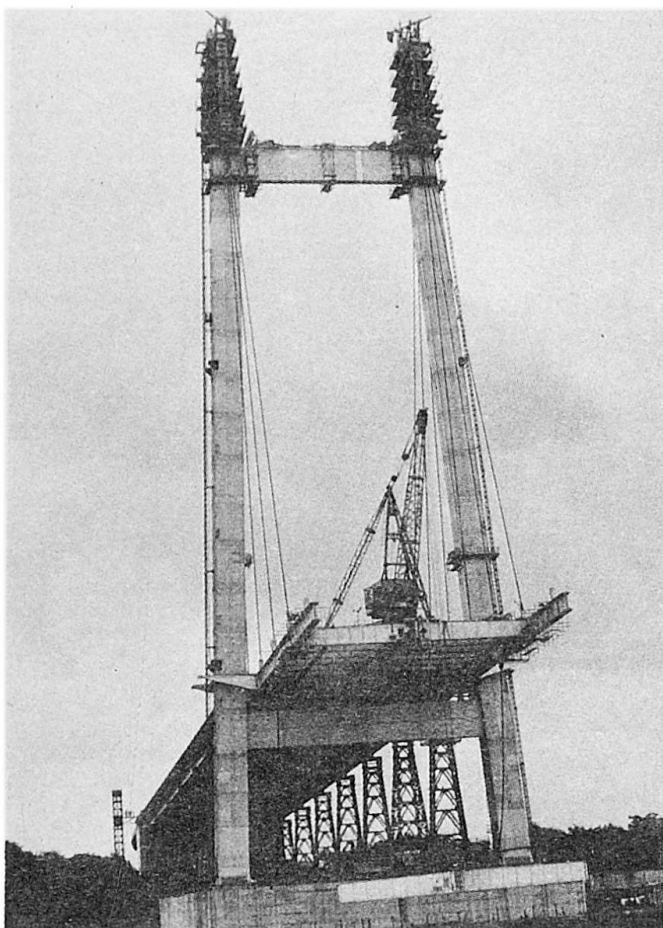
**Fig. 1**

H-shaped, 122 m high pylon at Calcutta side

Space restrictions and progress of erection did not permit a full shop floor layout for the towers as it had been done for previous bridges. Transport and lifting facilities limited the length of a single box to a maximum of 6 m. Therefore one pylon leg comprises 19 sections up to the level of top portal.

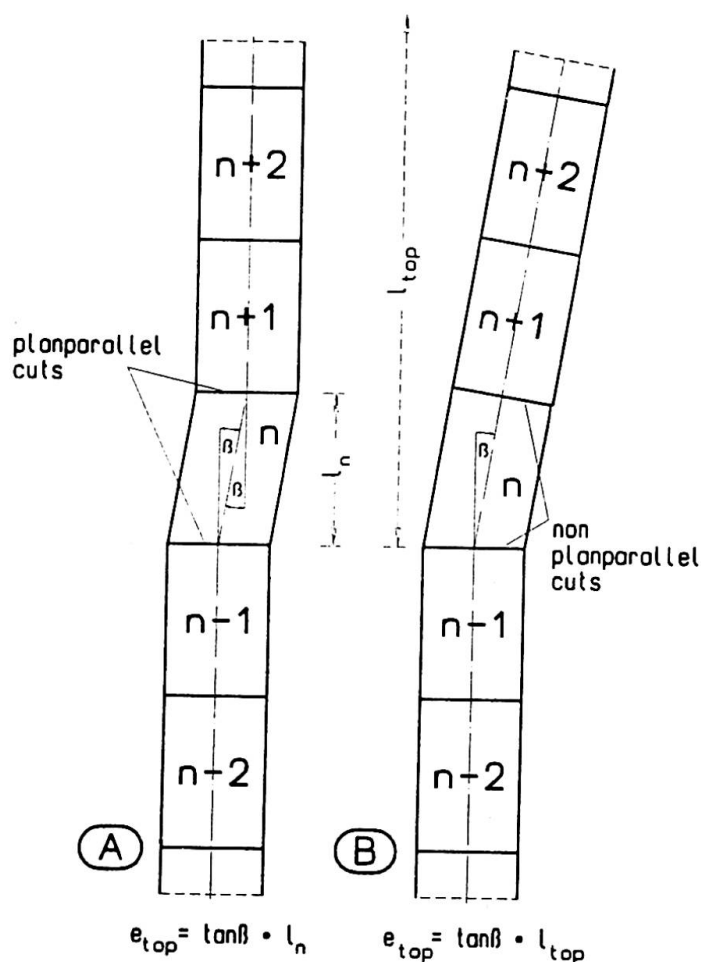
**Fig. 2**  
Axis deviation due to skew cutting of individual section. For illustration (A) the skewed but planparallel cuts cause only a negligible shift of the axis.

Deviations from nominal pylon leg axis are caused mainly through skewed cutting of box section ends. On this account utmost care was taken during individual box machining. Before cutting of the second face was taken up, the box was aligned in reference to the face which was cut first. For this a dial gauge was mounted on the extended spindle of milling cutter to check perfect setting.

If cuts of an individual box are not perpendicular but planparallel (see A in Fig. 2), the amount of deviation from nominal axis is negligible, whereas non-planparallel cuts may lead to unacceptable eccentricities (see B in Fig. 2).

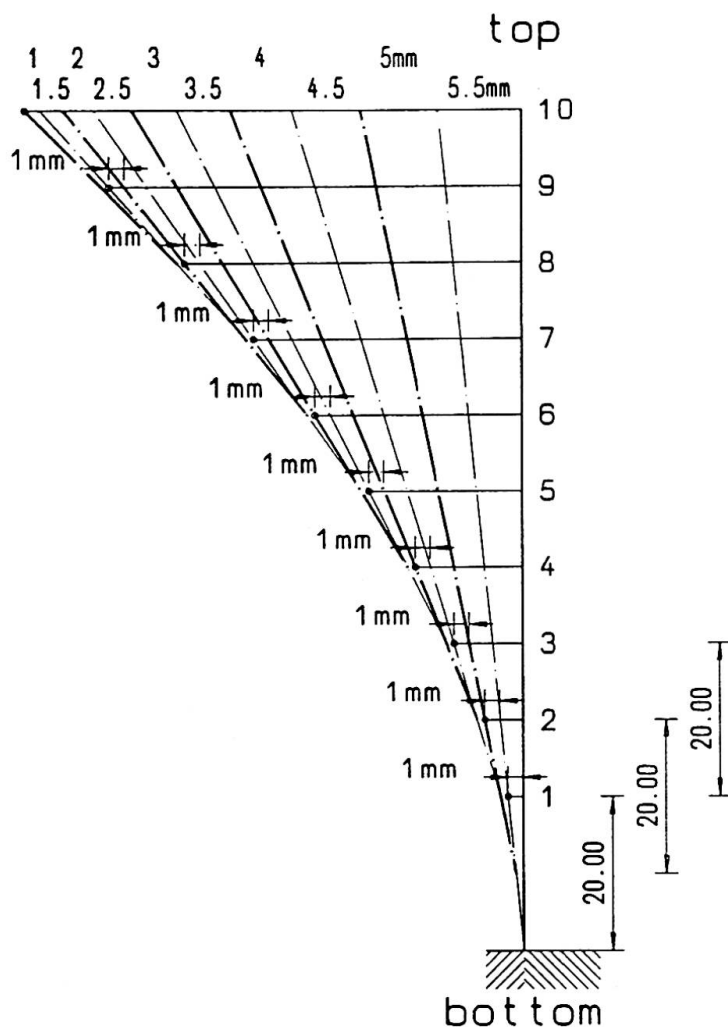
Fig. 3

Undetected deviation from nominal axis due to accumulative built-in error in control assembly survey, 10 nos. of assemblies with reference length of 20 m for each assembly lead to an eccentricity of 32.5 mm at top if built-in error is 1 mm per assembly.

An additional, but undetected deviation from the axis occurs due to a built-in error in survey procedure. Considering a 1 mm error per control assembly survey and assuming that the error accumulates in same direction for further assemblies, the deviation from nominal axis at the top amounts to 32.5 mm taking entirely 10 nos. of assemblies and the reference length is 20 m per assembly (see Fig. 3).

The undetected deviation at the tower top will increase with less reference length per assembly and more numbers of surveys. For that reason it could not be agreed to control assemblies with 3 or even 2 sections only.

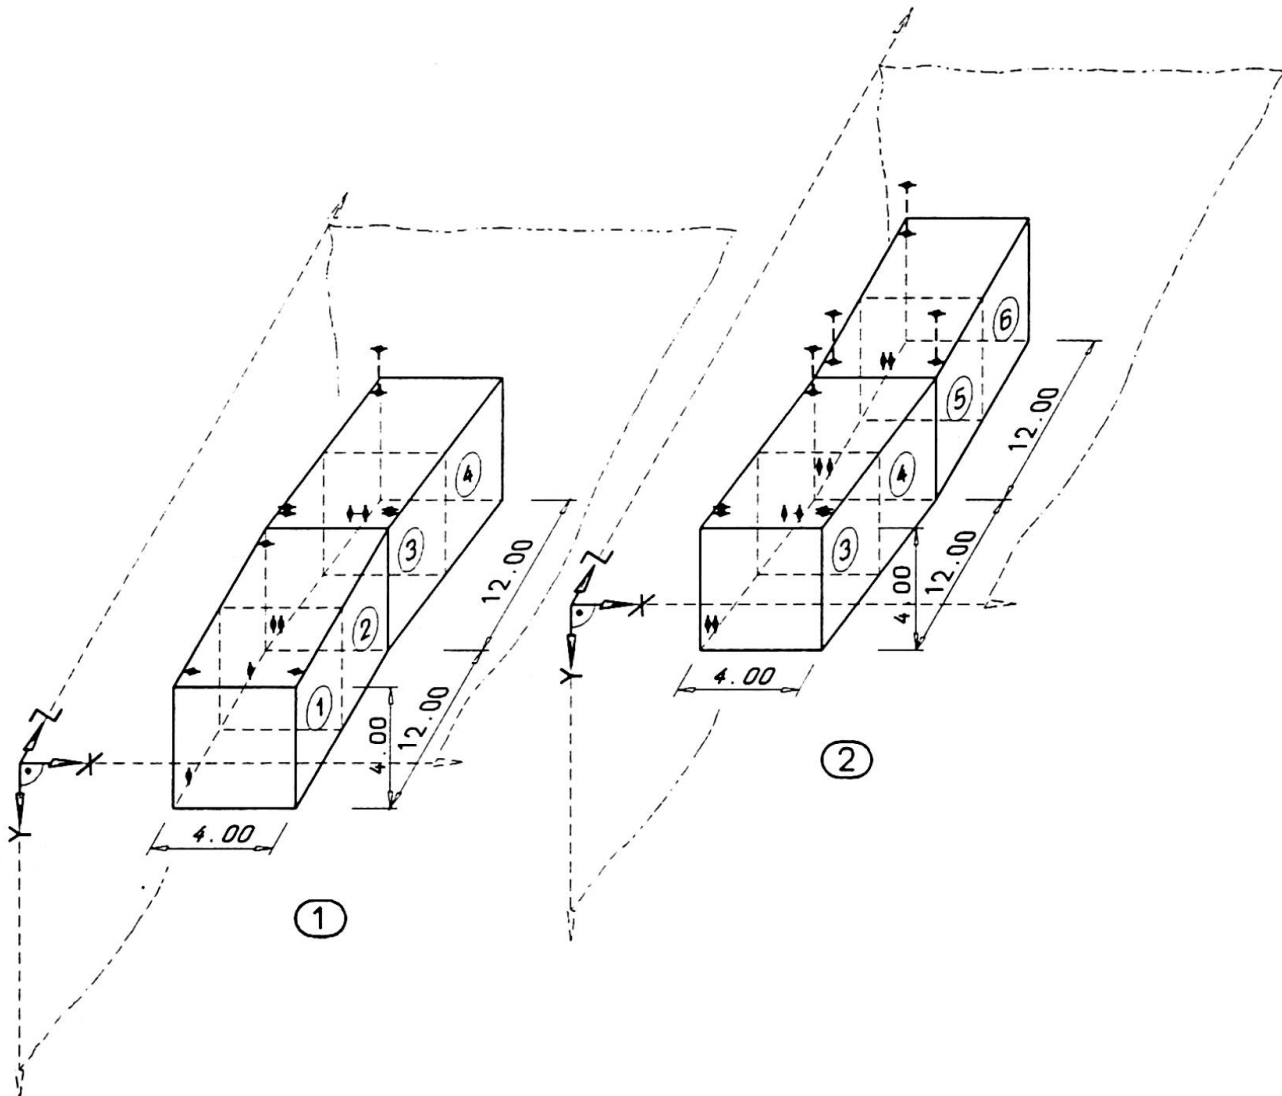
**Fig. 4**

Sequence of control assembly for pylon leg, offsets at boxes 3 + 4 in assembly (1) are identical to offsets at same boxes in assembly (2) achieved by analytical transformation.

Shop floor survey for pylon legs has been executed with 4 sections per assembly horizontally laid out starting with base elements. By removing 2 rear sections and adding 2 sections at the front next assembly configuration was found. In Fig. 4 survey procedure for pylon legs is shown in principle for two subsequent assemblies. With a theodolite two perpendicular optical planes have been established. The intersecting line of these two optical planes represents nominal pylon leg axis. The offsets from the optical planes towards the wallplates of box sections were measured by scale in x-and y-direction. As a result, deviations from the axis were recorded.

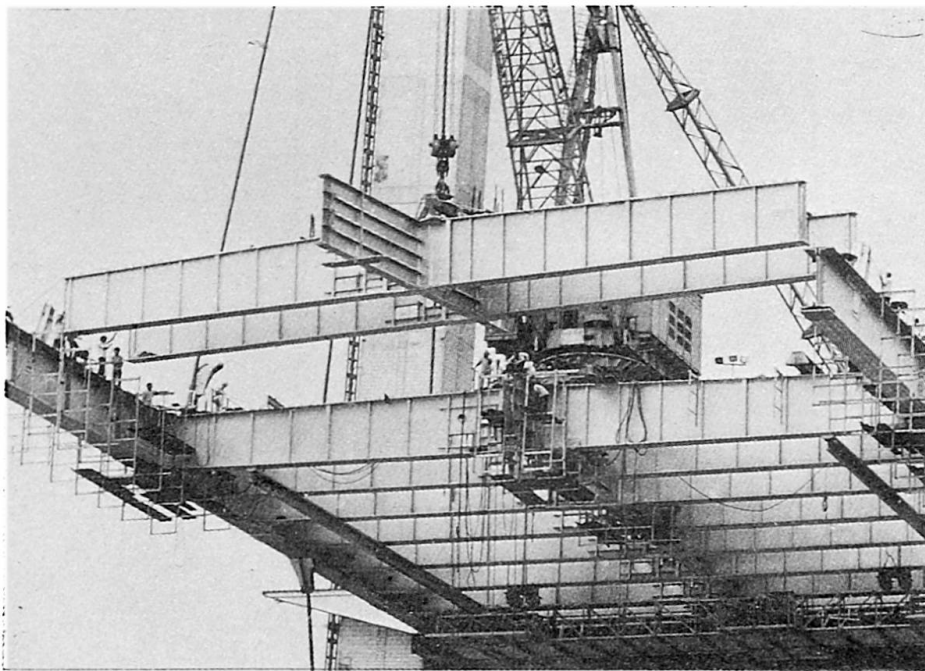
**Fig. 5**

Preassembly of middle girder and 4 cross girders being lifted. Both main girders are already in final position.
