Artikel: Investigations concerning the co-operation of old and newly added concrete structural parts
Autor: Pogany, Adalbert
DOI: <https://doi.org/10.5169/seals-9711>

Investigations concerning the co-operation of old and newly added concrete structural parts

Ing. ADALBERT POGANY, Cracow.

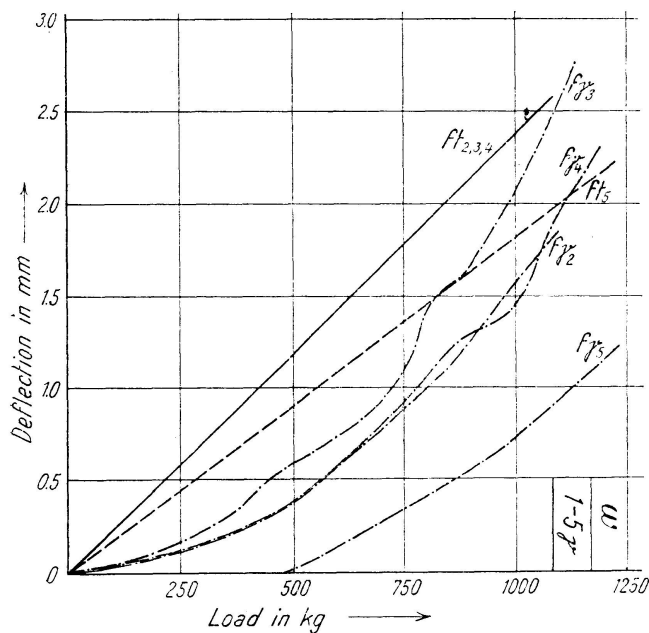
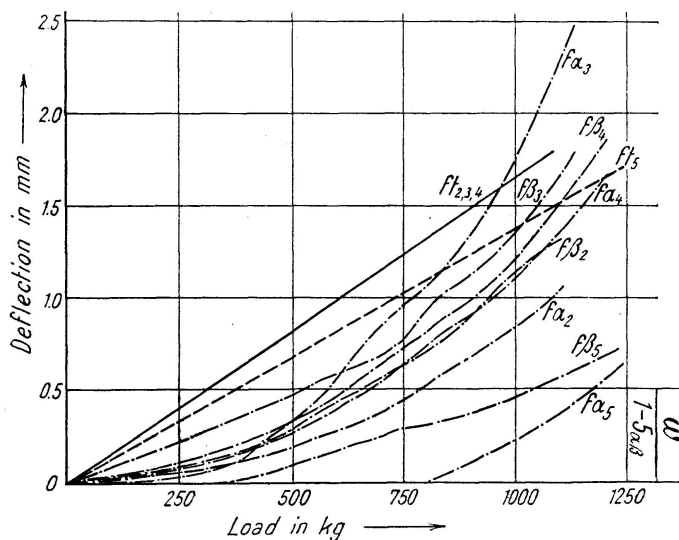
Comparison of the deflection

In the 6 graphic schedules three demonstrate the deflexion of the girders at the points α and β , also at points where the symmetric loads have their effects; the other three demonstrate the deflexion of the girders at the central points. On each schedule 5 girders of equal reinforcement are dealt with. One of them is homogeneously built of concrete, the four others in partly

new and partly old concrete with junctions at a different distance. For each of the groups the theoretical deflexion-line was calculated and traced out. It is known that the deflexion-line of a certain point is a straight one, i.e. that the deflexion of a point is theoretically proportional to the load. In practice there generally is a great discrepancy concerning this linear relation. The deflexion-lines for the points α and β should be theoretically the same. But this is not so, not even if homogeneously built. The disparity of deflexion is probably due to structural want of symmetry. The deflexion-lines of the points α and β and the deflexion-line of the point γ are not parallel. The γ lines generally are steeper, the moment and stress greater, the fractures show earlier and the deflexion-line reaches earlier the plastic sphere than at α and β -lines.

On a plain girder there is generally (but not always) the smallest deflexion to be seen. The cracks in it are nearly always later shown and the plastic sphere is reached at the latest time.

The deflexion-lines of the girders newly joined with concrete, are variable and more sensitive. They have not the same slightly parabolic character as those of the plain girders. One has the feeling as if on the newly joined parts on the deflexion internal stretchings are levelled down in wave-like step, similar to the re-crystallization of cast-iron bars. The concrete girders built in two stages which, as above mentioned, reach the plastic sphere earlier, have a smaller load capacity.

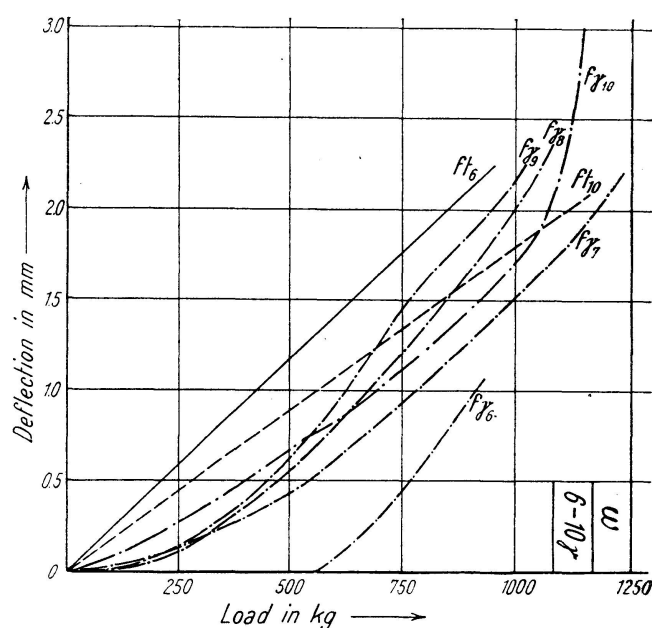
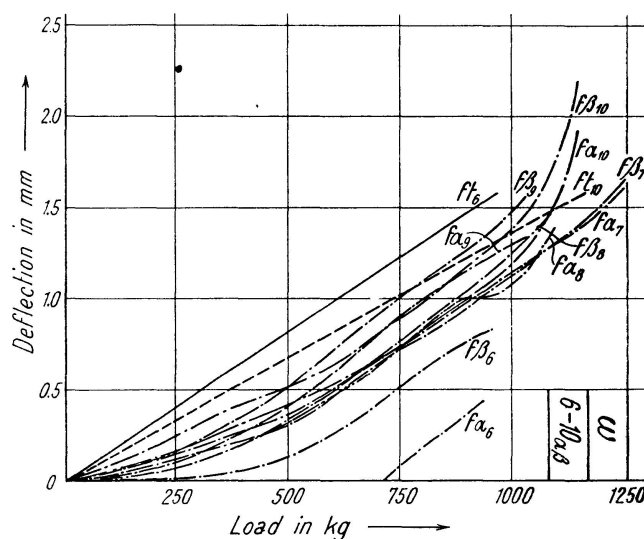
crete. The biggest differences generally are in the smallest deflexions and slowly diminish in the plastic sphere. The analysis of the curve-lines of the girders No. 16 to 19 confirm the result obtained of the deflexion-line. It is clear also here that the reinforcement works even under a smaller load already in the plastic sphere, thus explaining the early proceeding of cracks in the concrete. The E -curve-line of girder No. 20 (one part concrete-addition to new reinforcement) is also traced out concerning the smaller sphere of load and shows in the sphere of initial loading very big values. Loading of about 600 kg (1323 lb.) causes a very big change of deformation. On the girder built of two part concrete the first part of the deformation of the E -curve-line with its steep branches could not be established.

There were nearly no cracks at the joints.
