Artikel: Tests on a model composite bridge girder

Tests on a Model Composite Bridge Girder

The testing of the composite girder described in this paper was part of a programme of model studies and tests carried out in the design stages of the Tay Road Bridge project. The model studies were concerned with the effects of the bridge piers on the movement of river bed material, the evaluation of wind forces on the superstructure and the structural behaviour of the composite box girders.

The main test in the third part of these studies was carried out on a quarter scale model 45 feet span and is discussed in this paper.

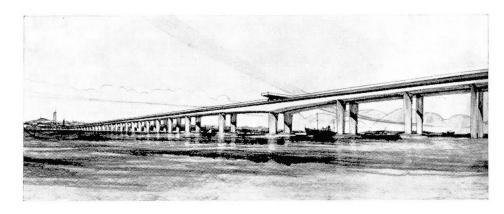
The bridge is at present under construction and will provide a dual carriageway 1.4 miles long across the Firth of Tay in Scotland. An artist's impression of the bridge is shown in Fig. 1. Each span consists of a pair of welded steel box girders spaced 20 feet apart and braced together at the ends and 1/3rd points. On top of each girder is cast a reinforced concrete slab to carry a two-lane carriageway, connected to the box by stud welded shear connectors. The superstructure is carried on reinforced concrete columns which rise to a maximum of 104 feet above the water level.

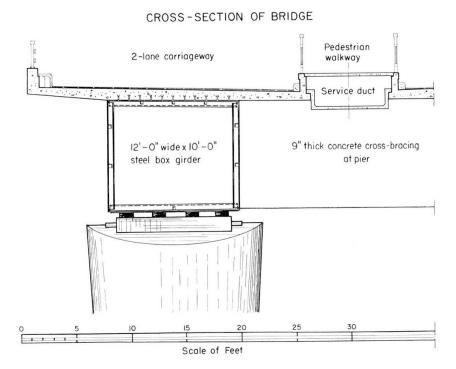
The bridge has 42 spans, 31 of which are 180 feet long so that this span was chosen as the basis for model tests and is shown in Fig. 2. The girder is of composite construction, the connection of the slab to the steel box being made

by 1300 stud welded $^3/_4$ in. dia. shear connectors. The tension flange is of high yield stress steel to B.S. 968 (1962) and all other parts are of normal structural mild steel. The steel end plates of each girder are set back from the extreme ends to allow the casting of a $10^1/_2$ inch thick reinforced concrete end wall in the space between the projecting ends of the webs and the lower flange. This detail is used to provide an economic form of stiffening over the points of support and at the same time to avoid the painting of closely spaced girder end plates. The cross bracings between the girders at the ends are 9 inch reinforced concrete walls, while those at the third points are 2 ft. 6 in. wide by 9 ft. deep steel box sections attached by high strength friction grip bolts. All stiffening of the box girder plating is internal using an orthogonal system of toe welded angles which are proportioned to the requirements of B.S. 153 Part 4 (1958). Before erection an 8 inch reinforced concrete slab is cast over the full width of the flange plate, this reduced composite section therefore carrying the full dead load.

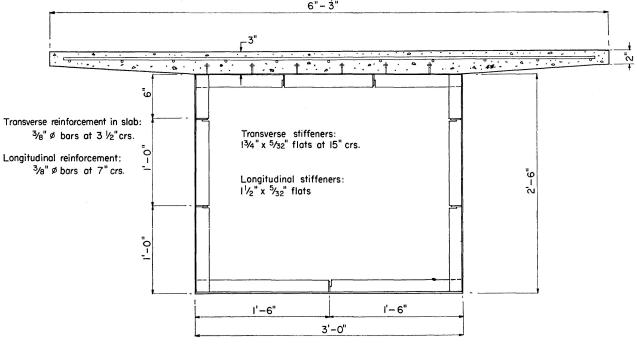
Fig. 3.

Model Girder (Fig. 3)

The scale selected was 1:4 which produced the largest span (45 feet) which could be accommodated on the test bed. A smaller scale would have increased the difficulties of welding thin plates and casting thin concrete slabs.

Since the correct thickness is not rolled, plates nominally 0.099 in. were used instead of the correct $^3/_{32}$ in. and all other thicknesses were taken from the nearest "Birmingham Sheet Gauge" sizes. There was considerable variation in plate thickness within each plate of the same order as the difference between the correct scale thickness and that actually used. To simulate angle stiffeners to scale flats were used having the same outstand and second moment of area about their junction with the web. The shear connection was by standard screwed studs $^3/_{16}$ in. dia. fitted with nuts after welding. The concrete deck slab and area of reinforcement were reduced accurately to scale with the exception that the edge kerbs were omitted. The maximum aggregate size used was $^3/_{8}$ in.

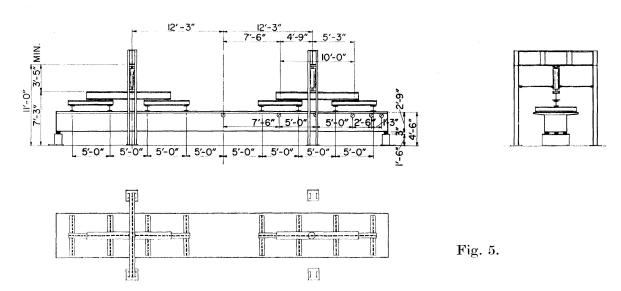
• Fig. 5 shows the general arrangement of the loading system to represent U.D.L., the detail dimensions being dictated by the details of the test floor in the laboratory. A clear space of 10 feet was left in the centre of the span to accommodate the local concentrated load. It will be noticed that the eight load points are not equally loaded but the shear and moment diagrams shown in Fig. 6 are not significantly affected in shape. Load was supplied by two "Losenhausen" hydraulic jacks of the packless type driven from a hydraulic pump system which supplied both static and pulsating loads.

Relative movement, or slip, between the concrete deck and the steel box was checked by $26^{1}/_{1000}$ in., dial gauges positioned as in Fig. 5 and held in position as in Fig. 9.

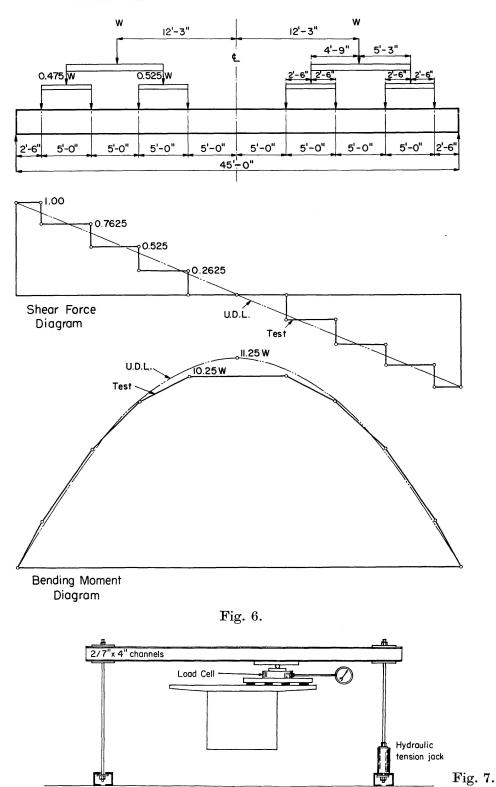
A general arrangement of the concentrated loading (H.B. type to B.S. 153) is shown in Fig. 7 the wheel contact areas being simulated by $^1/_2$ in. thick rubber pads cut to scale size and loaded through a 1 in. thick steel plate. For the "H.B." loadings the load was measured directly by a resistance gauge load cell.

Tests were made on the off-centre load effects by simulating one bogie of the H.B. loading as shown already in Fig. 7. This loading was applied on the "slow" lane both at the centre of the span and at the third point. Differential movement of the two girders was simulated by providing elastic supports at the connecting diaphragms, Fig. 23 and applying the usual central loading to the girder.

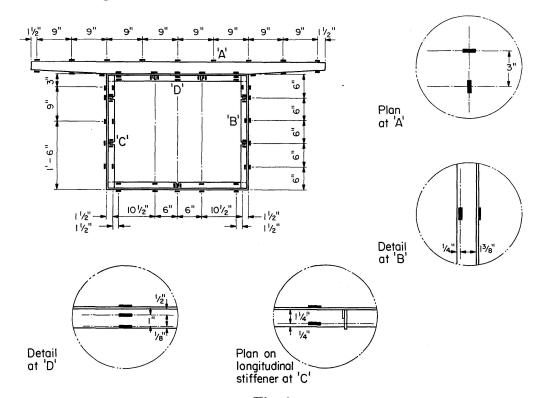
The positions of the strain gauges at the centre cross-section discussed in this paper are shown in Fig. 8.

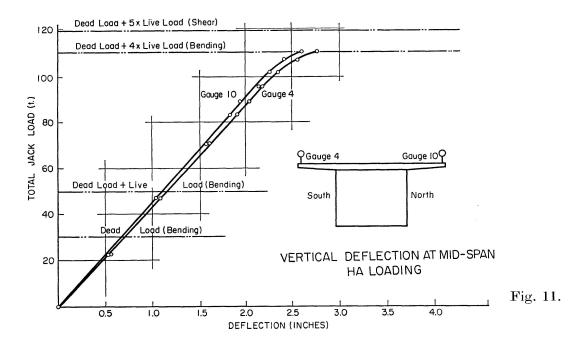
Deflections of the centre of the span during the loading to 117 t are shown in Fig. 11. There is no significant twist and the behaviour is linear up to 90 t total jack load indicating an effective moment of inertia of about 7,050 in.⁴ (steel units). It is shown below that all stresses are well below the yield stress of the steel at this stage and as the slip gauges show negligible loss of bond this departure from linearity is probably due to the effects of web deformations. The web finally failed at the corner which would show a larger movement of deflection gauge 4 as in Fig. 11.

Calculation of the probable deflection due to the shear stresses in the web shows that shear accounts for about 8% of the total deflection and this has been allowed for in the above calculation of I.

Deflections with the concentrated "H.B." load at mid span give an effective "I" value of 7,700 in.⁴.

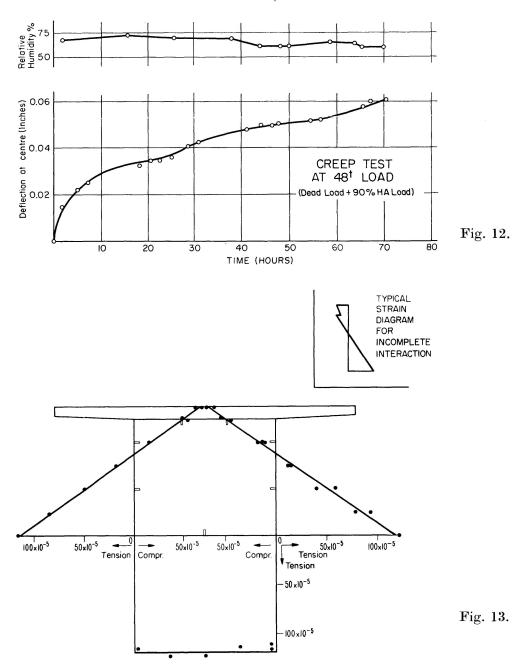
The strain distribution at the central cross-section, Fig. 13, is well defined. From these strains and the measured neutral axis depth and assuming complete interaction between concrete and steel I is calculated to be 7,330 in.⁴

The observed neutral axis depth with I = 7,330 in.⁴ corresponds to a reduction of about 10% in the axial compression in the deck slab and the strain distribution must have been of the form shown in the inset in Fig. 13.

showing a modular ratio of 8. However, this value of the modular ratio gives a neutral axis depth of 6.5 in. whereas the measured depth is 9 in. below the top of the steel. Hence it is apparent that full interaction is not realised although the relative movement of slab and box was not measurable with the $^{1}/_{1000}$ in. slip gauges.

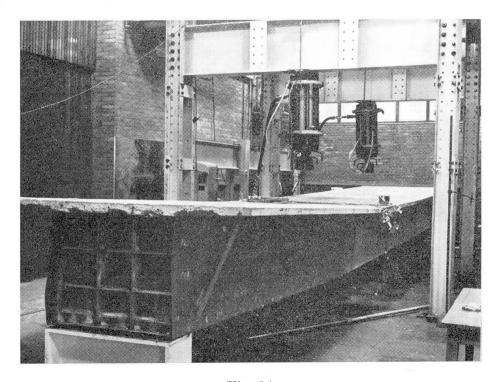
After the model had failed in the second main test by web buckling the first 8 feet of the girder was cut off and a new steel bulkhead welded into the open end, Fig. 14. In order to prevent a second failure by buckling diagonal angle stiffeners were welded to the outside of all four end panels.

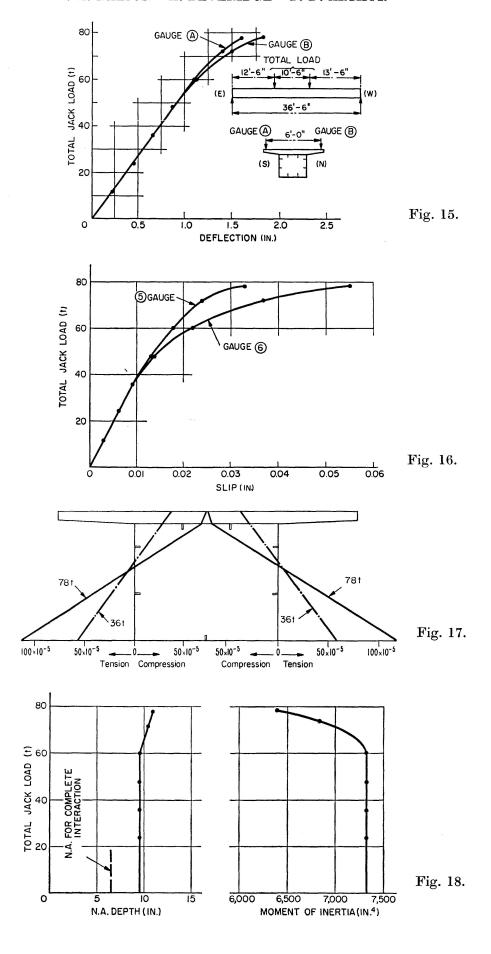
The model was set up again but loaded with two equal point loads applied to the slab through 12 in. × 12 in. B. F. Bs. across the full width of the deck slab. Due to the test floor anchorages this loading could not be symmetrical. Deflection and slip gauge readings for this repeat loading are shown in Figs. 15 and 16.

Strain measurements at loads below 60 t showed that the neutral axis depth was 9.5 in. from the top of the steel box, which corresponds to about 90% interaction. At loads above 60 t the neutral axis depth increased until just before failure at 78 t it reached 10.8 in. indicating a further reduction in the interaction. The values of I calculated from the measured strains altered from 7330 in.⁴ at 60 t to 6400 in.⁴ at 78 t and from deflection readings was 6550 in.⁴. Fig. 17 shows the strain distributions at 36 t and at 78 t and Fig. 18 shows the variation of neutral axis depth and I value with the load.

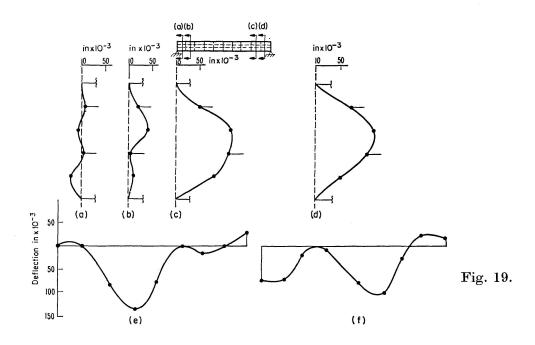
A preliminary survey of the web profile is shown in Fig. 19 which indicates

in (a), (b), (c) and (d) the vertical profiles near the centre of the end two panels at opposite ends of the girder. Fig. 19 (e) and (f) give the same data for horizontal profiles near the centre of the web depth. There was no convenient way of establishing a base for these horizontal profiles to show any initial bend of the stiffener but in the vertical direction at the east end, Figs. 19 (c) and (d), the marked bulge of the complete web and stiffener assembly is obvious. Failure occurred at this end preceded by large overall bulging as well as deflections of the web plate within the stiffener panels.

The plate bulges are of the order of 0.60 to 1.35 times the plate thickness. Additional deflections of the web were recorded during loading, Fig. 20, but

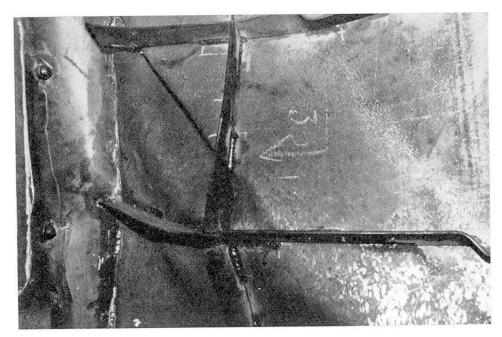
Fig. 22.

The inside of the panel after collapse is shown in Fig. 22 and clearly shows

the overall bending and the tear of the joint in the vertical stiffener. The ultimate strength of the model girder depended entirely on the presence and magnification of this large initial bend of the complete web-stiffener assembly at one corner.

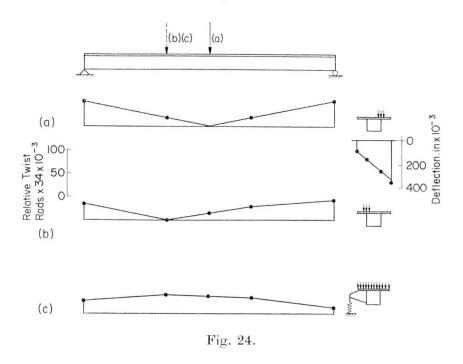
The differential deflection between the edges of the box section is a measure of the torsional twist and Fig. 24 shows the values from which the effective torsional stiffness is calculated as follows

Fig. 24 (a) and (b) off-centre loads: J = 1600 in.⁴; Fig. 24 (c) differential movt.: J = 5700 in.⁴, calculation (m = 10): J = 5220 in.⁴.

It is difficult to account analytically for the very low value obtained from the off-centre load case. Strain measurements in Fig. 25 show clearly a sway or racking near the concentrated load which would be interpreted as an appreciable reduction in the effective torsion stiffness.
