Artikel: Tests on a model composite bridge girder
Autor: Nelson, H.M. / Beveridge, A. / Arthur, P.D.
DOI: <https://doi.org/10.5169/seals-19406>

Tests on a Model Composite Bridge Girder

The testing of the composite girder described in this paper was part of a programme of model studies and tests carried out in the design stages of the Tay Road Bridge project. The model studies were concerned with the effects of the bridge piers on the movement of river bed material, the evaluation of wind forces on the superstructure and the structural behaviour of the composite box girders.

The main test in the third part of these studies was carried out on a quarter scale model 45 feet span and is discussed in this paper.

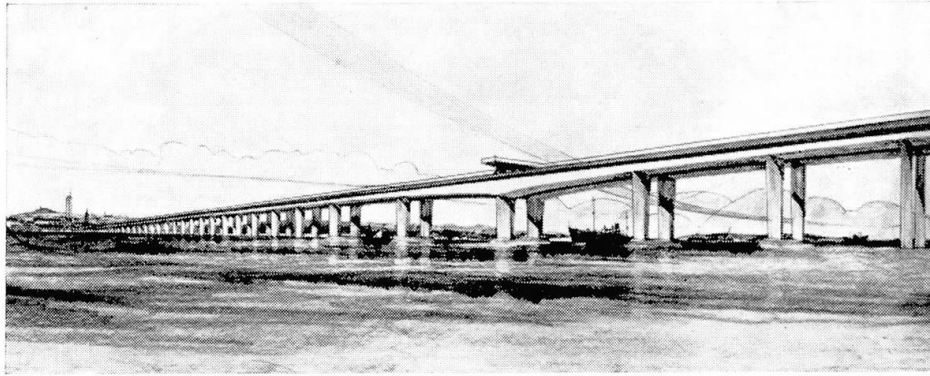
The bridge is at present under construction and will provide a dual carriageway 1.4 miles long across the Firth of Tay in Scotland. An artist's impression of the bridge is shown in Fig. 1. Each span consists of a pair of welded steel box girders spaced 20 feet apart and braced together at the ends and 1/3rd points. On top of each girder is cast a reinforced concrete slab to carry a two-lane carriageway, connected to the box by stud welded shear connectors. The superstructure is carried on reinforced concrete columns which rise to a maximum of 104 feet above the water level.

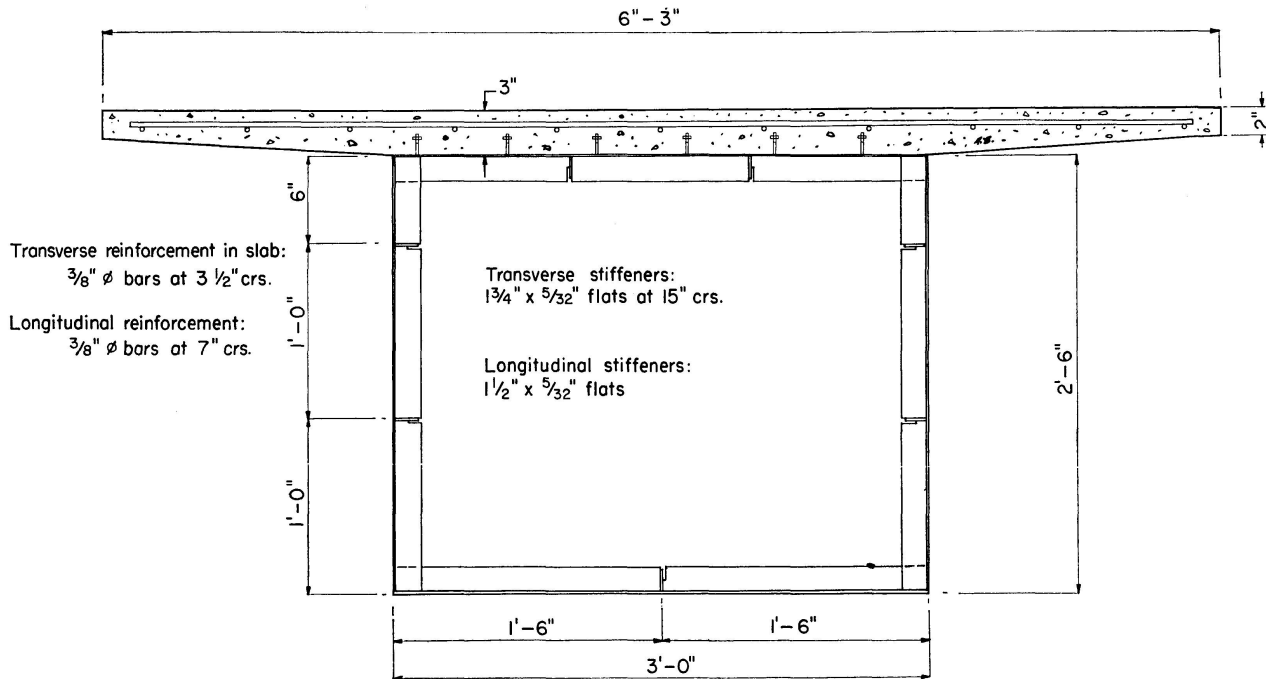
Fig. 3.

Model Girder (Fig. 3)

The scale selected was 1 : 4 which produced the largest span (45 feet) which could be accommodated on the test bed. A smaller scale would have increased the difficulties of welding thin plates and casting thin concrete slabs.

Since the correct thickness is not rolled, plates nominally 0.099 in. were used instead of the correct $3/32$ in. and all other thicknesses were taken from the nearest "Birmingham Sheet Gauge" sizes. There was considerable variation in plate thickness within each plate of the same order as the difference between the correct scale thickness and that actually used. To simulate angle stiffeners to scale flats were used having the same outstand and second moment of area about their junction with the web. The shear connection was by standard screwed studs $3/16$ in. dia. fitted with nuts after welding. The concrete deck slab and area of reinforcement were reduced accurately to scale with the exception that the edge kerbs were omitted. The maximum aggregate size used was $3/8$ in.

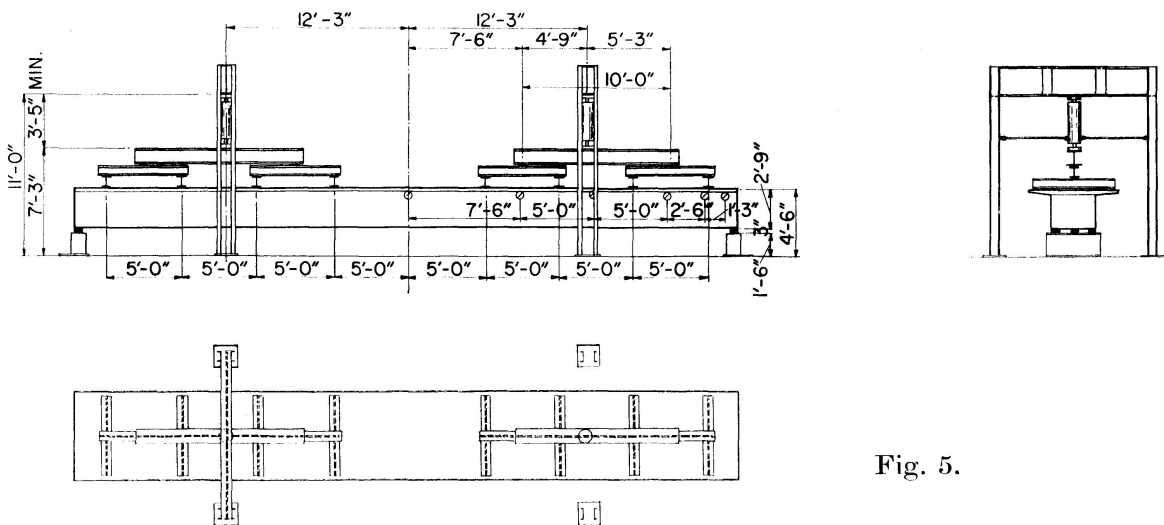
Fig. 5.

Fig. 5 shows the general arrangement of the loading system to represent U.D.L., the detail dimensions being dictated by the details of the test floor in the laboratory. A clear space of 10 feet was left in the centre of the span to accommodate the local concentrated load. It will be noticed that the eight load points are not equally loaded but the shear and moment diagrams shown in Fig. 6 are not significantly affected in shape. Load was supplied by two "Losenhausen" hydraulic jacks of the packless type driven from a hydraulic pump system which supplied both static and pulsating loads.

Relative movement, or slip, between the concrete deck and the steel box was checked by $26\frac{1}{1000}$ in., dial gauges positioned as in Fig. 5 and held in position as in Fig. 9.

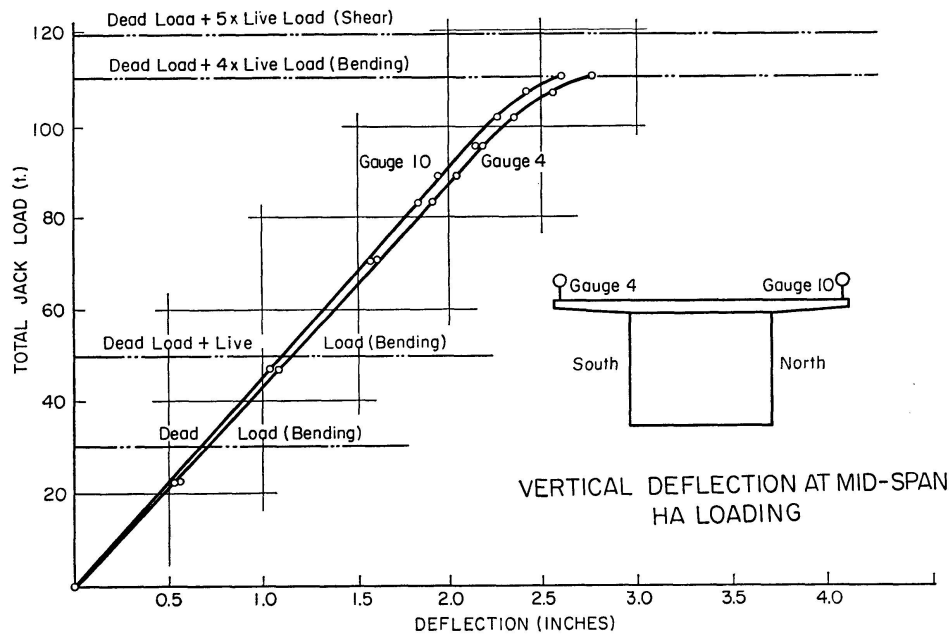
Deflections of the centre of the span during the loading to 117 t are shown in Fig. 11. There is no significant twist and the behaviour is linear up to 90 t total jack load indicating an effective moment of inertia of about 7,050 in.⁴ (steel units). It is shown below that all stresses are well below the yield stress of the steel at this stage and as the slip gauges show negligible loss of bond this departure from linearity is probably due to the effects of web deformations. The web finally failed at the corner which would show a larger movement of deflection gauge 4 as in Fig. 11.

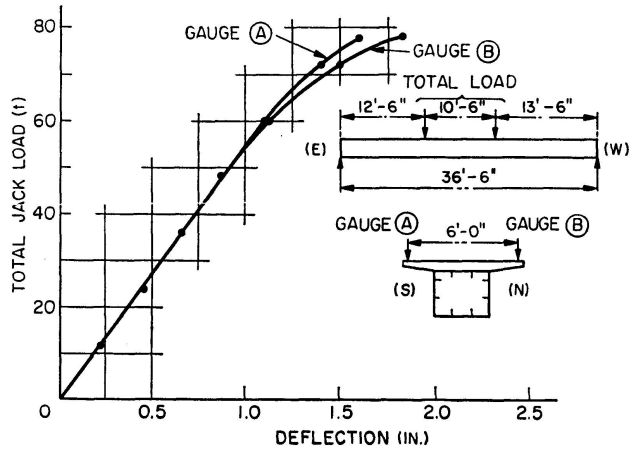
Fig. 15.

The model was set up again but loaded with two equal point loads applied to the slab through 12 in. \times 12 in. B.F.Bs. across the full width of the deck slab. Due to the test floor anchorages this loading could not be symmetrical. Deflection and slip gauge readings for this repeat loading are shown in Figs. 15 and 16.

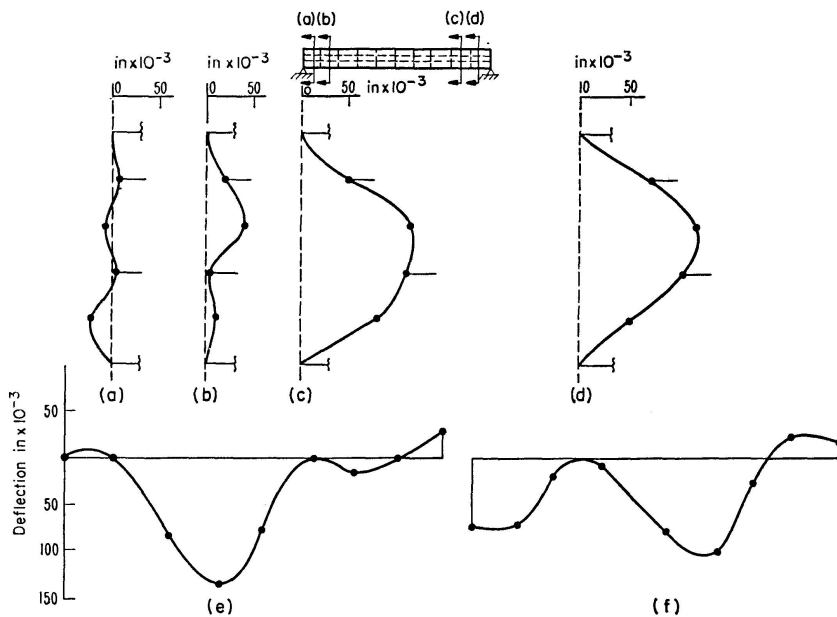
Fig. 19.

A preliminary survey of the web profile is shown in Fig. 19 which indicates

in (a), (b), (c) and (d) the vertical profiles near the centre of the end two panels at opposite ends of the girder. Fig. 19 (e) and (f) give the same data for horizontal profiles near the centre of the web depth. There was no convenient way of establishing a base for these horizontal profiles to show any initial bend of the stiffener but in the vertical direction at the east end, Figs. 19 (c) and (d), the marked bulge of the complete web and stiffener assembly is obvious. Failure occurred at this end preceded by large overall bulging as well as deflections of the web plate within the stiffener panels.

The plate bulges are of the order of 0.60 to 1.35 times the plate thickness. Additional deflections of the web were recorded during loading, Fig. 20, but

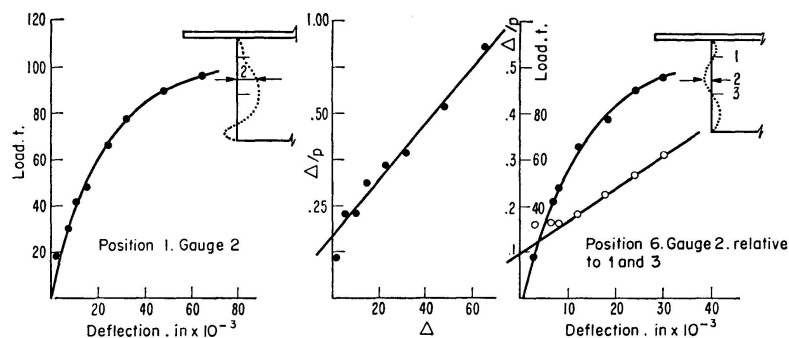
Fig. 20.

are so small compared to the initial values that SOUTHWELL'S [2] method for estimating the buckling load was not reliable. However the results selected and shown in Fig. 20 do indicate a critical load to be of the order of 140 t. It is to be noted that the curves plotted for point 2, in Fig. 20 include the overall deflection of the stiffener assembly. This compares with the theoretical value for a simply supported panel buckling in shear of 167 t.

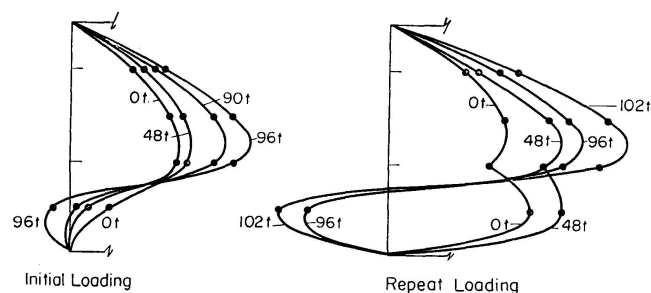
Fig. 21.

The critical features of the test are clearly shown by the movements of the gauges in Fig. 21 which show the increase in overall bulging and of deflection at gauge 4 up to a load of 96 t.

After the weld failure at 102 t there was a large permanent buckle at gauge 4 which was hammered in after the girder had been repaired. The plate profile under the repeat loading shows the return of this bulge after 72 t. At 90 t the buckles in this panel were obvious to the eye and final collapse occurred at a load of 117 t.

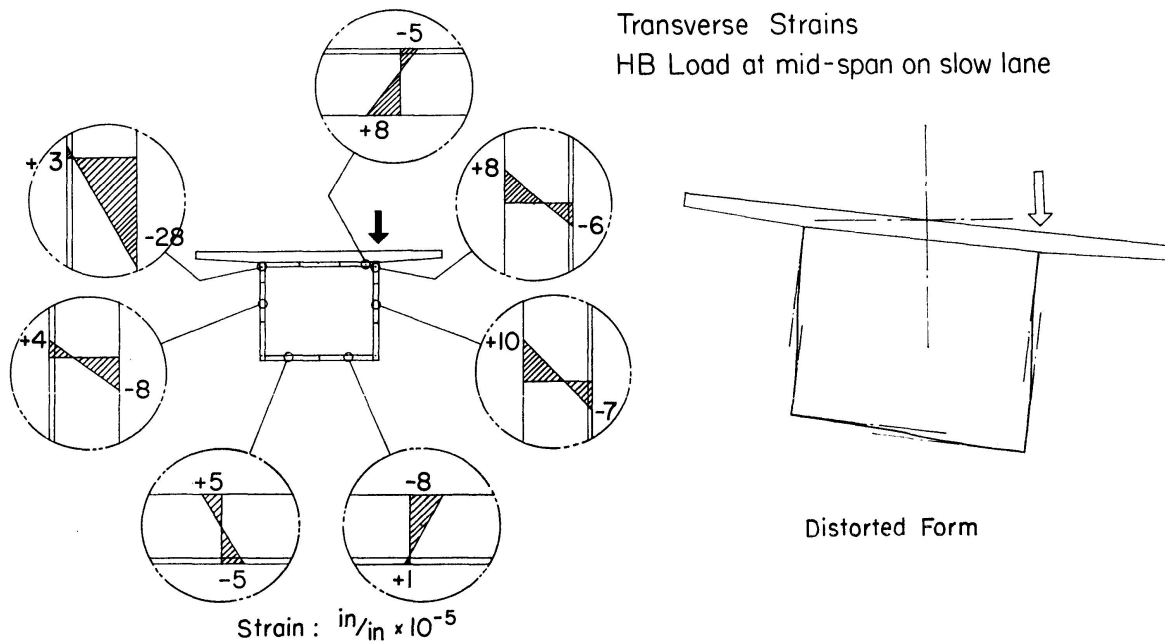
Fig. 25.

It is difficult to account analytically for the very low value obtained from the off-centre load case. Strain measurements in Fig. 25 show clearly a sway

or racking near the concentrated load which would be interpreted as an appreciable reduction in the effective torsion stiffness.
