Artikel: Tests on a model composite bridge girder
Autor: Nelson, H.M. / Beveridge, A. / Arthur, P.D.
DOI: <https://doi.org/10.5169/seals-19406>

Tests on a Model Composite Bridge Girder

H. M. NELSON
B. Sc., A.R.C.S.T.,
A.M.I.C.E.
Glasgow University

The testing of the composite girder described in this paper was part of a programme of model studies and tests carried out in the design stages of the Tay Road Bridge project. The model studies were concerned with the effects of the bridge piers on the movement of river bed material, the evaluation of wind forces on the superstructure and the structural behaviour of the composite box girders.

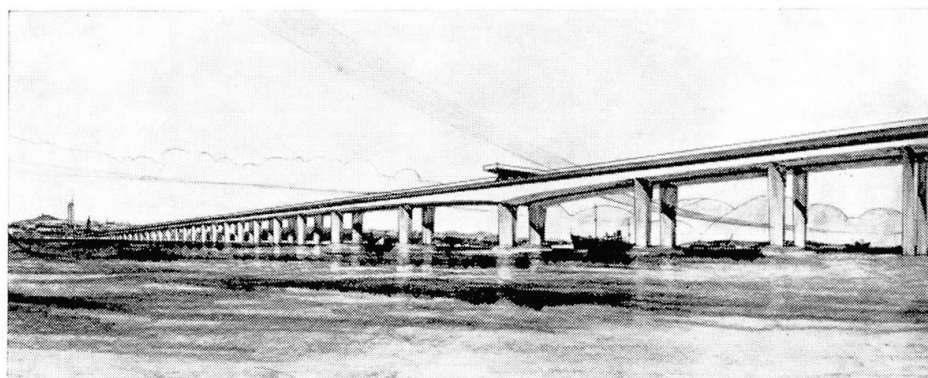
The bridge is at present under construction and will provide a dual carriageway 1.4 miles long across the Firth of Tay in Scotland. An artist's impression of the bridge is shown in Fig. 1. Each span consists of a pair of welded steel box girders spaced 20 feet apart and braced together at the ends and 1/3rd points. On top of each girder is cast a reinforced concrete slab to carry a two-lane carriageway, connected to the box by stud welded shear connectors. The superstructure is carried on reinforced concrete columns which rise to a maximum of 104 feet above the water level.

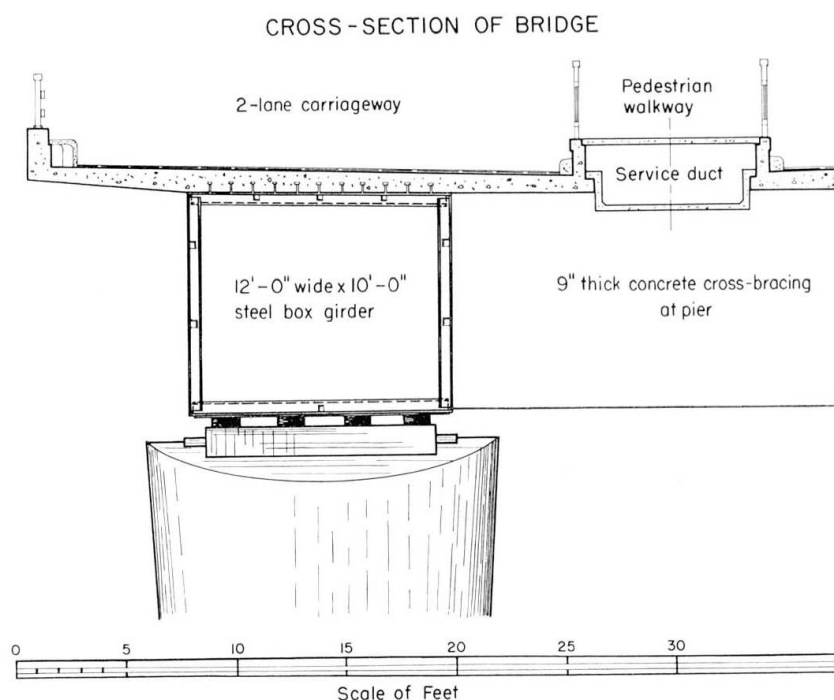
The bridge has 42 spans, 31 of which are 180 feet long so that this span was chosen as the basis for model tests and is shown in Fig. 2. The girder is of composite construction, the connection of the slab to the steel box being made

by 1300 stud welded $\frac{3}{4}$ in. dia. shear connectors. The tension flange is of high yield stress steel to B.S. 968 (1962) and all other parts are of normal structural mild steel. The steel end plates of each girder are set back from the extreme ends to allow the casting of a $10\frac{1}{2}$ inch thick reinforced concrete end wall in the space between the projecting ends of the webs and the lower flange. This detail is used to provide an economic form of stiffening over the points of support and at the same time to avoid the painting of closely spaced girder end plates. The cross bracings between the girders at the ends are 9 inch reinforced concrete walls, while those at the third points are 2 ft. 6 in. wide by 9 ft. deep steel box sections attached by high strength friction grip bolts. All stiffening of the box girder plating is internal using an orthogonal system of toe welded angles which are proportioned to the requirements of B.S. 153 Part 4 (1958). Before erection an 8 inch reinforced concrete slab is cast over the full width of the flange plate, this reduced composite section therefore carrying the full dead load.

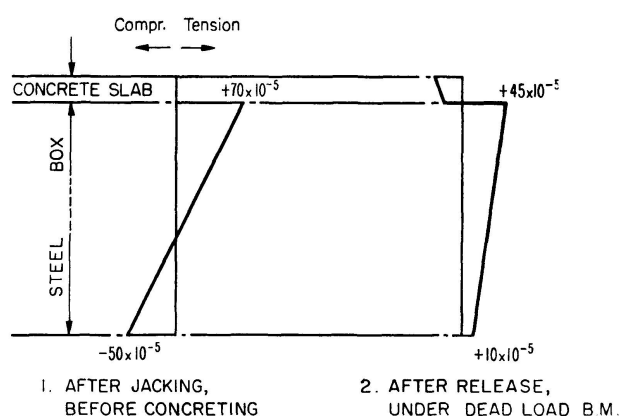
The first stage of the concreting of the full-size girder will be done with the girder supported at its third points so that the concrete will lock in a prestress induced by the dead weight of the steel box. This was accomplished

in the model by anchoring it to the floor at the ends and applying upward jack loads at the $\frac{1}{3}$ points. The jack loads were adjusted to produce a maximum stress of 5 T/in.² in compression in the bottom flange. The concrete was poured in alternate bays approx. 6 ft. long, but the end diaphragms and 2 ft. of the slab at each end were left unconcreted until the internal strain gauging was complete. Immediately after casting, the eight loading beams were bedded on the wet concrete in order to ensure perfect contact when under load.

The girder was set on its bearings 32 days after the first concrete was cast, the strain gauges then showing a tensile stress in the lower flange of 1.3 T/in.² under the dead load of the complete girder and the eight loading beams.

The strains during the various stages of the prestressing operation are shown in Fig. 4.

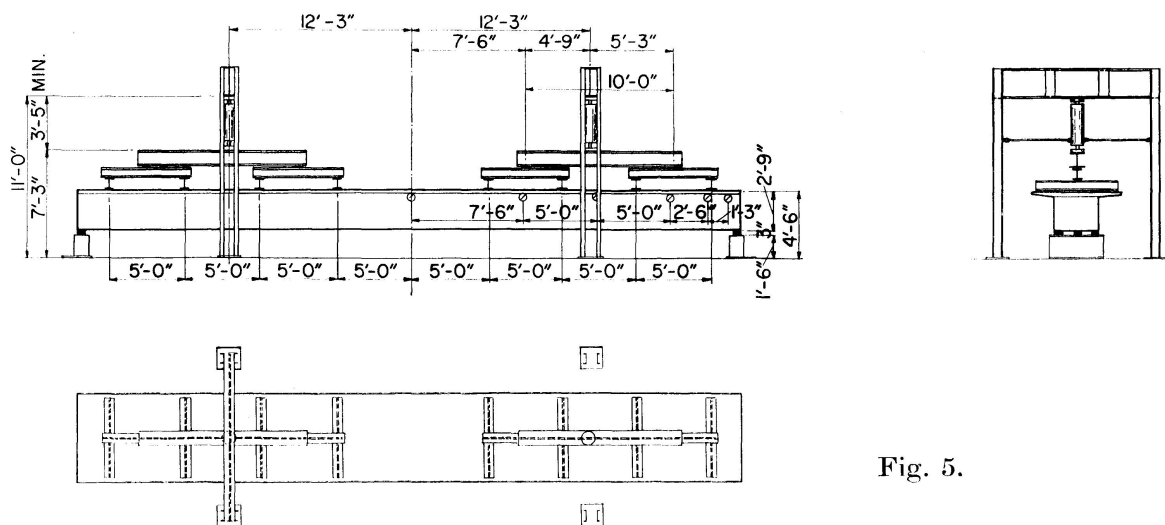
Fig. 5.

Fig. 5 shows the general arrangement of the loading system to represent U.D.L., the detail dimensions being dictated by the details of the test floor in the laboratory. A clear space of 10 feet was left in the centre of the span to accommodate the local concentrated load. It will be noticed that the eight load points are not equally loaded but the shear and moment diagrams shown in Fig. 6 are not significantly affected in shape. Load was supplied by two "Losenhausen" hydraulic jacks of the packless type driven from a hydraulic pump system which supplied both static and pulsating loads.

Relative movement, or slip, between the concrete deck and the steel box was checked by $26\frac{1}{1000}$ in. dial gauges positioned as in Fig. 5 and held in position as in Fig. 9.

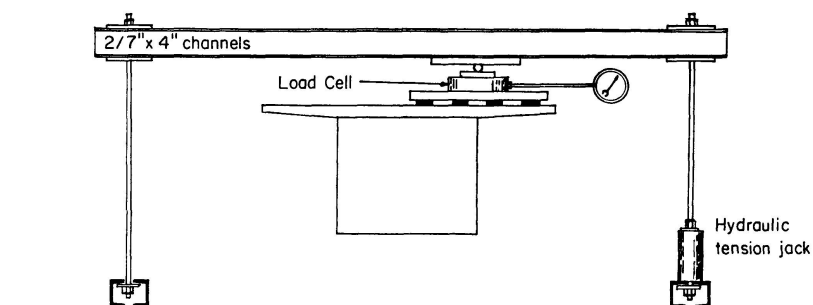
A general arrangement of the concentrated loading (H.B. type to B.S. 153) is shown in Fig. 7 the wheel contact areas being simulated by $\frac{1}{2}$ in. thick rubber pads cut to scale size and loaded through a 1 in. thick steel plate. For the "H.B." loadings the load was measured directly by a resistance gauge load cell.

Tests were made on the off-centre load effects by simulating one bogie of the H.B. loading as shown already in Fig. 7. This loading was applied on the "slow" lane both at the centre of the span and at the third point. Differential movement of the two girders was simulated by providing elastic supports at the connecting diaphragms, Fig. 23 and applying the usual central loading to the girder.

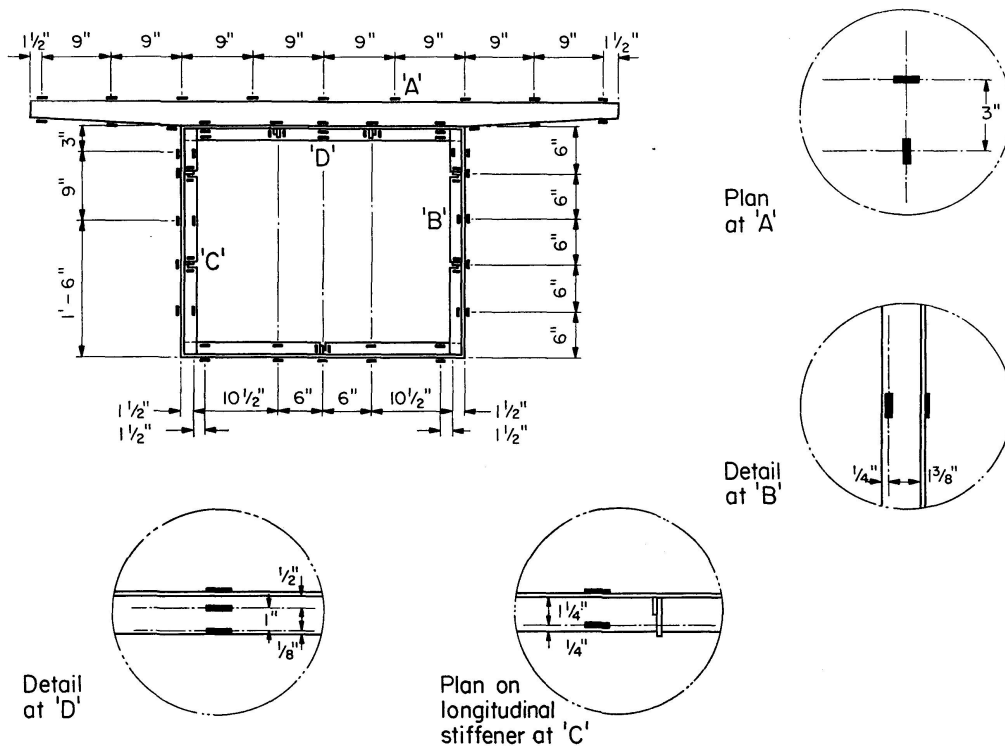
The positions of the strain gauges at the centre cross-section discussed in this paper are shown in Fig. 8.

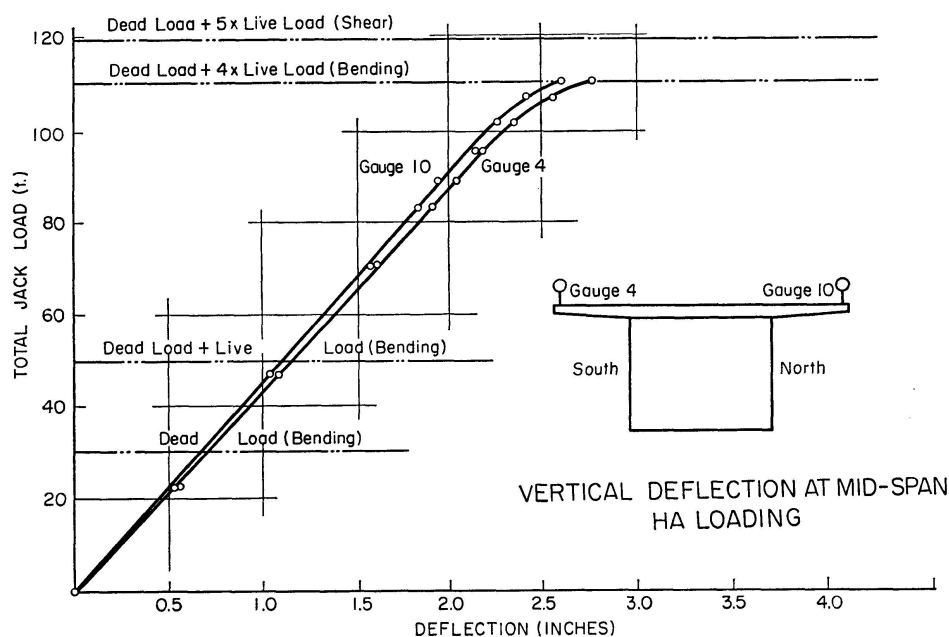
Deflections of the centre of the span during the loading to 117 t are shown in Fig. 11. There is no significant twist and the behaviour is linear up to 90 t total jack load indicating an effective moment of inertia of about $7,050 \text{ in.}^4$ (steel units). It is shown below that all stresses are well below the yield stress of the steel at this stage and as the slip gauges show negligible loss of bond this departure from linearity is probably due to the effects of web deformations. The web finally failed at the corner which would show a larger movement of deflection gauge 4 as in Fig. 11.

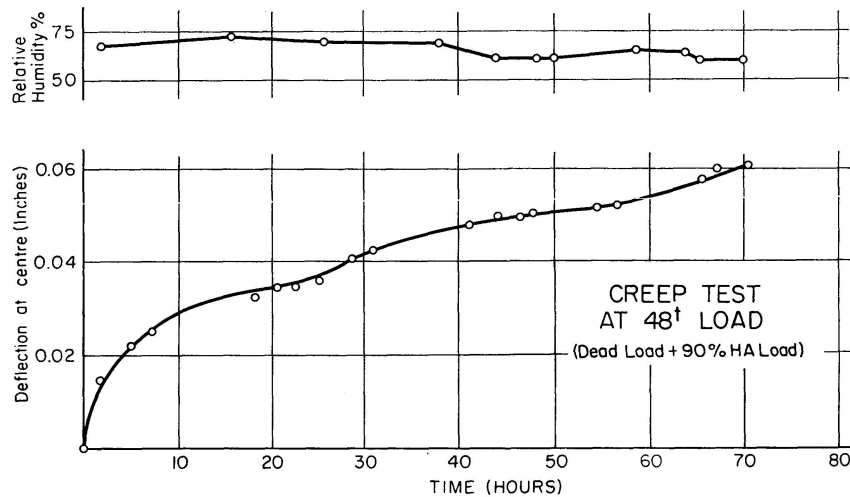
Fig. 12.

The creep of the central deflection during a 71 hour period is shown in Fig. 12, the loading being approximately the full dead plus maximum live load (i. e. 48 t instead of 50 t). Though the curve is not as regular as could be wished there is a marked change in the deflection rate after 5 hours and after 70 hours the deflection is still increasing slowly. At 70 hours a creep deflection reduces the apparent " I " value to 6,200 in.⁴ from 7,050 in.⁴ for the short time loading.

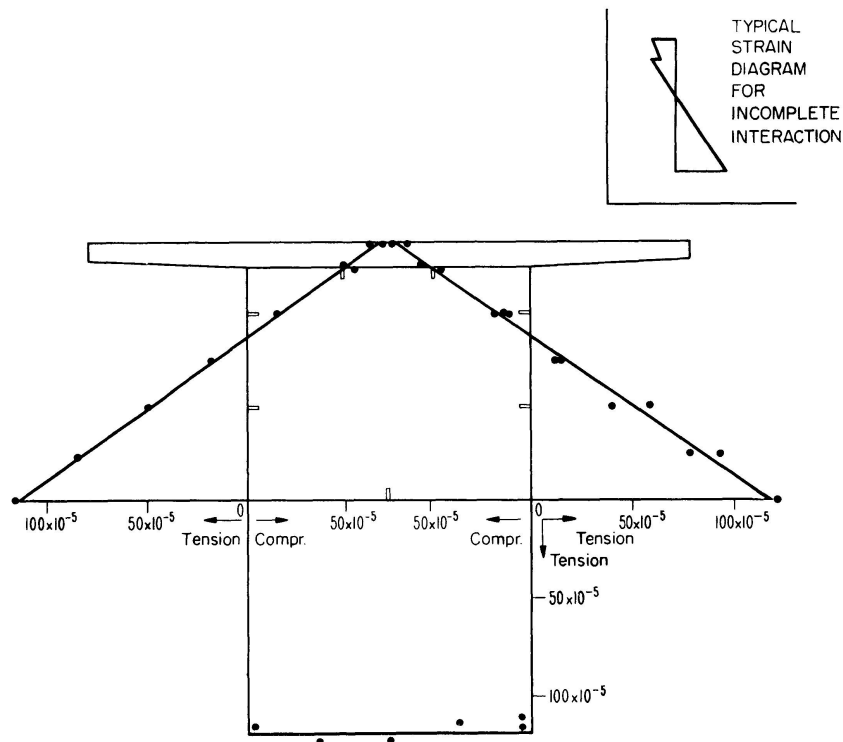
The strain distribution at the central cross-section, Fig. 13, is well defined. From these strains and the measured neutral axis depth and assuming complete interaction between concrete and steel I is calculated to be 7,330 in.⁴

showing a modular ratio of 8. However, this value of the modular ratio gives a neutral axis depth of 6.5 in. whereas the measured depth is 9 in. below the top of the steel. Hence it is apparent that full interaction is not realised although the relative movement of slab and box was not measurable with the $\frac{1}{1000}$ in. slip gauges.

The observed neutral axis depth with $I = 7,330 \text{ in.}^4$ corresponds to a reduction of about 10% in the axial compression in the deck slab and the strain distribution must have been of the form shown in the inset in Fig. 13.

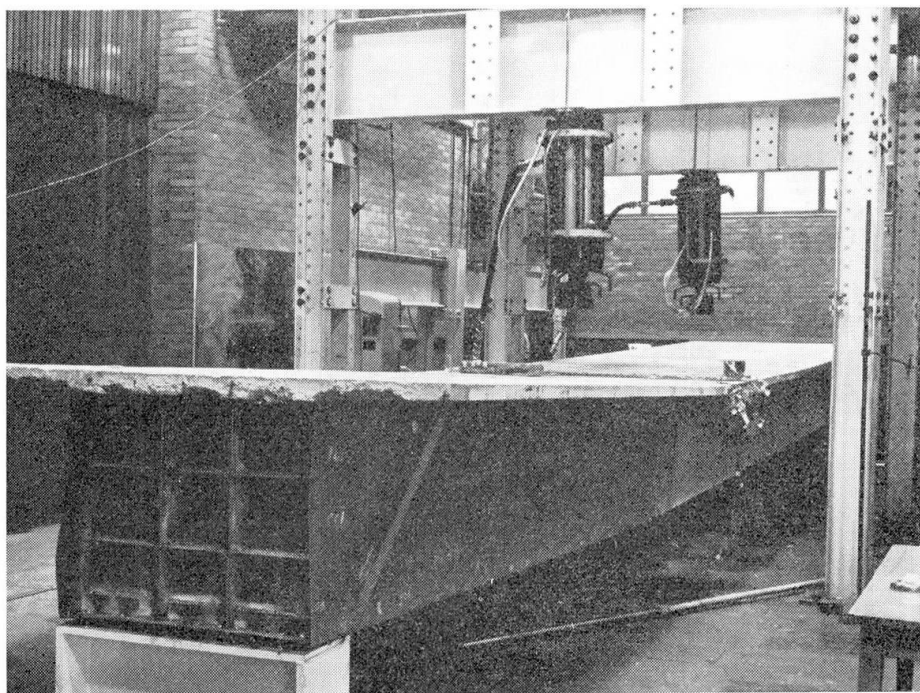
After the model had failed in the second main test by web buckling the first 8 feet of the girder was cut off and a new steel bulkhead welded into the open end, Fig. 14. In order to prevent a second failure by buckling diagonal angle stiffeners were welded to the outside of all four end panels.

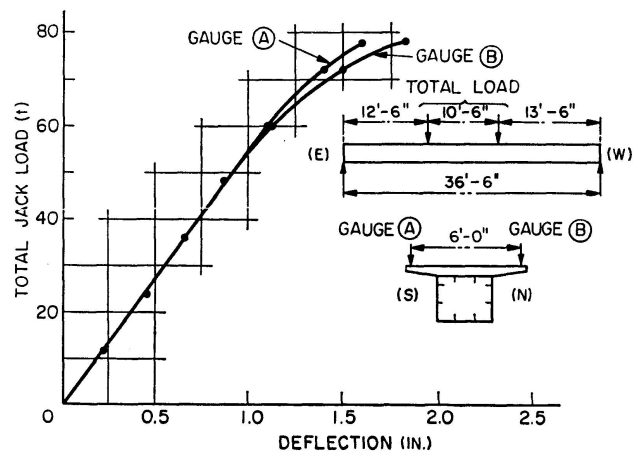
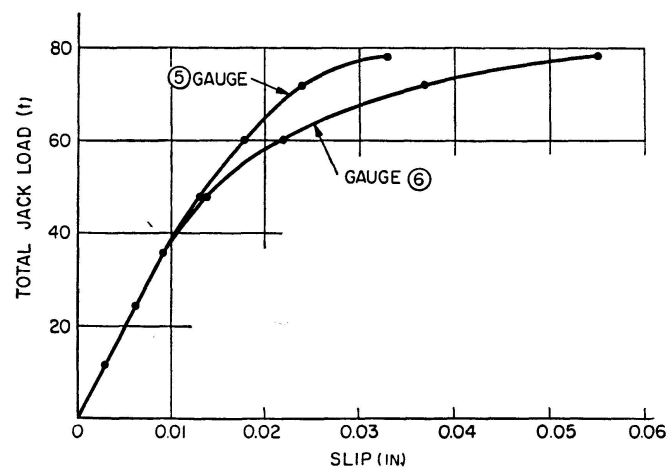
Fig. 15.

The model was set up again but loaded with two equal point loads applied to the slab through 12 in. \times 12 in. B.F.Bs. across the full width of the deck slab. Due to the test floor anchorages this loading could not be symmetrical. Deflection and slip gauge readings for this repeat loading are shown in Figs. 15 and 16.

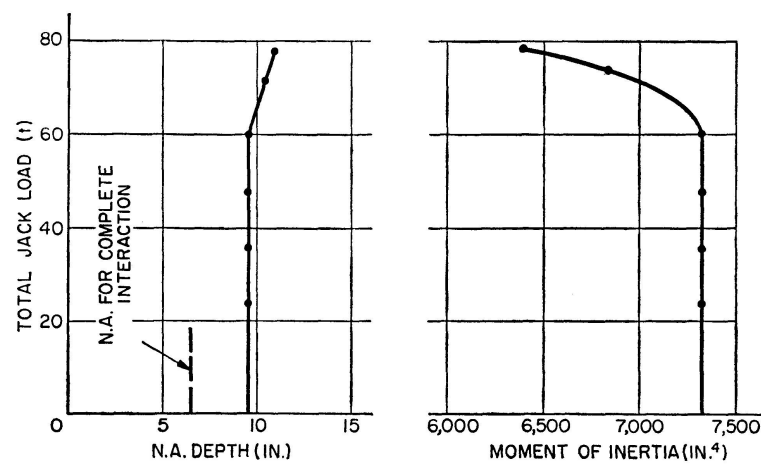
Fig. 18.

Strain measurements at loads below 60 t showed that the neutral axis depth was 9.5 in. from the top of the steel box, which corresponds to about 90% interaction. At loads above 60 t the neutral axis depth increased until just before failure at 78 t it reached 10.8 in. indicating a further reduction in the interaction. The values of I calculated from the measured strains altered from 7330 in.^4 at 60 t to 6400 in.^4 at 78 t and from deflection readings was 6550 in.^4 . Fig. 17 shows the strain distributions at 36 t and at 78 t and Fig. 18 shows the variation of neutral axis depth and I value with the load.

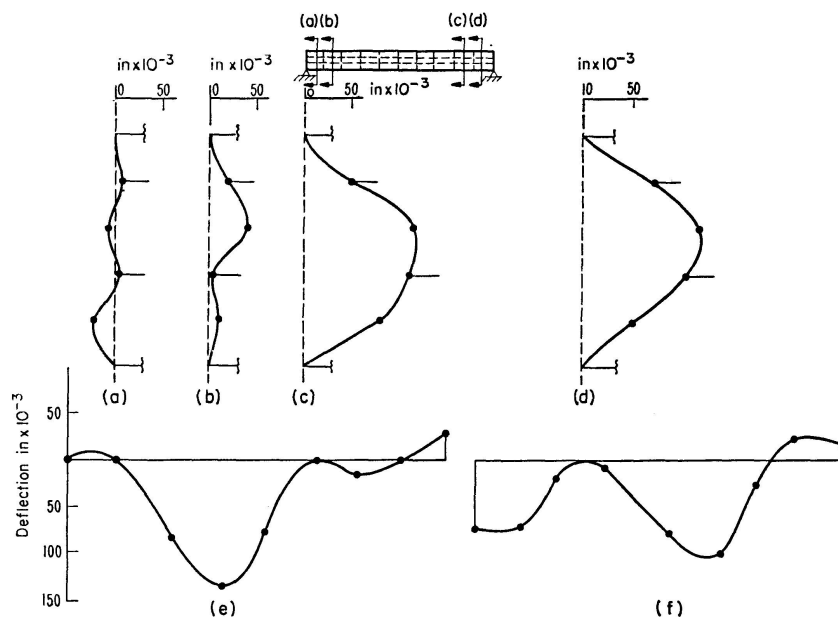
Fig. 19.

A preliminary survey of the web profile is shown in Fig. 19 which indicates

in (a), (b), (c) and (d) the vertical profiles near the centre of the end two panels at opposite ends of the girder. Fig. 19 (e) and (f) give the same data for horizontal profiles near the centre of the web depth. There was no convenient way of establishing a base for these horizontal profiles to show any initial bend of the stiffener but in the vertical direction at the east end, Figs. 19 (c) and (d), the marked bulge of the complete web and stiffener assembly is obvious. Failure occurred at this end preceded by large overall bulging as well as deflections of the web plate within the stiffener panels.

The plate bulges are of the order of 0.60 to 1.35 times the plate thickness. Additional deflections of the web were recorded during loading, Fig. 20, but

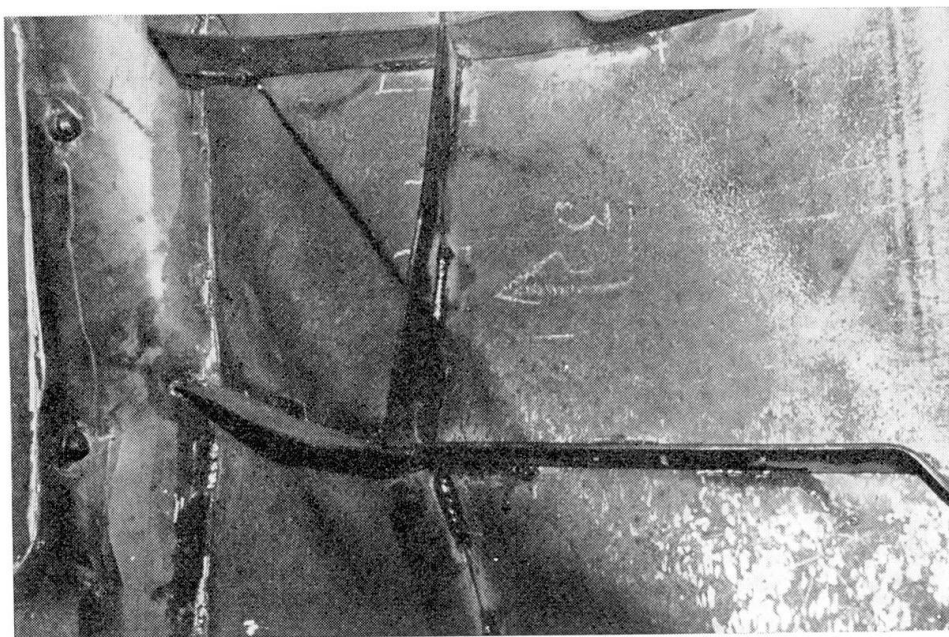
Fig. 22.

The inside of the panel after collapse is shown in Fig. 22 and clearly shows

the overall bending and the tear of the joint in the vertical stiffener. The ultimate strength of the model girder depended entirely on the presence and magnification of this large initial bend of the complete web-stiffener assembly at one corner.

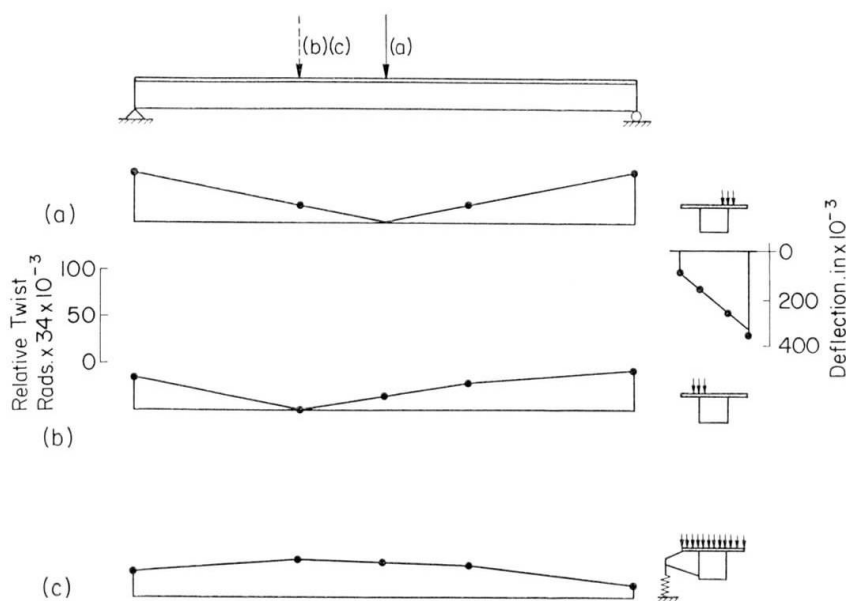
Fig. 24.

The differential deflection between the edges of the box section is a measure of the torsional twist and Fig. 24 shows the values from which the effective torsional stiffness is calculated as follows

Fig. 24 (a) and (b) off-centre loads: $J = 1600 \text{ in.}^4$;

Fig. 24 (c) differential movt.: $J = 5700 \text{ in.}^4$, calculation ($m = 10$):
 $J = 5220 \text{ in.}^4$.

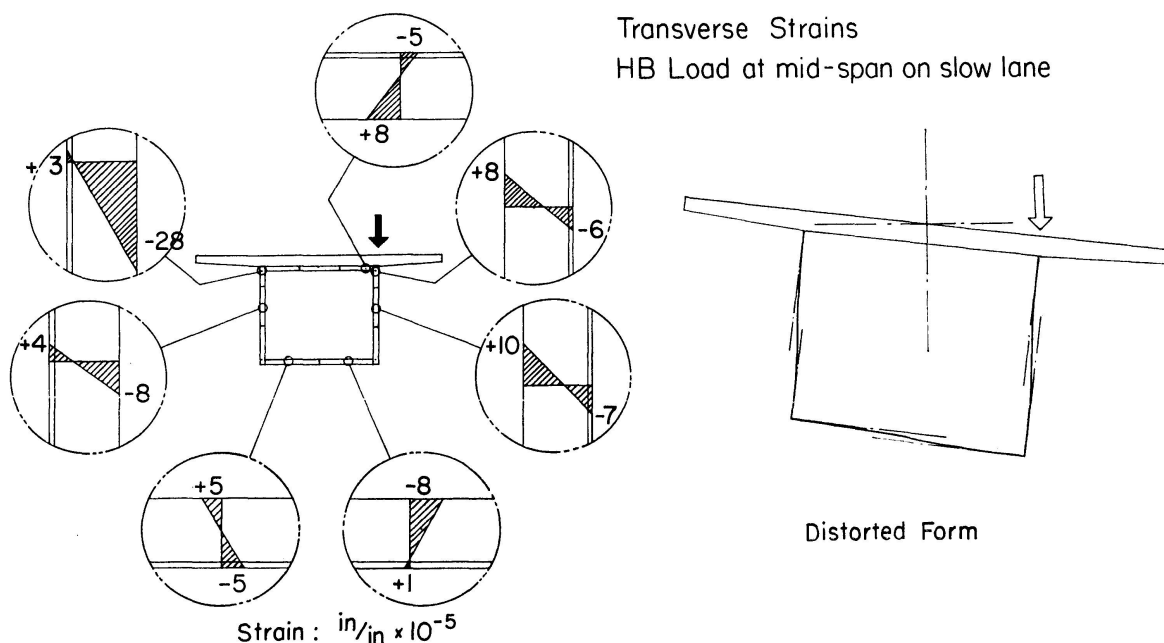
Fig. 25.

It is difficult to account analytically for the very low value obtained from the off-centre load case. Strain measurements in Fig. 25 show clearly a sway

or racking near the concentrated load which would be interpreted as an appreciable reduction in the effective torsion stiffness.
