Artikel: Tests on a model composite bridge girder
Autor: Nelson, H.M. / Beveridge, A. / Arthur, P.D.
DOI: <https://doi.org/10.5169/seals-19406>

Tests on a Model Composite Bridge Girder

The testing of the composite girder described in this paper was part of a programme of model studies and tests carried out in the design stages of the Tay Road Bridge project. The model studies were concerned with the effects of the bridge piers on the movement of river bed material, the evaluation of wind forces on the superstructure and the structural behaviour of the composite box girders.

The main test in the third part of these studies was carried out on a quarter scale model 45 feet span and is discussed in this paper.

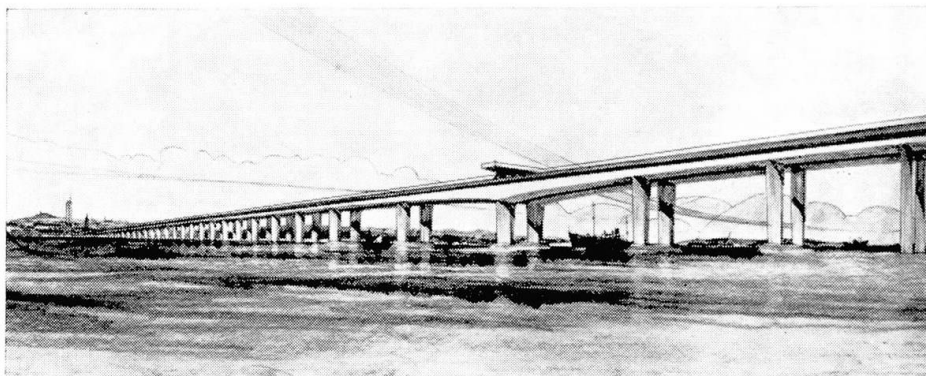
The bridge is at present under construction and will provide a dual carriageway 1.4 miles long across the Firth of Tay in Scotland. An artist's impression of the bridge is shown in Fig. 1. Each span consists of a pair of welded steel box girders spaced 20 feet apart and braced together at the ends and 1/3rd points. On top of each girder is cast a reinforced concrete slab to carry a two-lane carriageway, connected to the box by stud welded shear connectors. The superstructure is carried on reinforced concrete columns which rise to a maximum of 104 feet above the water level.

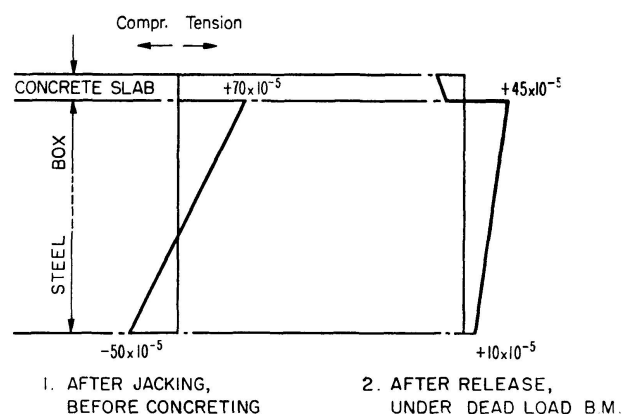
The strains during the various stages of the prestressing operation are shown in Fig. 4.

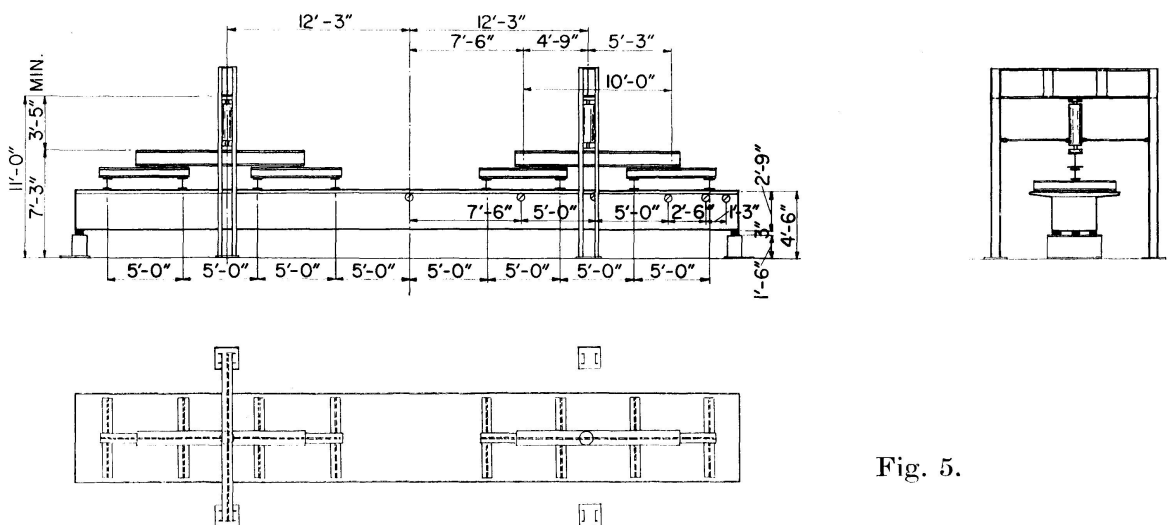
Fig. 5.

Fig. 5 shows the general arrangement of the loading system to represent U.D.L., the detail dimensions being dictated by the details of the test floor in the laboratory. A clear space of 10 feet was left in the centre of the span to accommodate the local concentrated load. It will be noticed that the eight load points are not equally loaded but the shear and moment diagrams shown in Fig. 6 are not significantly affected in shape. Load was supplied by two "Losenhausen" hydraulic jacks of the packless type driven from a hydraulic pump system which supplied both static and pulsating loads.

Relative movement, or slip, between the concrete deck and the steel box was checked by $26\frac{1}{1000}$ in. dial gauges positioned as in Fig. 5 and held in position as in Fig. 9.

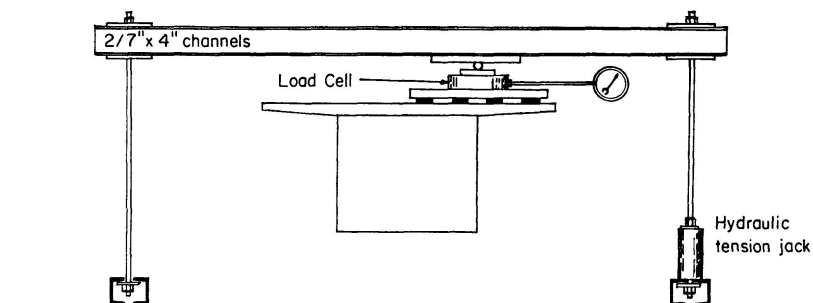
A general arrangement of the concentrated loading (H.B. type to B.S. 153) is shown in Fig. 7 the wheel contact areas being simulated by $\frac{1}{2}$ in. thick rubber pads cut to scale size and loaded through a 1 in. thick steel plate. For the "H.B." loadings the load was measured directly by a resistance gauge load cell.

Tests were made on the off-centre load effects by simulating one bogie of the H.B. loading as shown already in Fig. 7. This loading was applied on the "slow" lane both at the centre of the span and at the third point. Differential movement of the two girders was simulated by providing elastic supports at the connecting diaphragms, Fig. 23 and applying the usual central loading to the girder.

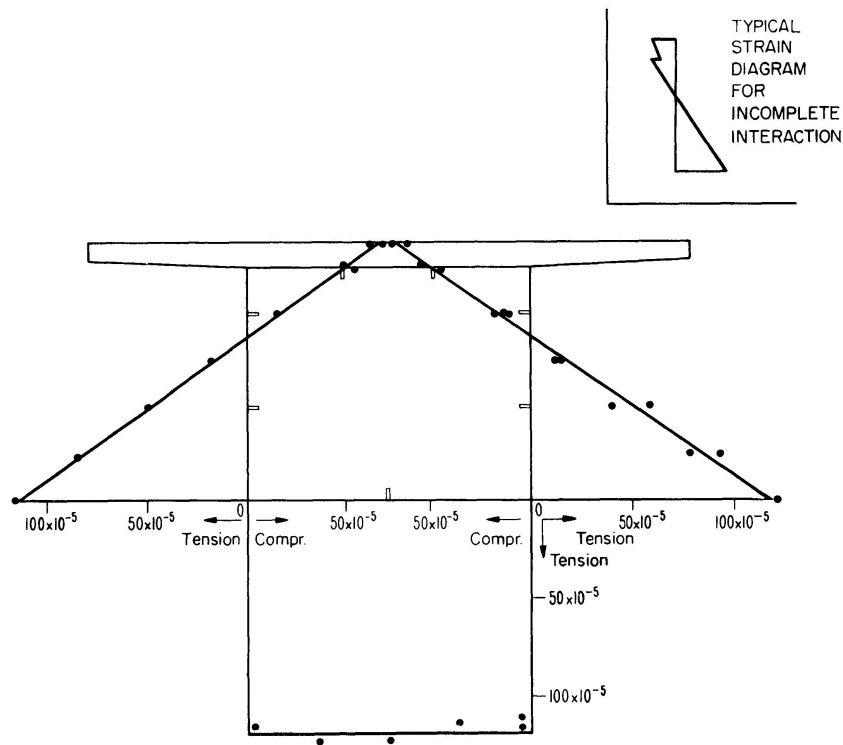
The strain distribution at the central cross-section, Fig. 13, is well defined. From these strains and the measured neutral axis depth and assuming complete interaction between concrete and steel I is calculated to be 7,330 in.⁴

The observed neutral axis depth with $I = 7,330 \text{ in.}^4$ corresponds to a reduction of about 10% in the axial compression in the deck slab and the strain distribution must have been of the form shown in the inset in Fig. 13.
