**Artikel:** Tests on a model composite bridge girder  
**Autor:** Nelson, H.M. / Beveridge, A. / Arthur, P.D.  
**DOI:** <https://doi.org/10.5169/seals-19406>

## **Tests on a Model Composite Bridge Girder**

The testing of the composite girder described in this paper was part of a programme of model studies and tests carried out in the design stages of the Tay Road Bridge project. The model studies were concerned with the effects of the bridge piers on the movement of river bed material, the evaluation of wind forces on the superstructure and the structural behaviour of the composite box girders.

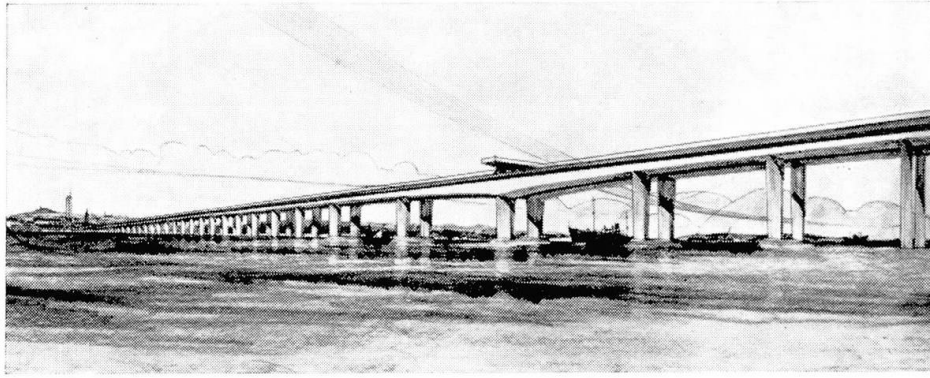
The bridge is at present under construction and will provide a dual carriageway 1.4 miles long across the Firth of Tay in Scotland. An artist's impression of the bridge is shown in Fig. 1. Each span consists of a pair of welded steel box girders spaced 20 feet apart and braced together at the ends and 1/3rd points. On top of each girder is cast a reinforced concrete slab to carry a two-lane carriageway, connected to the box by stud welded shear connectors. The superstructure is carried on reinforced concrete columns which rise to a maximum of 104 feet above the water level.

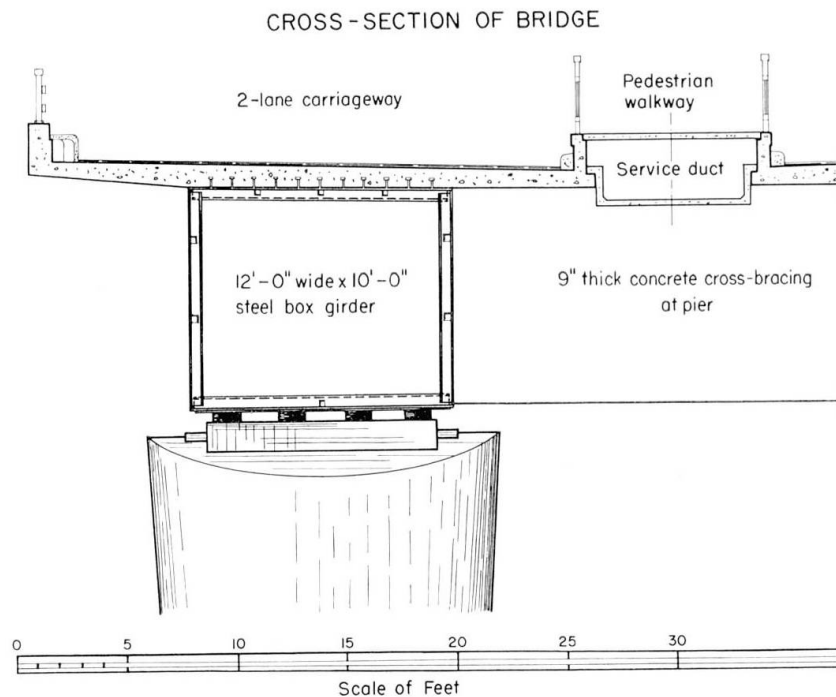
The bridge has 42 spans, 31 of which are 180 feet long so that this span was chosen as the basis for model tests and is shown in Fig. 2. The girder is of composite construction, the connection of the slab to the steel box being made

by 1300 stud welded  $\frac{3}{4}$  in. dia. shear connectors. The tension flange is of high yield stress steel to B.S. 968 (1962) and all other parts are of normal structural mild steel. The steel end plates of each girder are set back from the extreme ends to allow the casting of a  $10\frac{1}{2}$  inch thick reinforced concrete end wall in the space between the projecting ends of the webs and the lower flange. This detail is used to provide an economic form of stiffening over the points of support and at the same time to avoid the painting of closely spaced girder end plates. The cross bracings between the girders at the ends are 9 inch reinforced concrete walls, while those at the third points are 2 ft. 6 in. wide by 9 ft. deep steel box sections attached by high strength friction grip bolts. All stiffening of the box girder plating is internal using an orthogonal system of toe welded angles which are proportioned to the requirements of B.S. 153 Part 4 (1958). Before erection an 8 inch reinforced concrete slab is cast over the full width of the flange plate, this reduced composite section therefore carrying the full dead load.

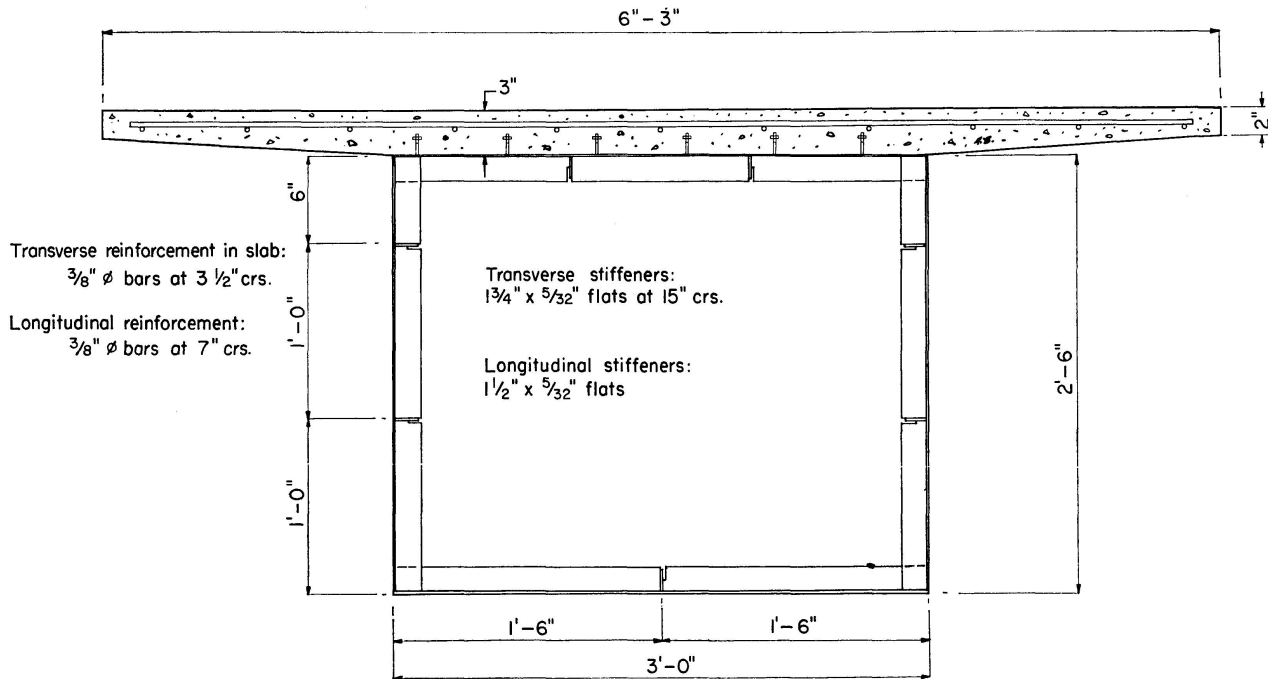
Fig. 3.

**Model Girder (Fig. 3)**

The scale selected was 1 : 4 which produced the largest span (45 feet) which could be accommodated on the test bed. A smaller scale would have increased the difficulties of welding thin plates and casting thin concrete slabs.

Since the correct thickness is not rolled, plates nominally 0.099 in. were used instead of the correct  $3/32$  in. and all other thicknesses were taken from the nearest "Birmingham Sheet Gauge" sizes. There was considerable variation in plate thickness within each plate of the same order as the difference between the correct scale thickness and that actually used. To simulate angle stiffeners to scale flats were used having the same outstand and second moment of area about their junction with the web. The shear connection was by standard screwed studs  $3/16$  in. dia. fitted with nuts after welding. The concrete deck slab and area of reinforcement were reduced accurately to scale with the exception that the edge kerbs were omitted. The maximum aggregate size used was  $3/8$  in.

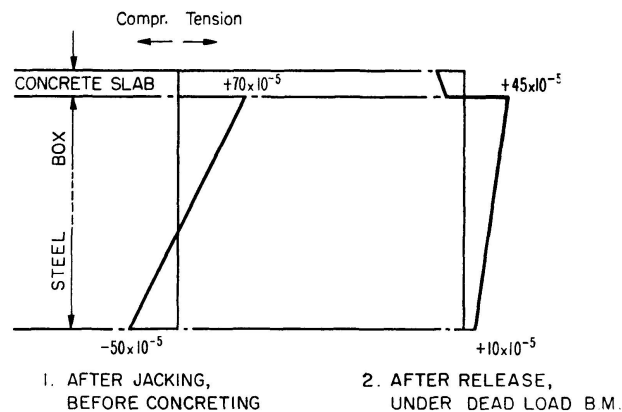
The strains during the various stages of the prestressing operation are shown in Fig. 4.

The girder was set on its bearings 32 days after the first concrete was cast, the strain gauges then showing a tensile stress in the lower flange of 1.3 T/in.<sup>2</sup> under the dead load of the complete girder and the eight loading beams.

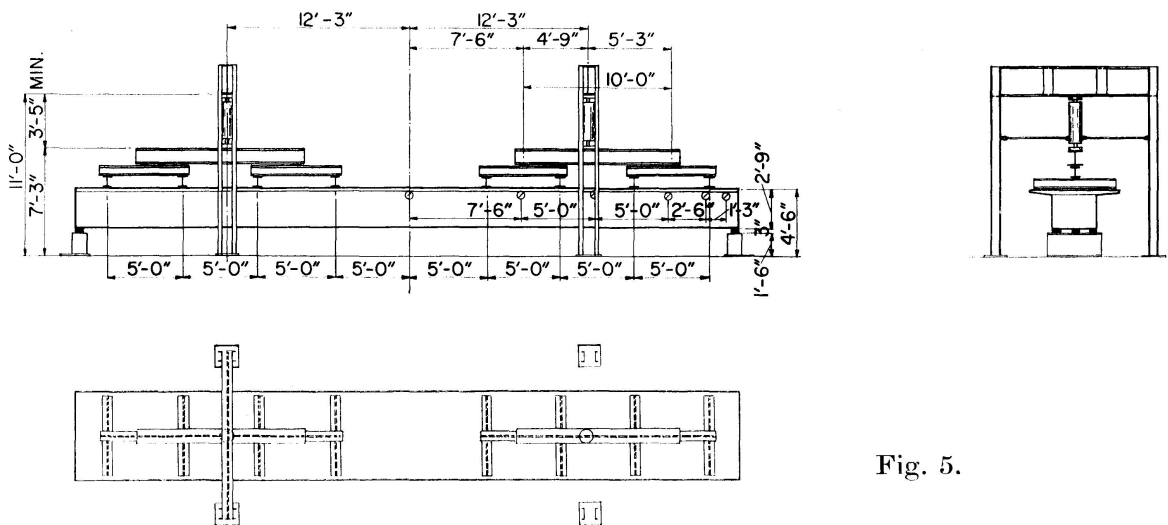
Fig. 5.

Fig. 5 shows the general arrangement of the loading system to represent U.D.L., the detail dimensions being dictated by the details of the test floor in the laboratory. A clear space of 10 feet was left in the centre of the span to accommodate the local concentrated load. It will be noticed that the eight load points are not equally loaded but the shear and moment diagrams shown in Fig. 6 are not significantly affected in shape. Load was supplied by two "Losenhausen" hydraulic jacks of the packless type driven from a hydraulic pump system which supplied both static and pulsating loads.

Relative movement, or slip, between the concrete deck and the steel box was checked by  $26\frac{1}{1000}$  in., dial gauges positioned as in Fig. 5 and held in position as in Fig. 9.

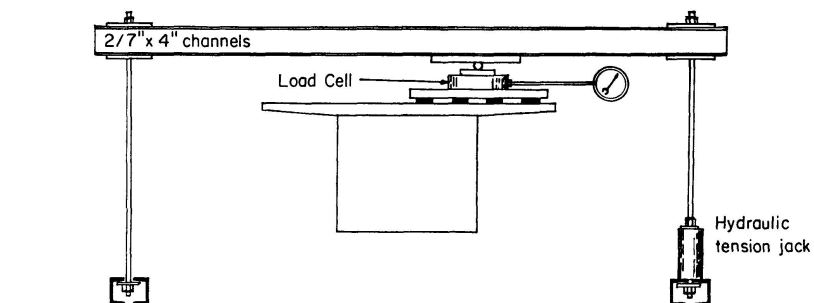
A general arrangement of the concentrated loading (H. B. type to B.S. 153) is shown in Fig. 7 the wheel contact areas being simulated by  $\frac{1}{2}$  in. thick rubber pads cut to scale size and loaded through a 1 in. thick steel plate. For the "H.B." loadings the load was measured directly by a resistance gauge load cell.

Tests were made on the off-centre load effects by simulating one bogie of the H. B. loading as shown already in Fig. 7. This loading was applied on the "slow" lane both at the centre of the span and at the third point. Differential movement of the two girders was simulated by providing elastic supports at the connecting diaphragms, Fig. 23 and applying the usual central loading to the girder.

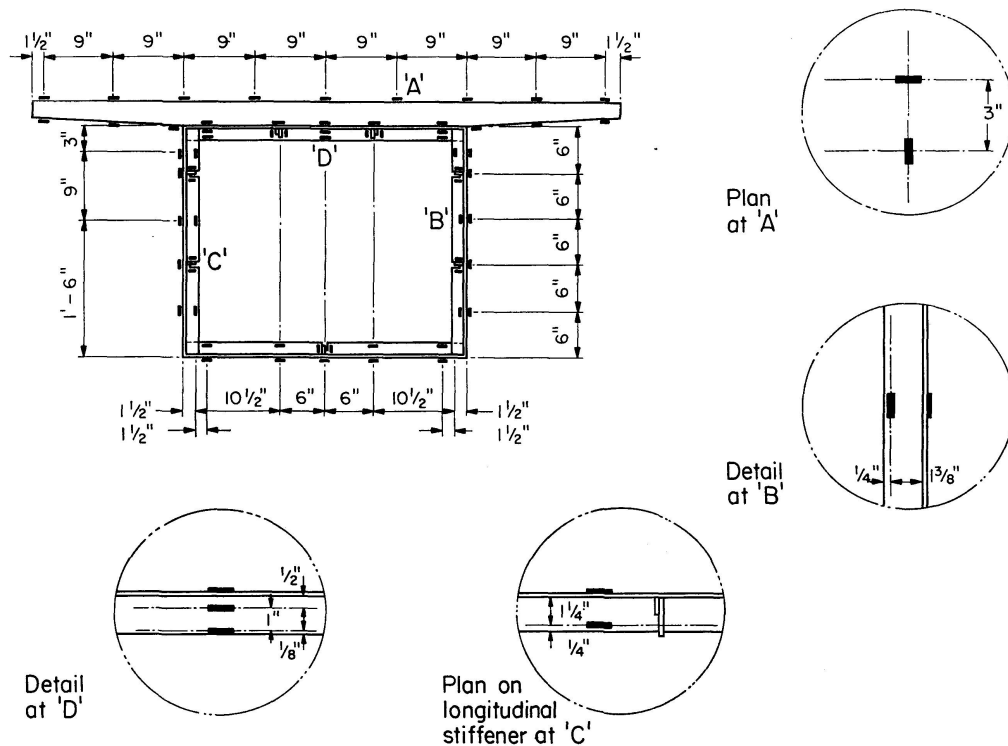
The positions of the strain gauges at the centre cross-section discussed in this paper are shown in Fig. 8.

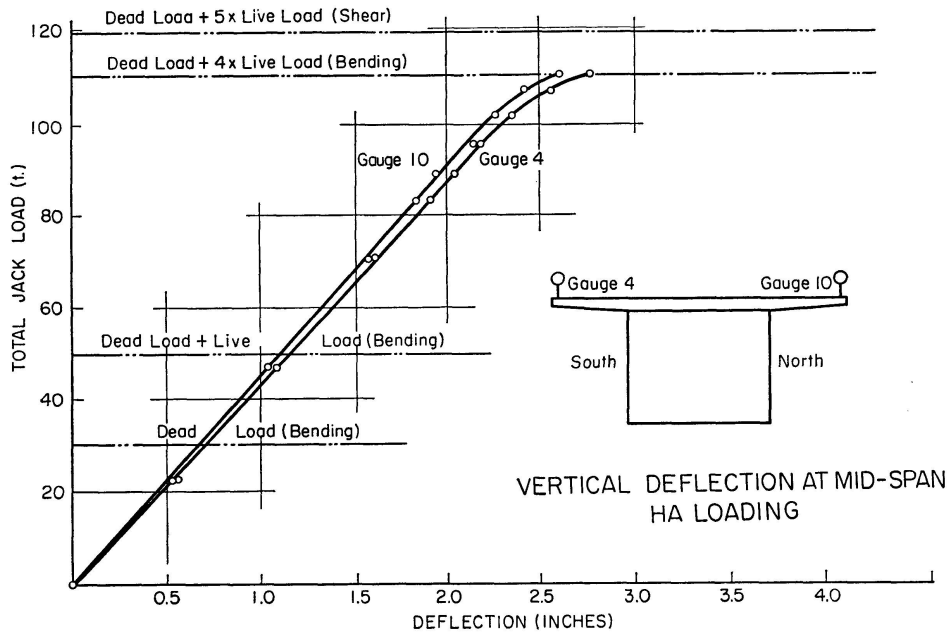
Deflections of the centre of the span during the loading to 117 t are shown in Fig. 11. There is no significant twist and the behaviour is linear up to 90 t total jack load indicating an effective moment of inertia of about  $7,050 \text{ in.}^4$  (steel units). It is shown below that all stresses are well below the yield stress of the steel at this stage and as the slip gauges show negligible loss of bond this departure from linearity is probably due to the effects of web deformations. The web finally failed at the corner which would show a larger movement of deflection gauge 4 as in Fig. 11.

Calculation of the probable deflection due to the shear stresses in the web shows that shear accounts for about 8% of the total deflection and this has been allowed for in the above calculation of  $I$ .

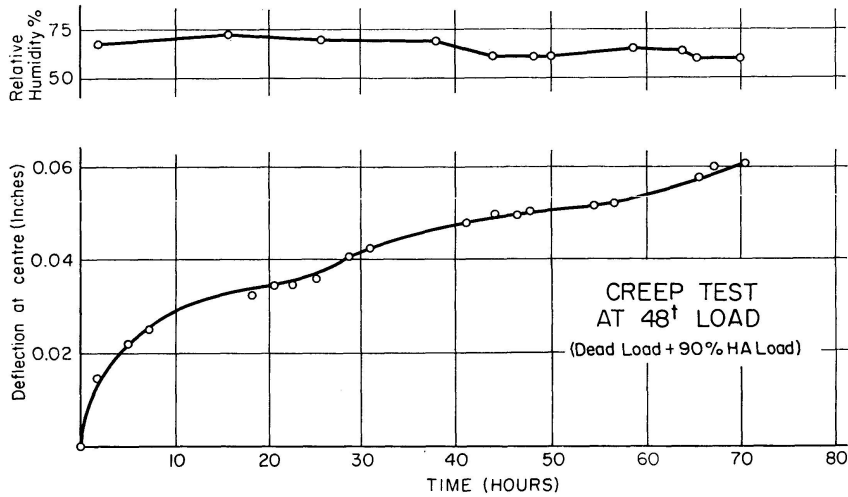
Fig. 12.

The creep of the central deflection during a 71 hour period is shown in Fig. 12, the loading being approximately the full dead plus maximum live load (i. e. 48 t instead of 50 t). Though the curve is not as regular as could be wished there is a marked change in the deflection rate after 5 hours and after 70 hours the deflection is still increasing slowly. At 70 hours a creep deflection reduces the apparent " $I$ " value to 6,200 in.<sup>4</sup> from 7,050 in.<sup>4</sup> for the short time loading.

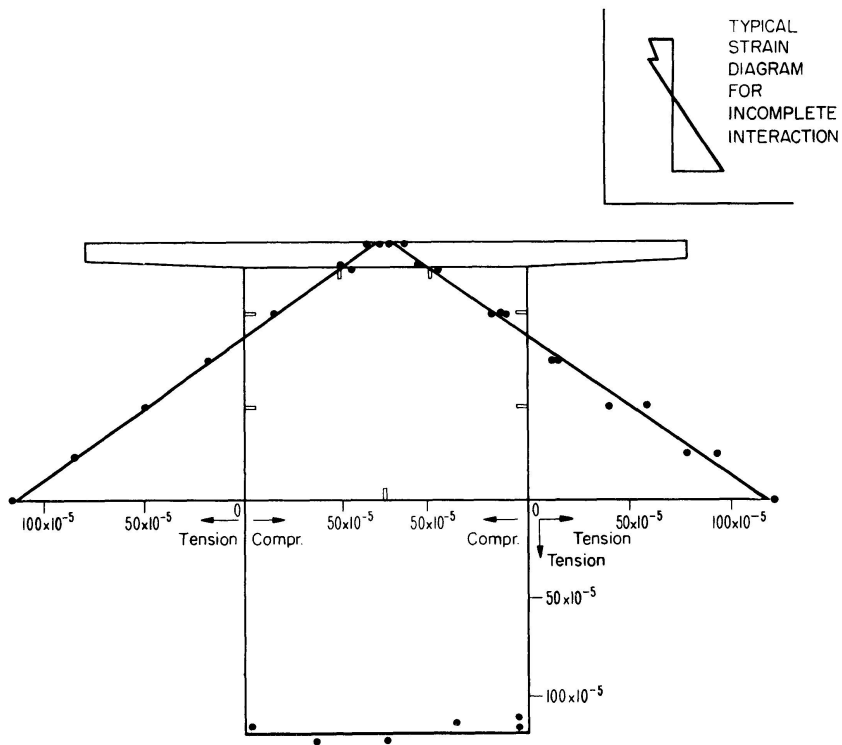
The strain distribution at the central cross-section, Fig. 13, is well defined. From these strains and the measured neutral axis depth and assuming complete interaction between concrete and steel  $I$  is calculated to be 7,330 in.<sup>4</sup>

showing a modular ratio of 8. However, this value of the modular ratio gives a neutral axis depth of 6.5 in. whereas the measured depth is 9 in. below the top of the steel. Hence it is apparent that full interaction is not realised although the relative movement of slab and box was not measurable with the  $\frac{1}{1000}$  in. slip gauges.

The observed neutral axis depth with  $I = 7,330 \text{ in.}^4$  corresponds to a reduction of about 10% in the axial compression in the deck slab and the strain distribution must have been of the form shown in the inset in Fig. 13.

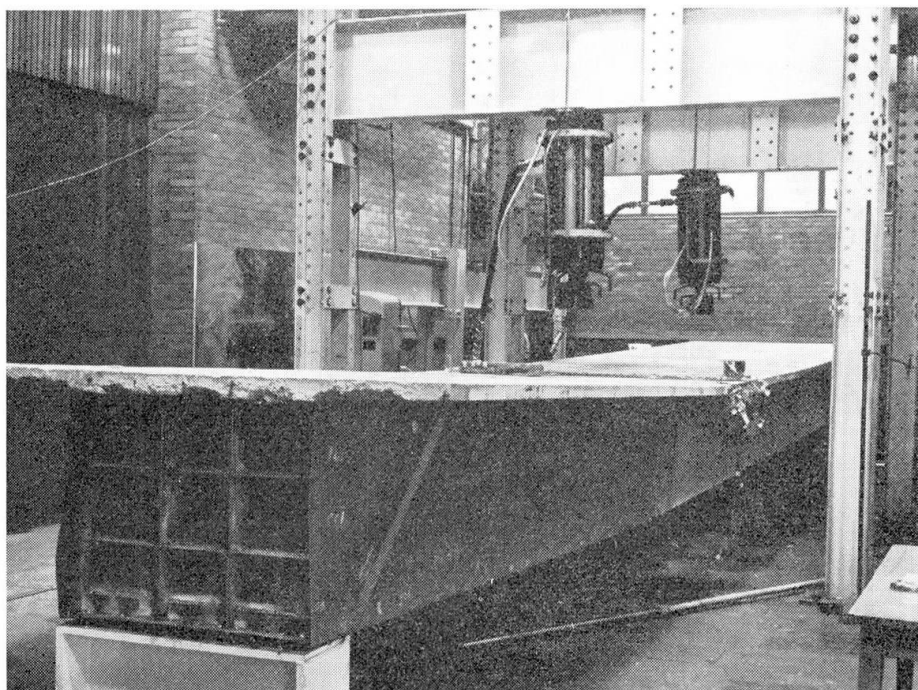
After the model had failed in the second main test by web buckling the first 8 feet of the girder was cut off and a new steel bulkhead welded into the open end, Fig. 14. In order to prevent a second failure by buckling diagonal angle stiffeners were welded to the outside of all four end panels.

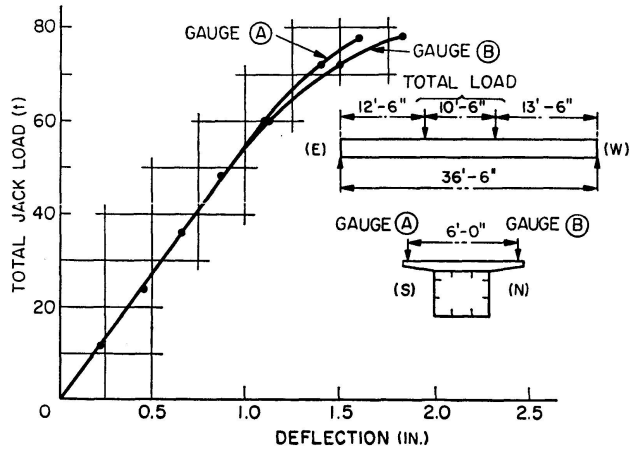
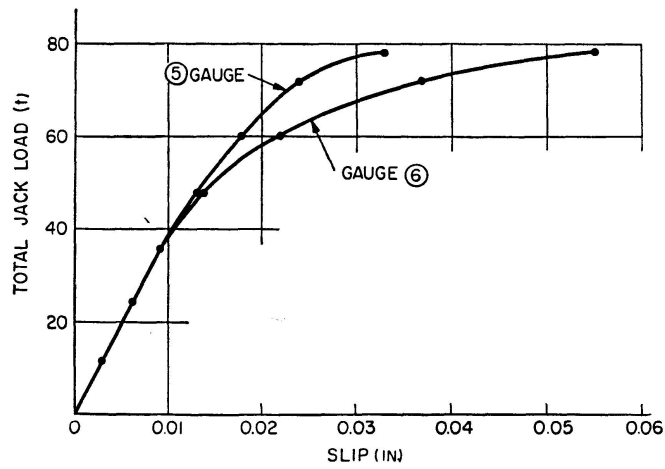
The model was set up again but loaded with two equal point loads applied to the slab through 12 in.  $\times$  12 in. B.F.Bs. across the full width of the deck slab. Due to the test floor anchorages this loading could not be symmetrical. Deflection and slip gauge readings for this repeat loading are shown in Figs. 15 and 16.

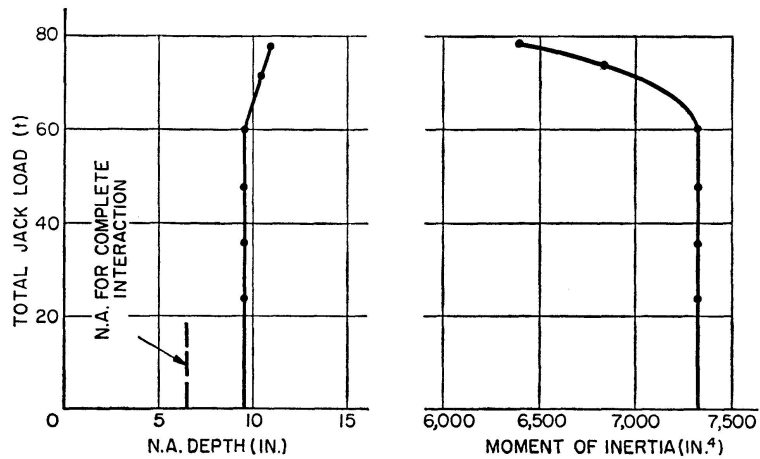
Fig. 18.

Strain measurements at loads below  $60 \text{ t}$  showed that the neutral axis depth was  $9.5 \text{ in.}$  from the top of the steel box, which corresponds to about  $90\%$  interaction. At loads above  $60 \text{ t}$  the neutral axis depth increased until just before failure at  $78 \text{ t}$  it reached  $10.8 \text{ in.}$  indicating a further reduction in the interaction. The values of  $I$  calculated from the measured strains altered from  $7330 \text{ in.}^4$  at  $60 \text{ t}$  to  $6400 \text{ in.}^4$  at  $78 \text{ t}$  and from deflection readings was  $6550 \text{ in.}^4$ . Fig. 17 shows the strain distributions at  $36 \text{ t}$  and at  $78 \text{ t}$  and Fig. 18 shows the variation of neutral axis depth and  $I$  value with the load.

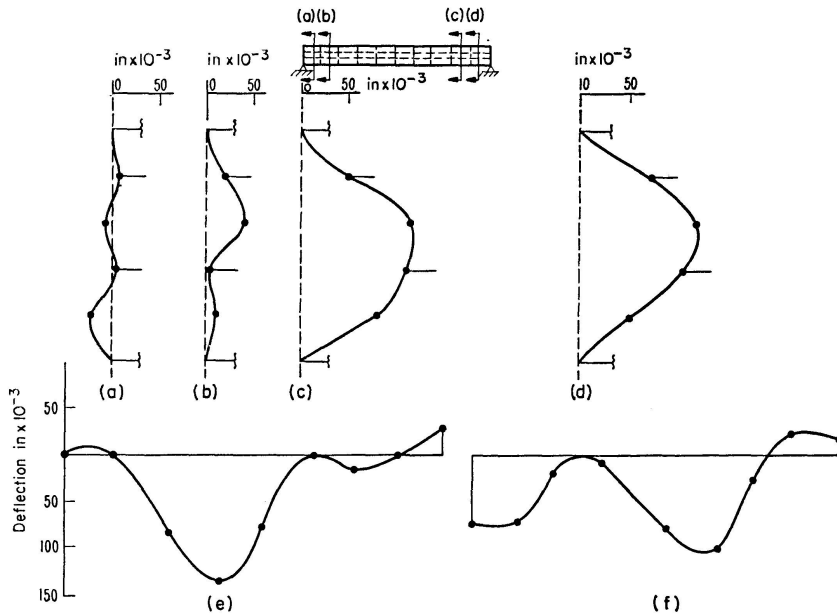
Fig. 19.

A preliminary survey of the web profile is shown in Fig. 19 which indicates

in (a), (b), (c) and (d) the vertical profiles near the centre of the end two panels at opposite ends of the girder. Fig. 19 (e) and (f) give the same data for horizontal profiles near the centre of the web depth. There was no convenient way of establishing a base for these horizontal profiles to show any initial bend of the stiffener but in the vertical direction at the east end, Figs. 19 (c) and (d), the marked bulge of the complete web and stiffener assembly is obvious. Failure occurred at this end preceded by large overall bulging as well as deflections of the web plate within the stiffener panels.

The plate bulges are of the order of 0.60 to 1.35 times the plate thickness. Additional deflections of the web were recorded during loading, Fig. 20, but

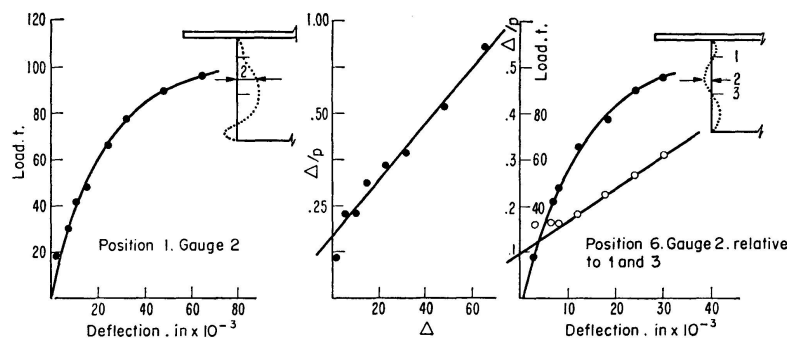
Fig. 20.

are so small compared to the initial values that SOUTHWELL'S [2] method for estimating the buckling load was not reliable. However the results selected and shown in Fig. 20 do indicate a critical load to be of the order of 140 t. It is to be noted that the curves plotted for point 2, in Fig. 20 include the overall deflection of the stiffener assembly. This compares with the theoretical value for a simply supported panel buckling in shear of 167 t.

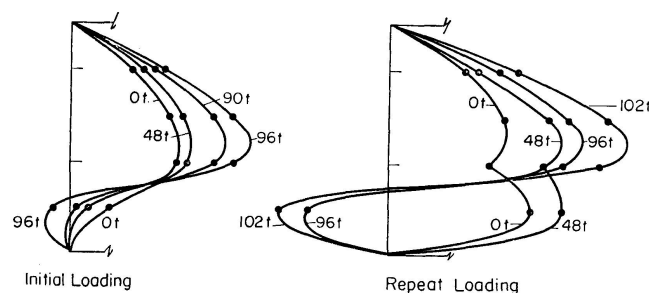
Fig. 21.

The critical features of the test are clearly shown by the movements of the gauges in Fig. 21 which show the increase in overall bulging and of deflection at gauge 4 up to a load of 96 t.

After the weld failure at 102 t there was a large permanent buckle at gauge 4 which was hammered in after the girder had been repaired. The plate profile under the repeat loading shows the return of this bulge after 72 t. At 90 t the buckles in this panel were obvious to the eye and final collapse occurred at a load of 117 t.

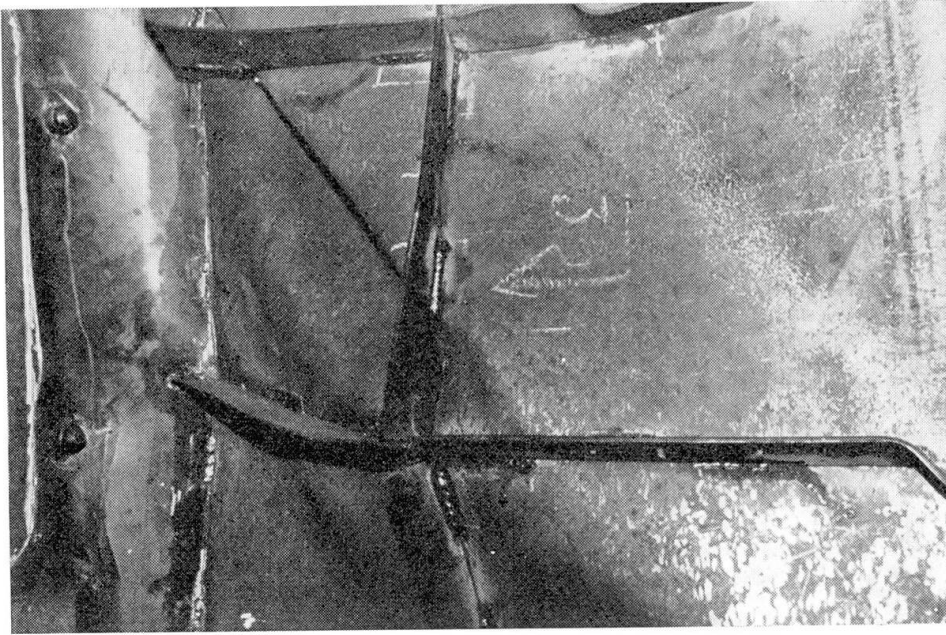
Fig. 22.

The inside of the panel after collapse is shown in Fig. 22 and clearly shows

the overall bending and the tear of the joint in the vertical stiffener. The ultimate strength of the model girder depended entirely on the presence and magnification of this large initial bend of the complete web-stiffener assembly at one corner.

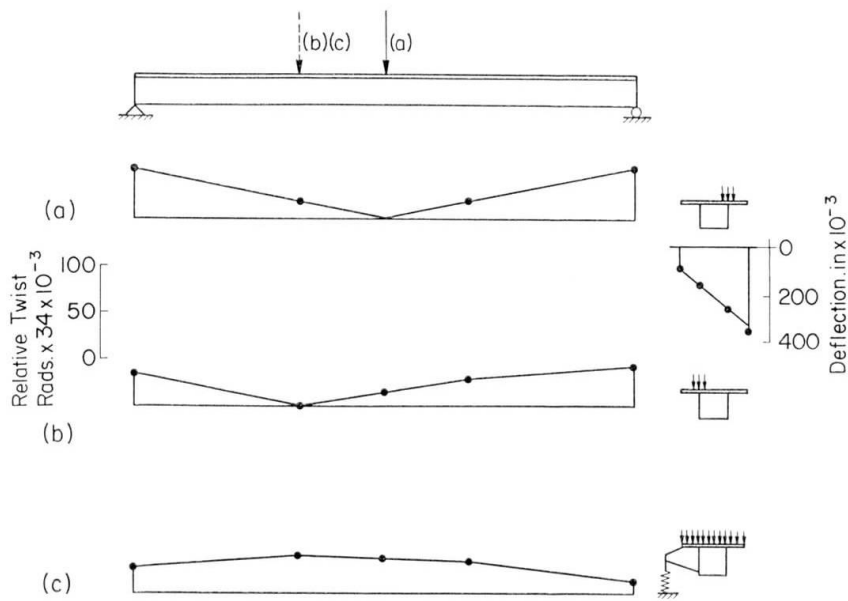
Fig. 24.

The differential deflection between the edges of the box section is a measure of the torsional twist and Fig. 24 shows the values from which the effective torsional stiffness is calculated as follows

Fig. 24 (a) and (b) off-centre loads:  $J = 1600 \text{ in.}^4$ ;

Fig. 24 (c) differential movt.:  $J = 5700 \text{ in.}^4$ , calculation ( $m = 10$ ):  
 $J = 5220 \text{ in.}^4$ .

It is difficult to account analytically for the very low value obtained from the off-centre load case. Strain measurements in Fig. 25 show clearly a sway

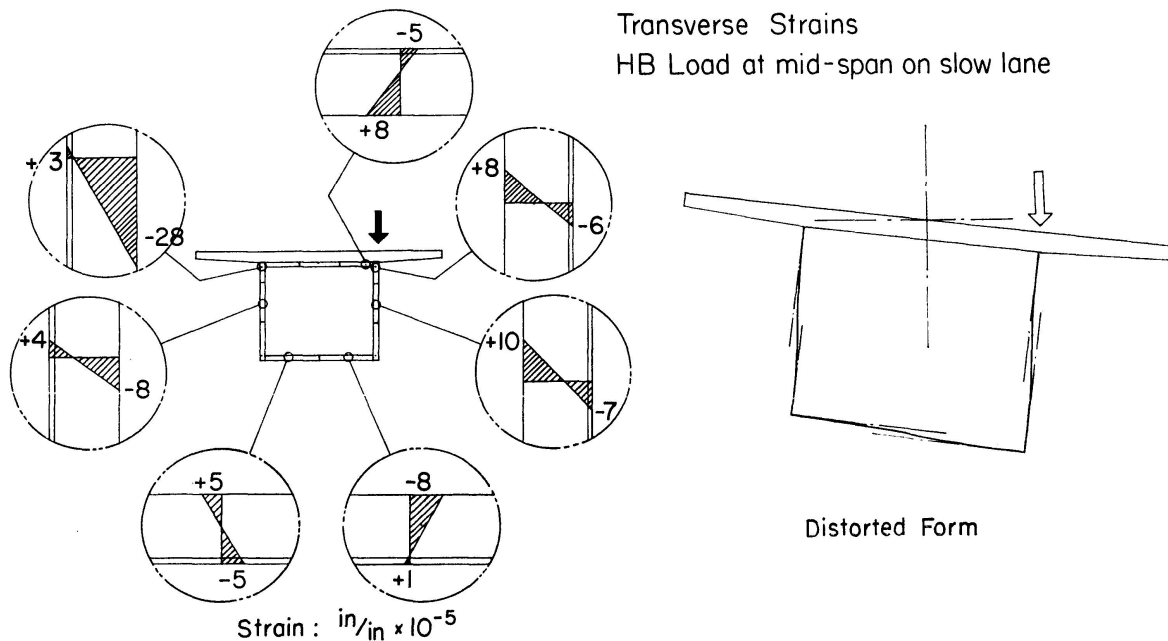
Fig. 25.

or racking near the concentrated load which would be interpreted as an appreciable reduction in the effective torsion stiffness.

Although an analytical estimate of this effect has not been possible it does not seem accurate enough to replace the real load in the orthodox manner with a central load and the equivalent torsional couple at the longitudinal axis of the girder.
