**Artikel:** Tests on a model composite bridge girder  
**Autor:** Nelson, H.M. / Beveridge, A. / Arthur, P.D.  
**DOI:** <https://doi.org/10.5169/seals-19406>

## **Tests on a Model Composite Bridge Girder**

The testing of the composite girder described in this paper was part of a programme of model studies and tests carried out in the design stages of the Tay Road Bridge project. The model studies were concerned with the effects of the bridge piers on the movement of river bed material, the evaluation of wind forces on the superstructure and the structural behaviour of the composite box girders.

The main test in the third part of these studies was carried out on a quarter scale model 45 feet span and is discussed in this paper.

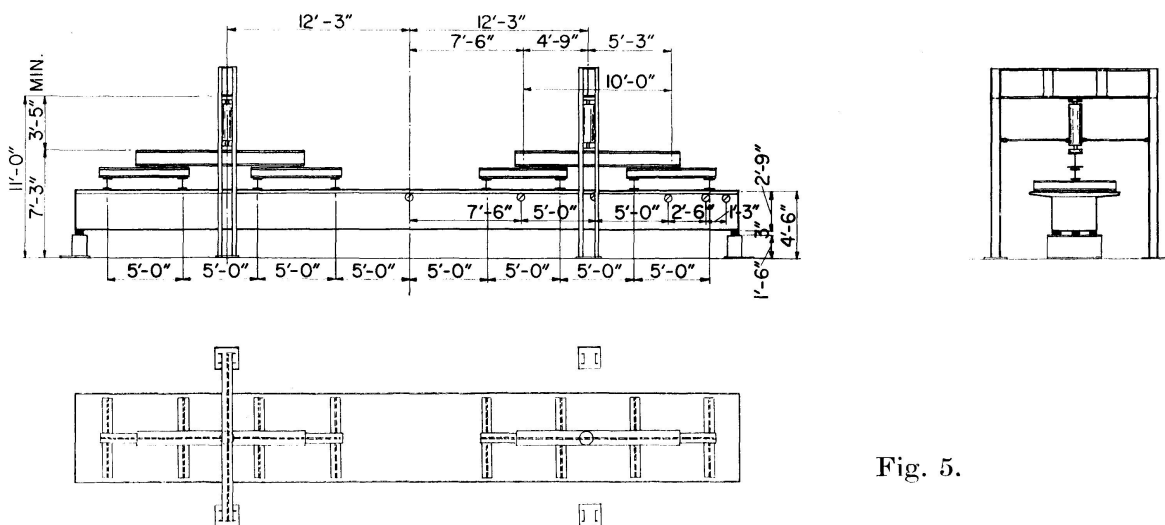
Fig. 5.

Fig. 5 shows the general arrangement of the loading system to represent U.D.L., the detail dimensions being dictated by the details of the test floor in the laboratory. A clear space of 10 feet was left in the centre of the span to accommodate the local concentrated load. It will be noticed that the eight load points are not equally loaded but the shear and moment diagrams shown in Fig. 6 are not significantly affected in shape. Load was supplied by two "Losenhausen" hydraulic jacks of the packless type driven from a hydraulic pump system which supplied both static and pulsating loads.

Relative movement, or slip, between the concrete deck and the steel box was checked by  $26\frac{1}{1000}$  in., dial gauges positioned as in Fig. 5 and held in position as in Fig. 9.

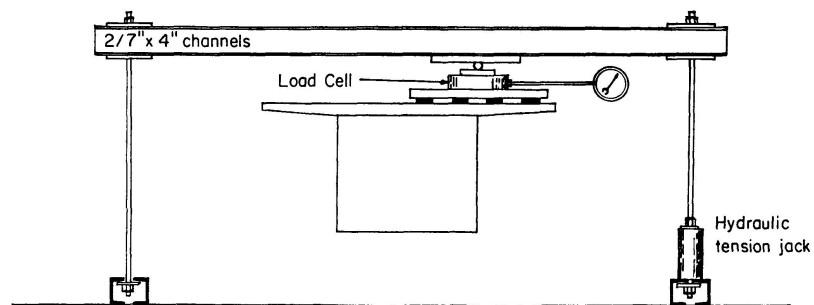
A general arrangement of the concentrated loading (H. B. type to B.S. 153) is shown in Fig. 7 the wheel contact areas being simulated by  $\frac{1}{2}$  in. thick rubber pads cut to scale size and loaded through a 1 in. thick steel plate. For the "H.B." loadings the load was measured directly by a resistance gauge load cell.

Tests were made on the off-centre load effects by simulating one bogie of the H. B. loading as shown already in Fig. 7. This loading was applied on the "slow" lane both at the centre of the span and at the third point. Differential movement of the two girders was simulated by providing elastic supports at the connecting diaphragms, Fig. 23 and applying the usual central loading to the girder.

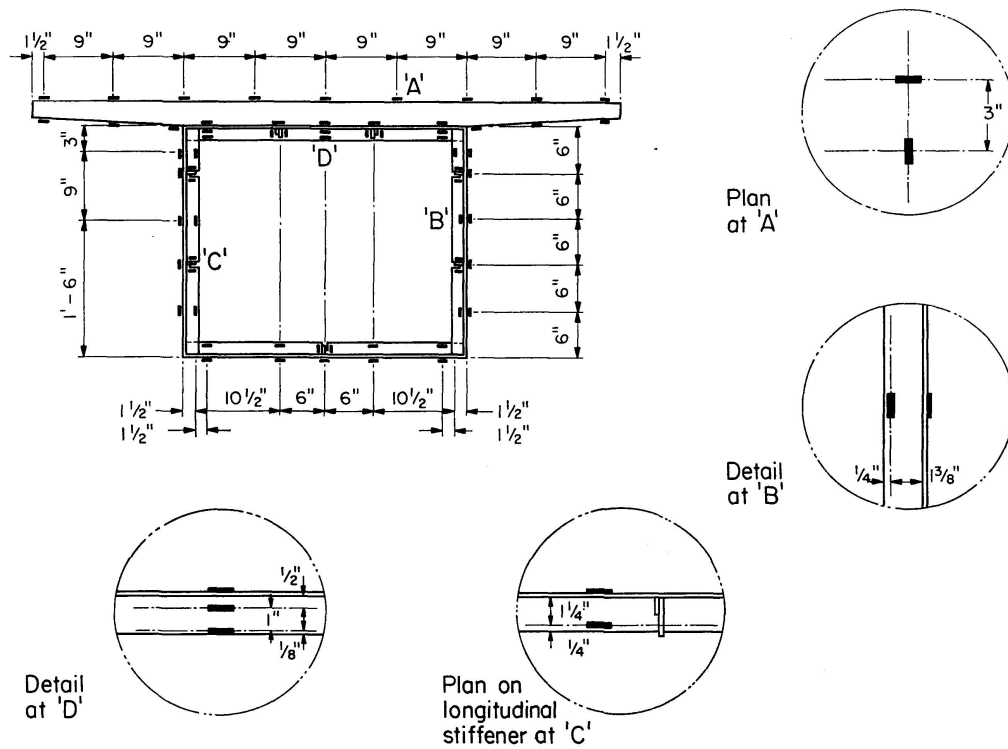
The positions of the strain gauges at the centre cross-section discussed in this paper are shown in Fig. 8.

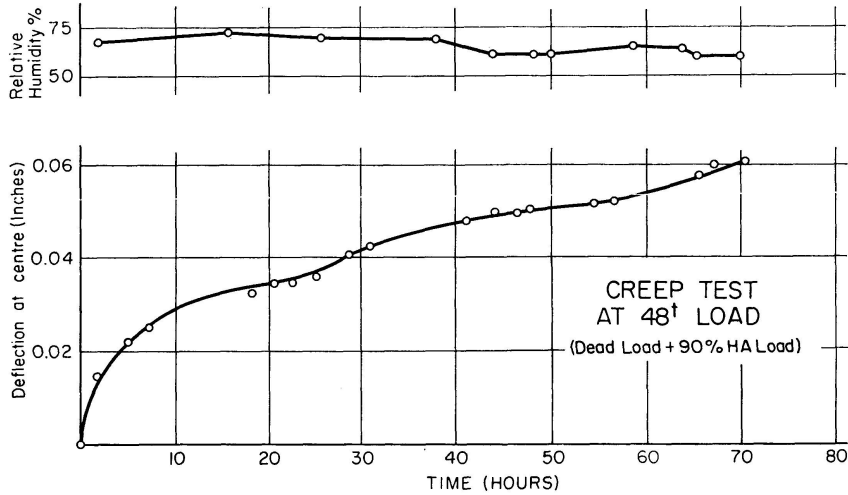
Fig. 12.

The creep of the central deflection during a 71 hour period is shown in Fig. 12, the loading being approximately the full dead plus maximum live load (i. e. 48 t instead of 50 t). Though the curve is not as regular as could be wished there is a marked change in the deflection rate after 5 hours and after 70 hours the deflection is still increasing slowly. At 70 hours a creep deflection reduces the apparent " $I$ " value to 6,200 in.<sup>4</sup> from 7,050 in.<sup>4</sup> for the short time loading.

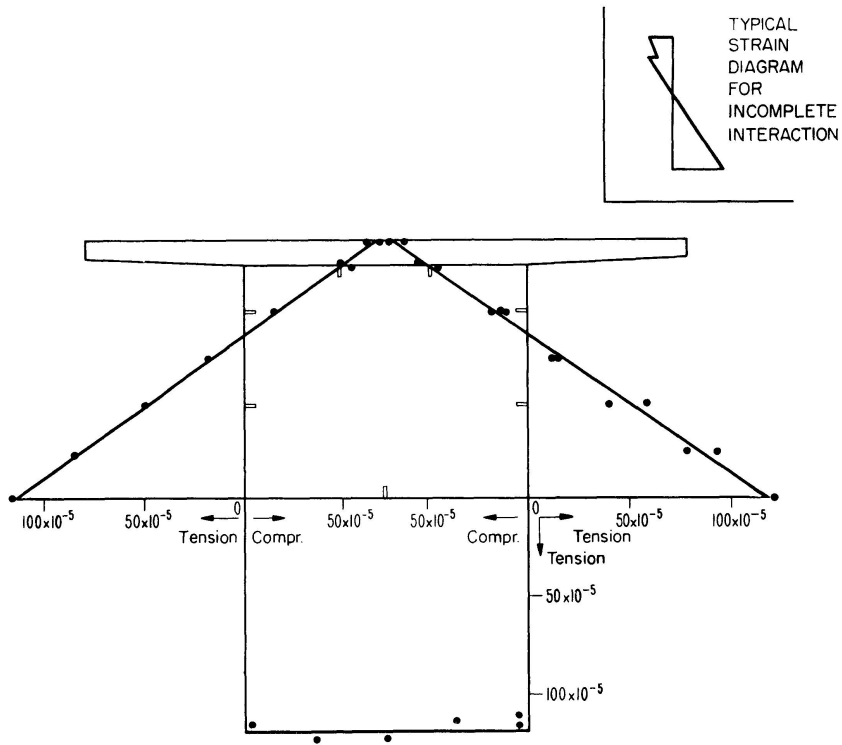
The strain distribution at the central cross-section, Fig. 13, is well defined. From these strains and the measured neutral axis depth and assuming complete interaction between concrete and steel  $I$  is calculated to be 7,330 in.<sup>4</sup>

showing a modular ratio of 8. However, this value of the modular ratio gives a neutral axis depth of 6.5 in. whereas the measured depth is 9 in. below the top of the steel. Hence it is apparent that full interaction is not realised although the relative movement of slab and box was not measurable with the  $\frac{1}{1000}$  in. slip gauges.

The observed neutral axis depth with  $I = 7,330 \text{ in.}^4$  corresponds to a reduction of about 10% in the axial compression in the deck slab and the strain distribution must have been of the form shown in the inset in Fig. 13.

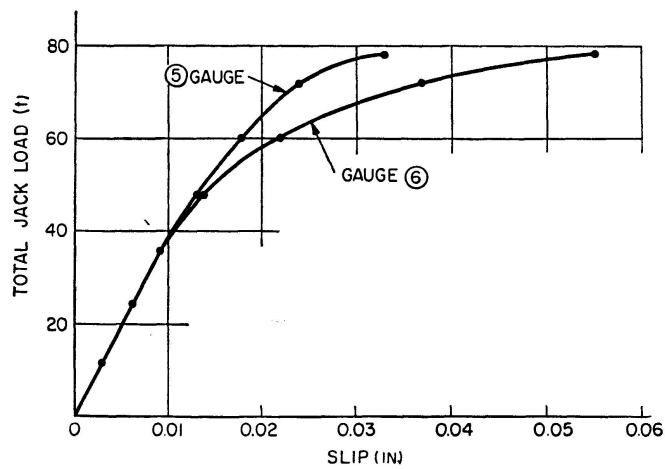
The model was set up again but loaded with two equal point loads applied to the slab through 12 in.  $\times$  12 in. B.F.Bs. across the full width of the deck slab. Due to the test floor anchorages this loading could not be symmetrical. Deflection and slip gauge readings for this repeat loading are shown in Figs. 15 and 16.

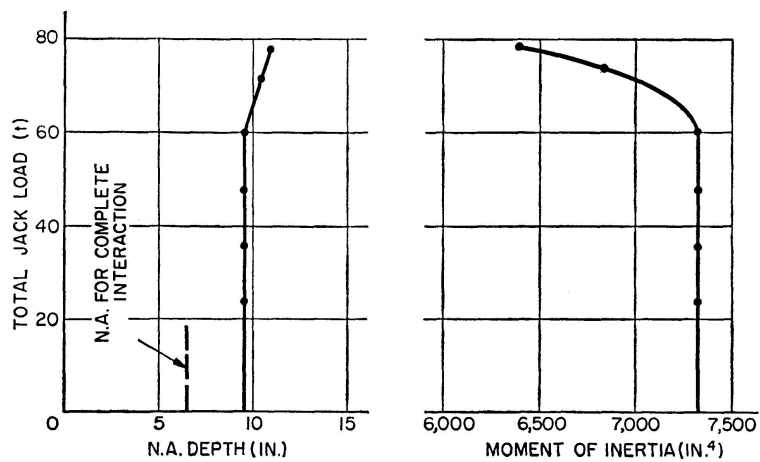
Fig. 18.

Strain measurements at loads below  $60 \text{ t}$  showed that the neutral axis depth was  $9.5 \text{ in.}$  from the top of the steel box, which corresponds to about  $90\%$  interaction. At loads above  $60 \text{ t}$  the neutral axis depth increased until just before failure at  $78 \text{ t}$  it reached  $10.8 \text{ in.}$  indicating a further reduction in the interaction. The values of  $I$  calculated from the measured strains altered from  $7330 \text{ in.}^4$  at  $60 \text{ t}$  to  $6400 \text{ in.}^4$  at  $78 \text{ t}$  and from deflection readings was  $6550 \text{ in.}^4$ . Fig. 17 shows the strain distributions at  $36 \text{ t}$  and at  $78 \text{ t}$  and Fig. 18 shows the variation of neutral axis depth and  $I$  value with the load.
