Zeitschrift: IABSE publications = Mémoires AIPC = IVBH Abhandlungen
Band: 26 (1966)

The Construction of the Forth Road Bridge

H. SHIRLEY-SMITH

C.B.E., B. Sc., M.I.C.E., Engineer in charge of construction for the contractors, the A.C.D. Bridge Co.

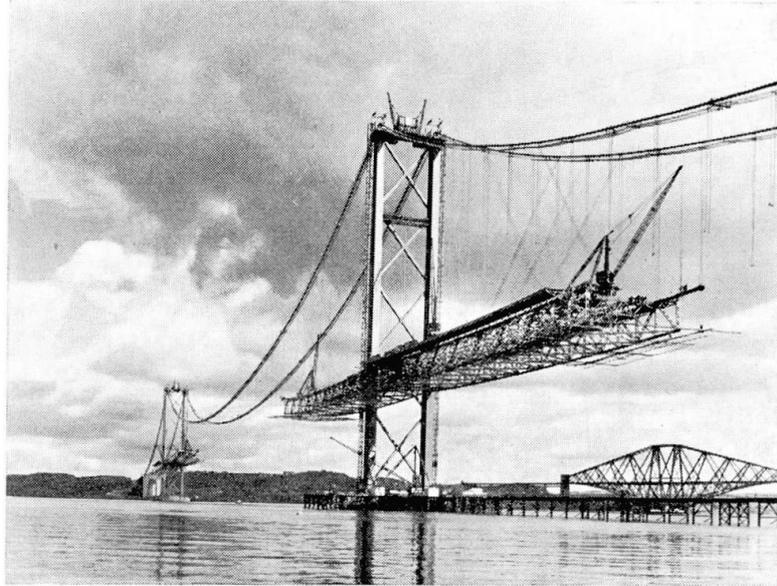
Fig. 8. A view during erection of suspended structure. Note temporary upward deflection of steelwork.

The first 90 ft. lengths of deck were cantilevered out from each side of each tower and the 15 ton travelling derricks assembled on them before the end of cable spinning, so that there would be no delay in starting deck erection. As soon as each panel of steelwork had been connected to the suspenders, the temporary crane tracks were extended and the derrick moved out to the end of the panel in order to erect the next one. The work in main and side spans was kept in balance until 18 panels had been erected on either side of each tower. Owing to the fact that the main cables, which were clamped in the saddles at the tower tops, had to stretch some 18 feet in their length of 7,000 feet between anchorages as the deck was erected and its dead load came onto them, the tops of the towers were at this stage deflected back a maximum of 30 ins. to the shore and the side spans were temporarily humped up. For this reason erection had then to be discontinued in the main span until the side span steelwork was completed. Concreting of the roadway panels in the side spans was then begun, the work being organized so as to spread the load as uniformly as possible along their length, whilst steel erection in the main span was completed. The gap at mid span before closure was $8\frac{1}{8}$ " in the top chord and $8\frac{5}{8}$ " in the lower chord which agreed within quarter inch of the calculated figures. Junction was then brought about by releasing the ends of the deck from the towers and so allowing the two halves to meet for connection at mid-span.
