**Zeitschrift:** IABSE structures = Constructions AIPC = IVBH Bauwerke  
**Band:** 4 (1980)  
**Heft:** C-13: Sports halls and stadia

**Artikel:** National Athletics Stadium, A.C.T. (Austria)  
**Autor:** Quinn, J.  
**DOI:** <https://doi.org/10.5169/seals-16539>

## 7. National Athletics Stadium, A.C.T., (Australia)

*Owner: National Capital Development Commission*

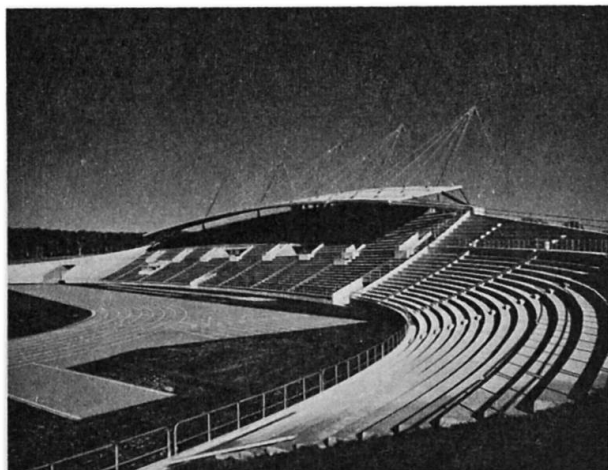
*View from inside the stadium showing the grandstand with its cable suspended roof.*

The seating part of the stand consists of transverse reinforced concrete frames supporting precast concrete seating units.

The roof consists of a cable-suspended structure with all of the supporting columns located at the rear of the stand to give unobstructed viewing from the seating.
