13. Bowen Bridge, Hobart (Australia)

Owner: Joint Committee on Second

Engineer: Maunsell and Partners Pty.

Contractor: Leighton Candac Hobart Bridge

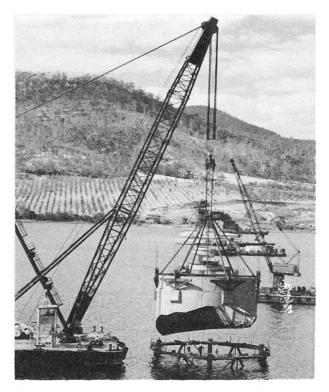
Fig. 4 Lowering first segment Pier 2 Cofferdam

The cofferdams were lowered under their own weight within a steel jacket as in Fig. 4. They were hung from external Dywidag rods connected to a hydraulic jacking system which enabled the forces in the hanging rod to be controlled by sequential excavation and lowering. The hydraulic system also permitted the cofferdam to be steered. In the stiffer silts near the geological interface, the cofferdams were jacked down by means of jacking down trusses. After pouring the tremie plug the pressure

relief holes were drilled through it and piezometers installed prior to dewatering the cofferdams.

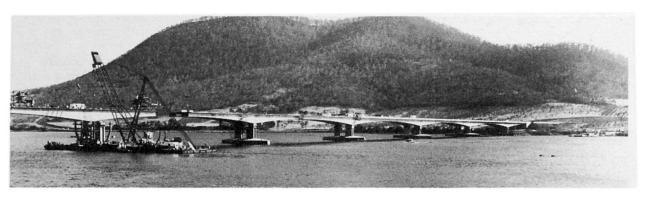
Fig. 5 Cantilever erection of deck

Deck erection was basically from the water using small erection gantries as shown in Fig. 5. The first five segments (325 tonnes) of a double cantilever were stressed in the casting yard and erected in one piece using the Contractor's large derrick barge.
