Artikel: Lietvesi Bridge, Puumala (Finland)
Autor: Hyvönen, J.
DOI: <https://doi.org/10.5169/seals-20905>

5. Lietvesi Bridge, Puumala (Finland)

Owner:	<i>Finnish Roads and Waterways Administration (RWA)</i>
Design:	<i>RWA and Insinööritoimisto Pontek Ky</i>
Contractor:	<i>OMP-Yhtymä Oy</i>
Construction Work Duration:	<i>18 months</i>
Completion:	<i>1986</i>

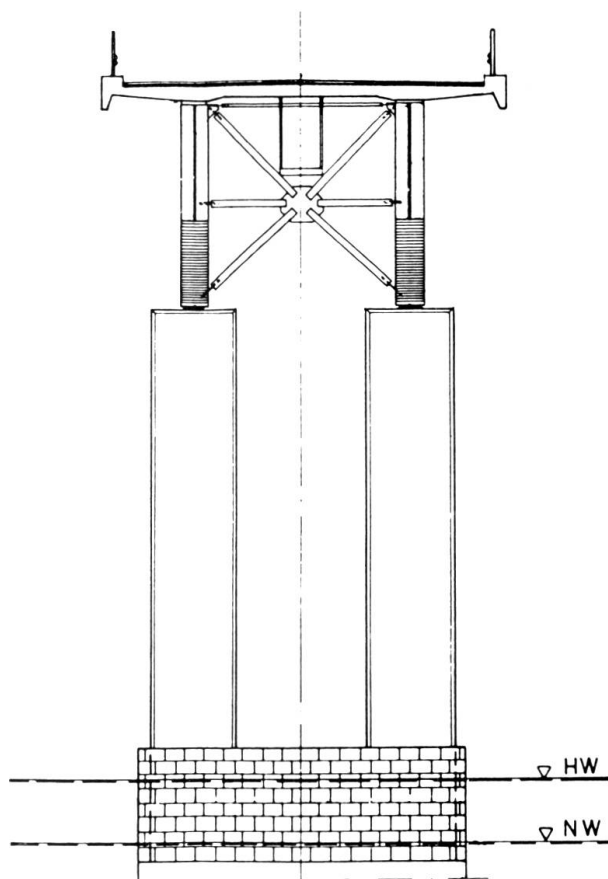
Fig. 1 Bridge cross-section

The bridge has a composite superstructure. The steel main girders are 5.0 meters apart. They are connected by cross frames at c/c 8.0 meters, by lateral bracing located 2.6 meters below the upper flange of the girder, and by a reinforced non-tensioned concrete deck slab. The superstructure was analysed using an element model. The result of the analysis consisted of the member forces of the cross as well as the lateral frames and of the forces of the main girders.

The main girders were manufactured according to Finnish Standards SFS 255 fine grained steel Fe 355E (corresp. TStE 355/DIN 17102). A total of 800 tons were used for the bridge. The main girder chords are 800 mm wide at their largest point, and their maximum thickness is 120 mm. The web thickness varies from 16 to 24 mm. At the piers, the lower chord is «bent», using a 10 meters radius. The cross and lateral frames are K-frames. Their members are made of square tubes steel grade Fe 520 according to Finnish Standard SFS 200 (St 52-3/DIN 17100). For the frames 40 tons of steel was used.

For the non-tensioned bridge slab 750 m³ of concrete and 160 tons of reinforced steel were used. The longitudinal slab reinforcement is, at the intermediate supports, about 2 % and even in the span about 1 % of the concrete cross-sectional area. In this way the crack width has been considerably limited. The price of reinforcing steel is only half the price of structural steel. It is therefore, at the intermediate supports, economical to use it «as the upper chord of the main girder».
